Property Description: (1) story single family home
Property age/ size: Built 1959, 1,310 s.f. per listing
Occupancy Status: Vacant

Inspection Date: 12/19/2011
Inspection Time: 11:00 A.M. – 2:00 P.M. +-
Weather Conditions: Overcast, 50 deg F +-

Hergert Inspection LLC

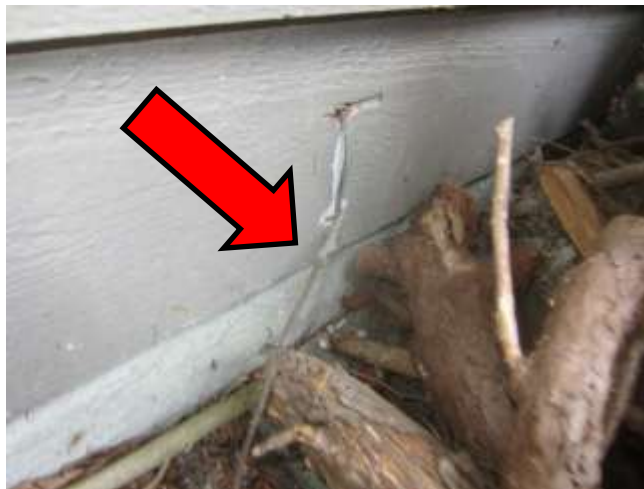
Exterior grounding wire

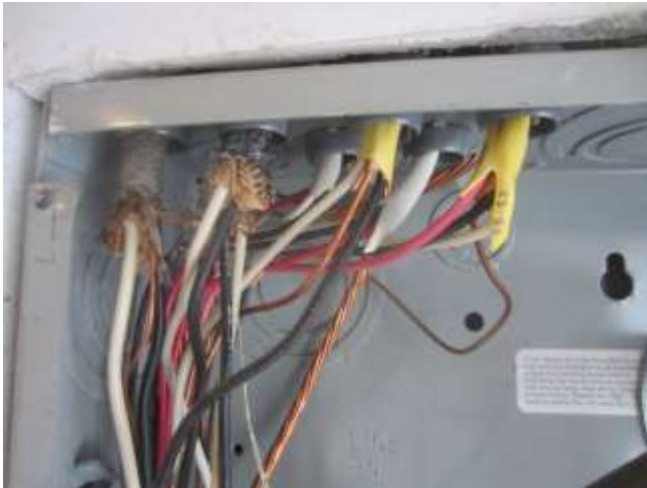
- The National Electrical Code (NEC) 406.3(D)(3) allows ungrounded (2) prong outlets without a third (grounding) wire, but only IF you install a GFCI receptacle to replace the 2-prong receptacle, or install a GFCI circuit breaker for that circuit, and mark the outlets "GFCI Protected" and "No Equipment Ground"
- Note: Surge suppressors used for computers and other electronic equipment require a properly installed grounding wire to work correctly

Wiring is a mix of 2 and 3 (grounded) branch wiring

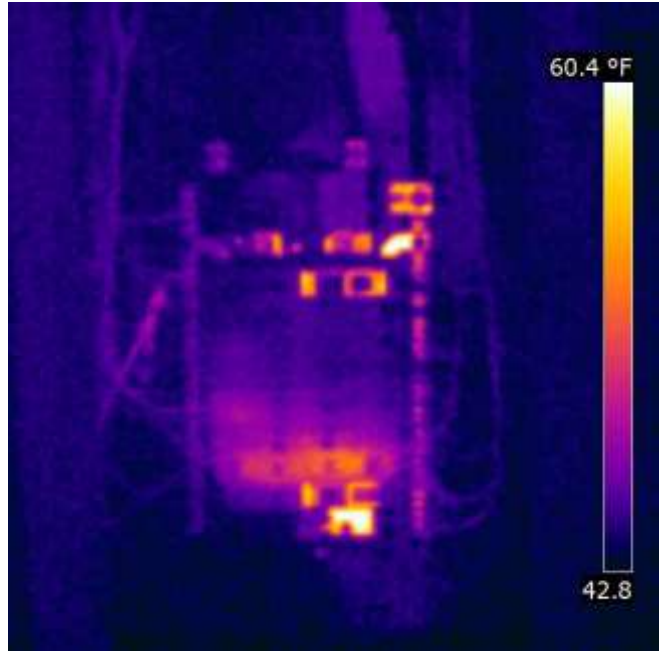
No evidence of over heating

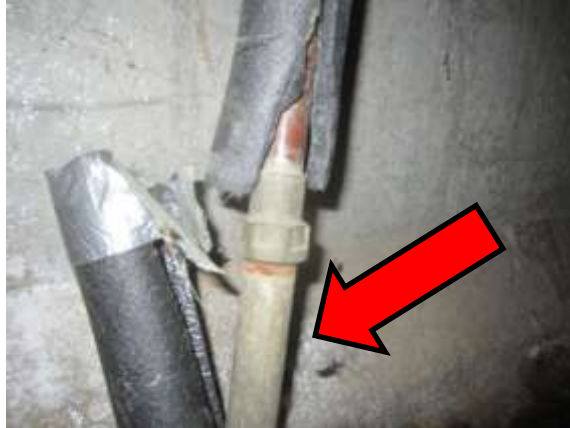
- Galvanized piping is a known defect. These pipes rust from the inside out causing a reduction in functional flow. This loss of functional flow is evident at this property

Galvanized supply pipe
Unable to verify proper galvanized to copper pipe connection. Improper connection will result in corrosion of the pipe

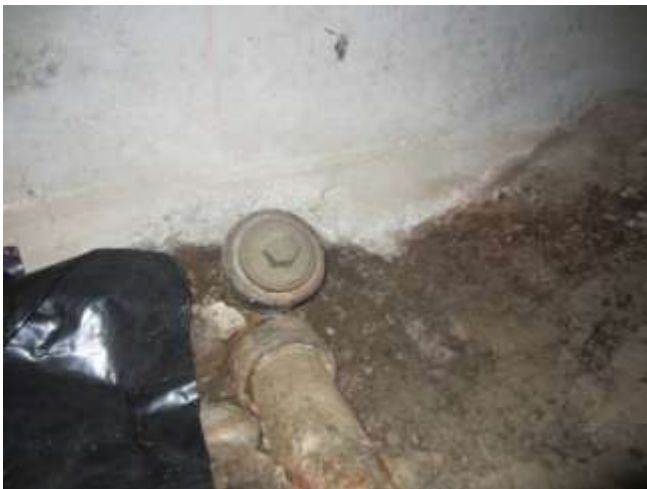
Cast iron waste line outfall near crawl access

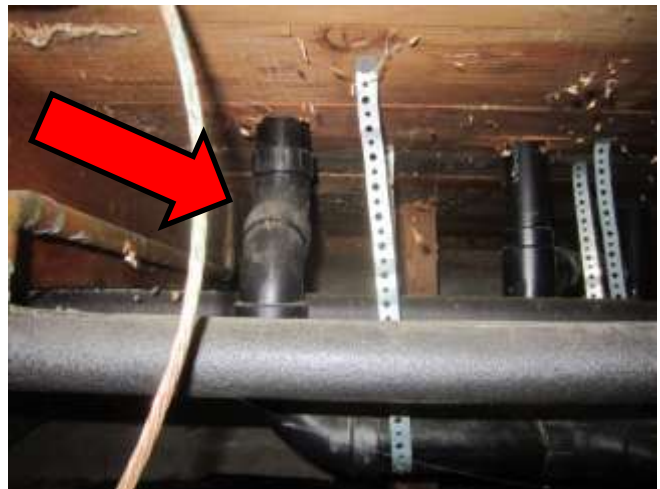
ABS waste lines beneath bathrooms

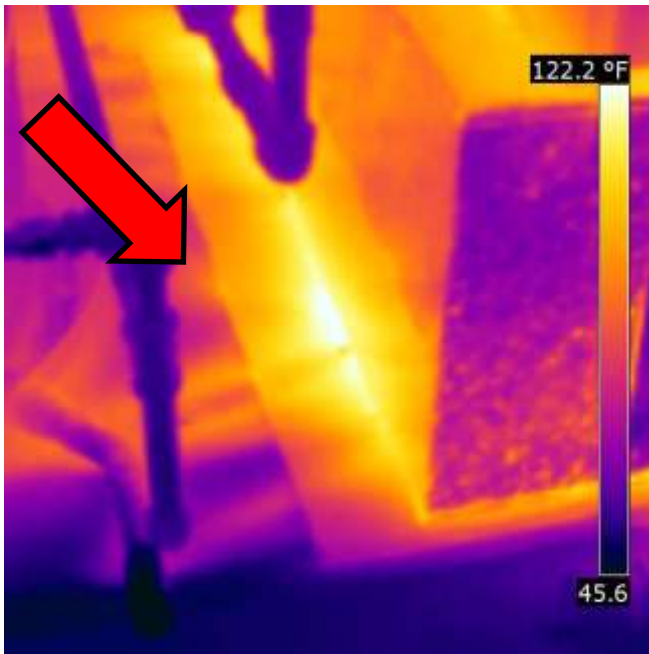
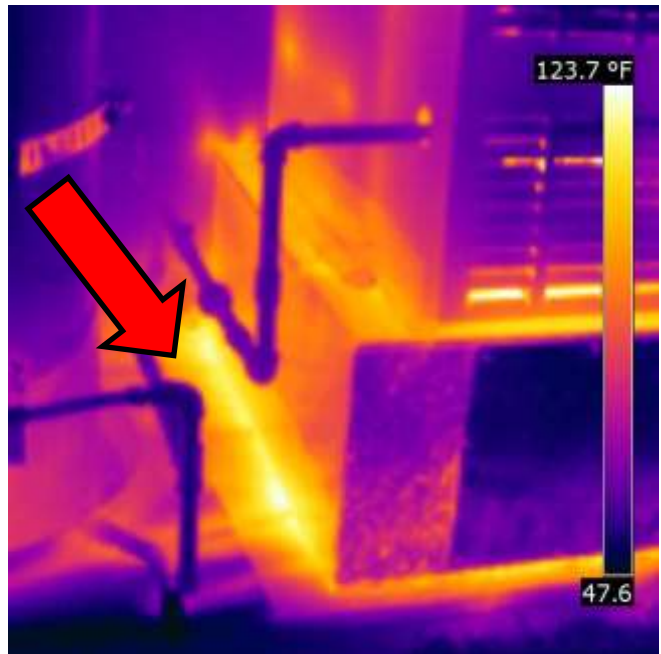
Air leakage at furnace

- Substantial air loss at the base of the furnace. Recommend have furnace serviced and seal all air leakage by a licensed heating contractor - technician

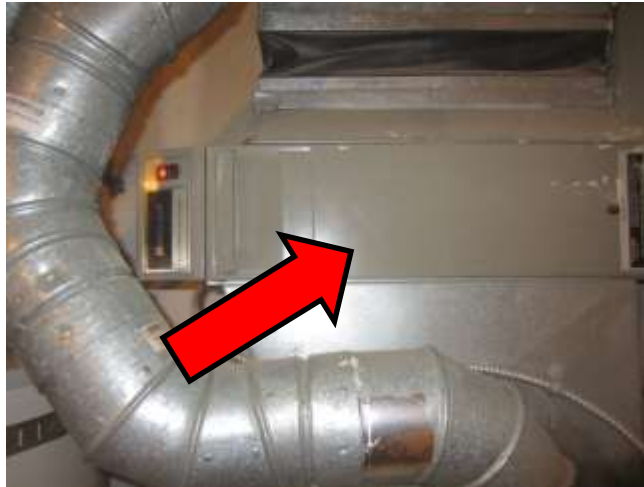
Furnace filter compartment

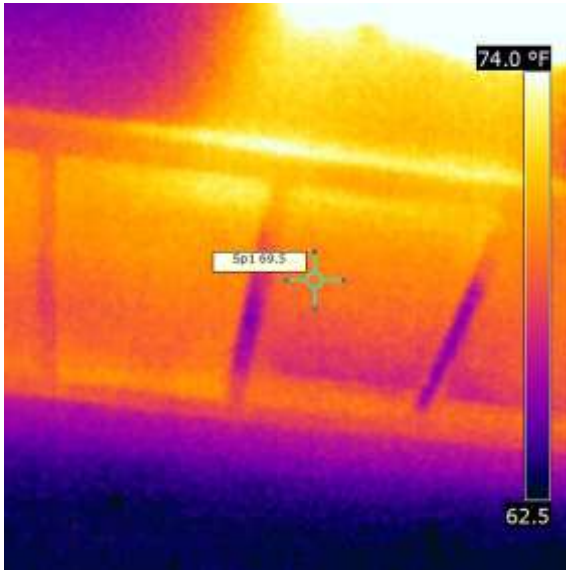
Rating: 45-75 deg F
@ return air: 69 deg F
@ nearest register: 118 deg F
Heat Gain: 49 deg F. Heat gain is within specifications of furnace

Temperature measured at return air

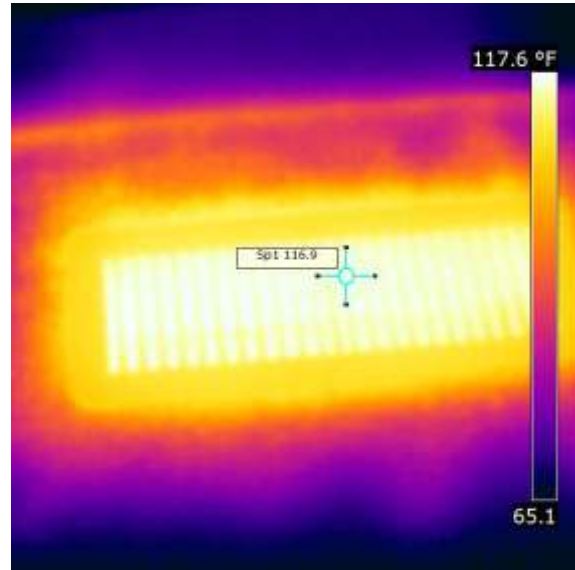
Temperature measured at heat register

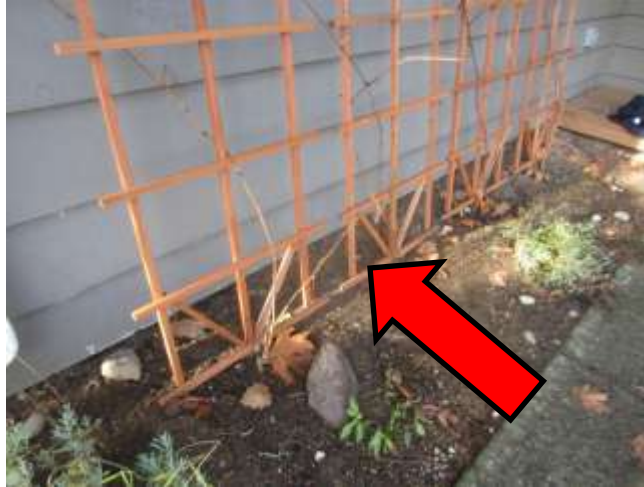
Ground in contact with siding (typical)

- Structure in contact with ground (WDO conducive condition). Recommend 4-6” separation between ground and structure

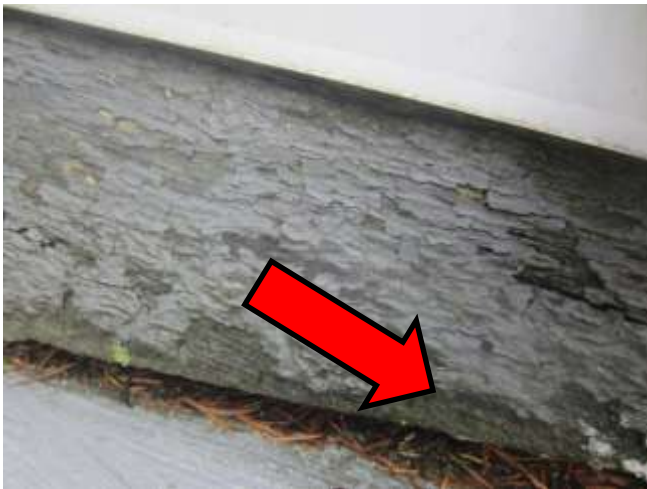
- Wood rot at fascia board at West upper gable end

Wood rot at fascia board

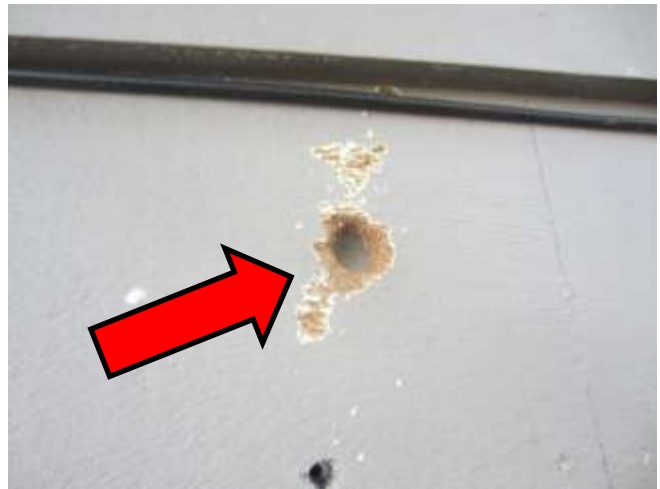
- Question to Seller: What is the reason for the hole at the East wall near the Dining Room area ?

Hole in Siding

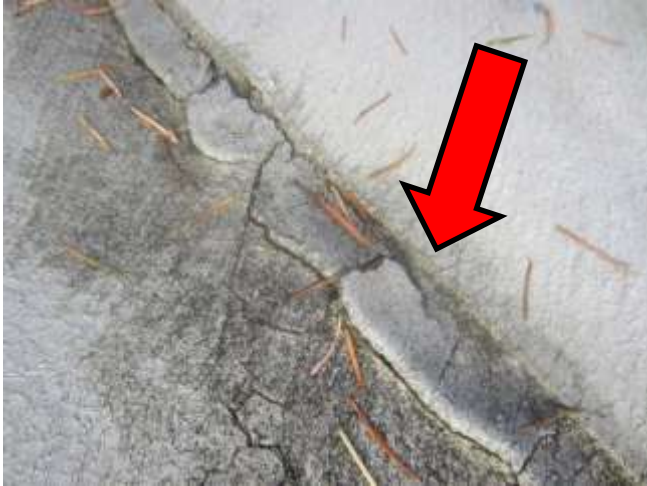
Recommend seal gaps at valley

- Recommend another finish coat at the East area of the roof and at the valley above the garage

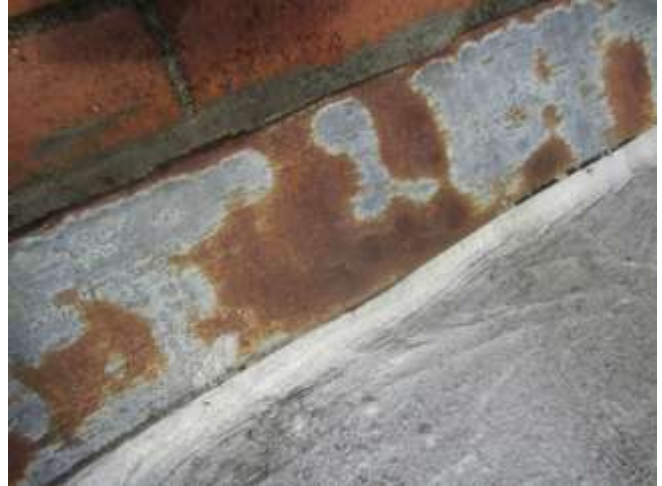
Counter flashing at chimney
A coat of rust kill-proof paint would help prevent further deterioration

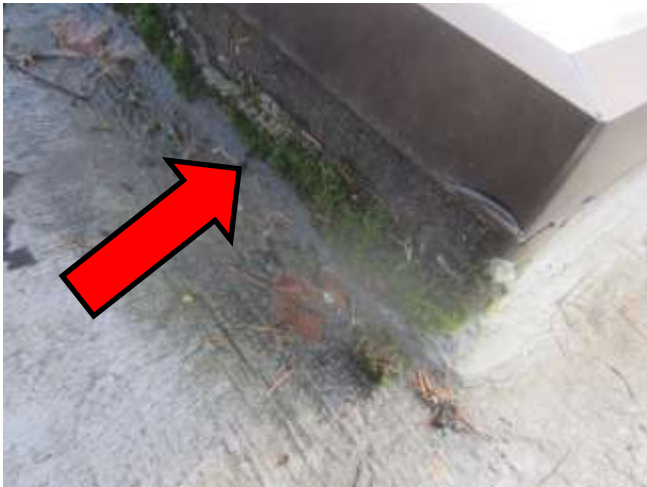
Moss build up at the upper side of the skylights

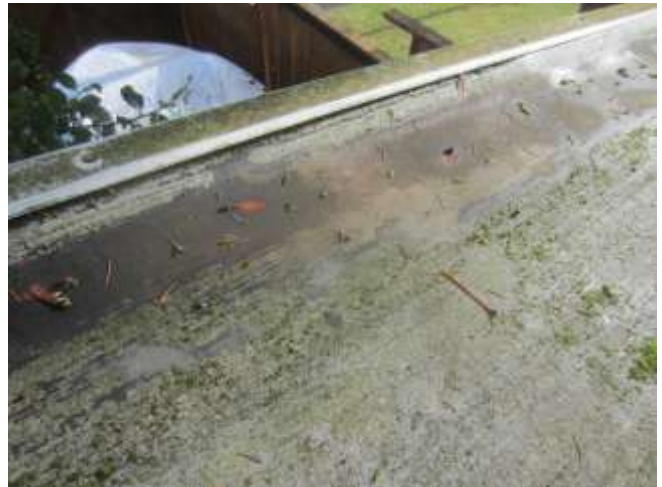
Moss build up and no coating at East roof area

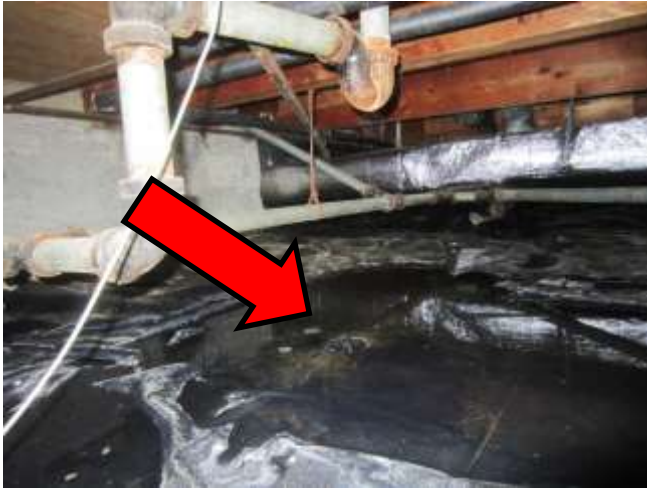
- Active leak detected beneath the Main bathroom tub area

Standing water beneath Main bathroom

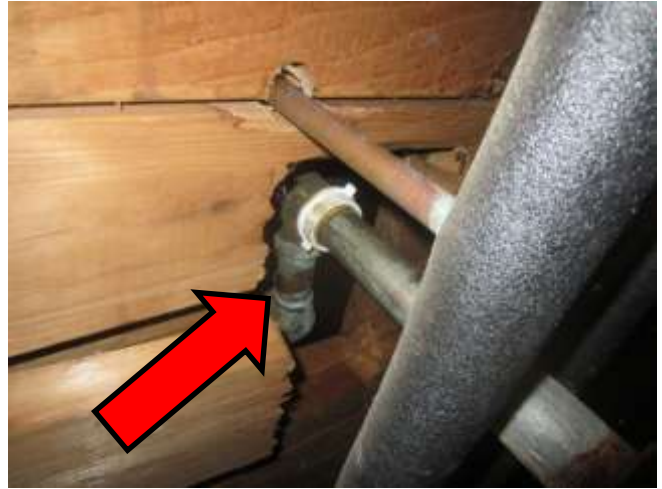
Water drips from tub drain area

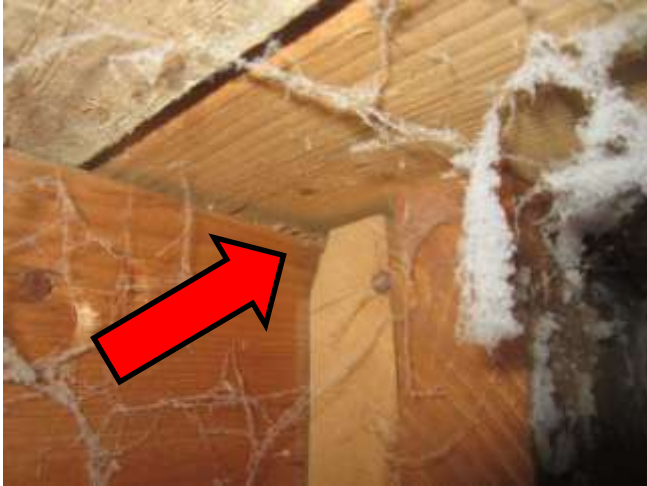
Floor beam below Master bedroom is tipped upwards at the splice creating a floor bump

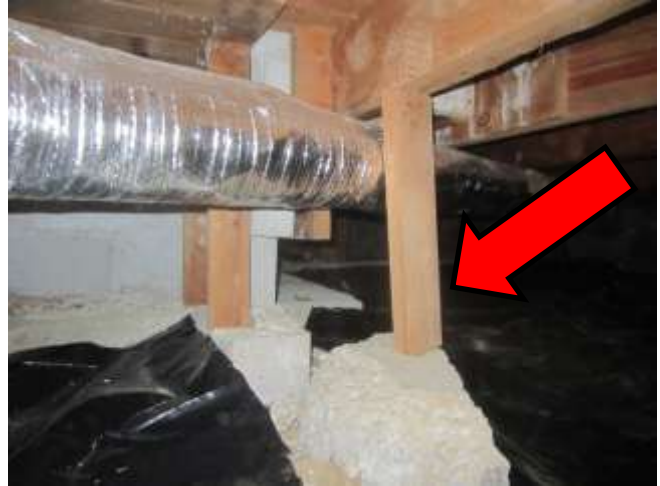
Support post is placed on concrete debris near the West side of the chimney area.
Wood is not pressure treated and is at an angle

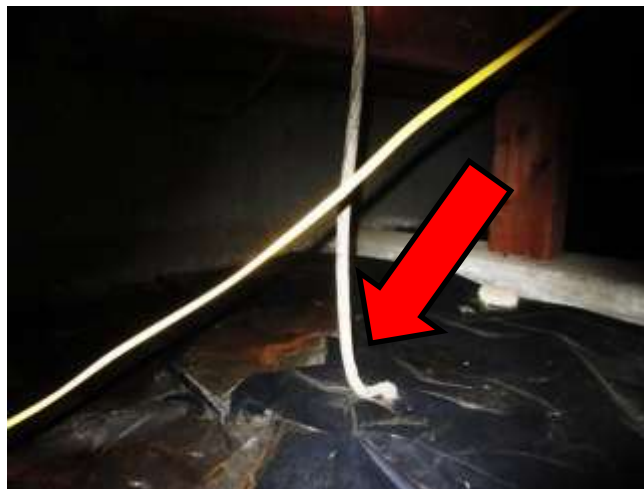
Presumed abandoned electrical wire in crawlspace
Yellow wire should be secured to framing above

- Abandoned electrical wires should be removed from the crawlspace

- Electrical wires should be properly secured to the framing

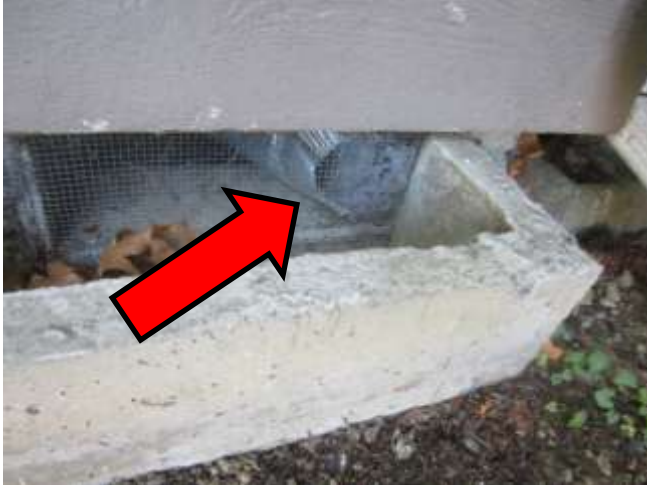
Dryer vent does not extend out from crawlspace

- Dryer vent appears to be leaking into the crawlspace and should be properly extended to vent to the exterior. Vent cover should not have a screen due to lint build-up

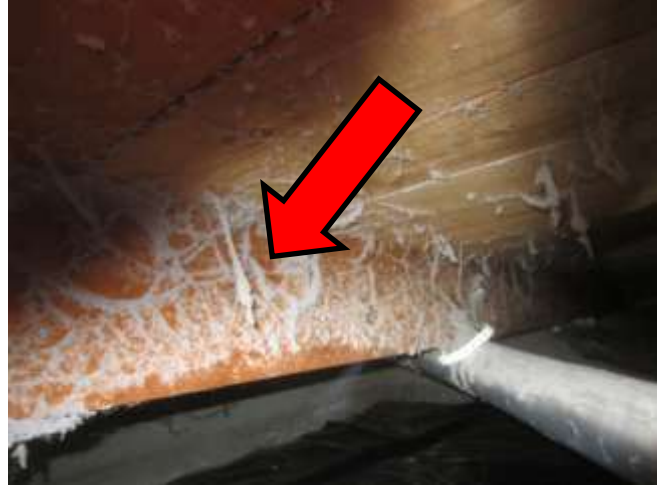
Lint inside the crawlspace

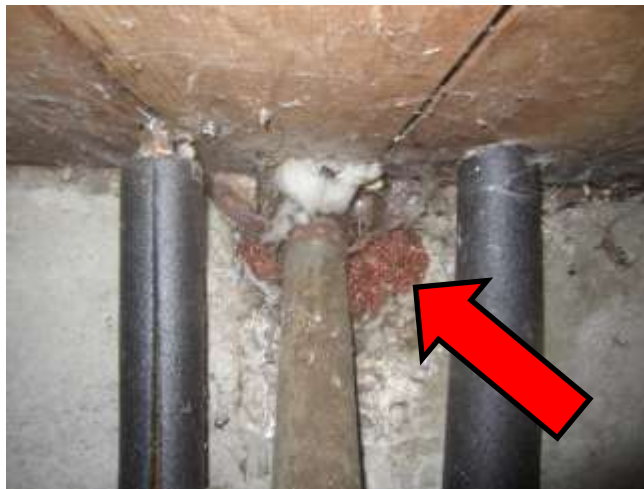
Metal mesh is placed beneath Kitchen sink to deter rodents from chewing into cabinet above

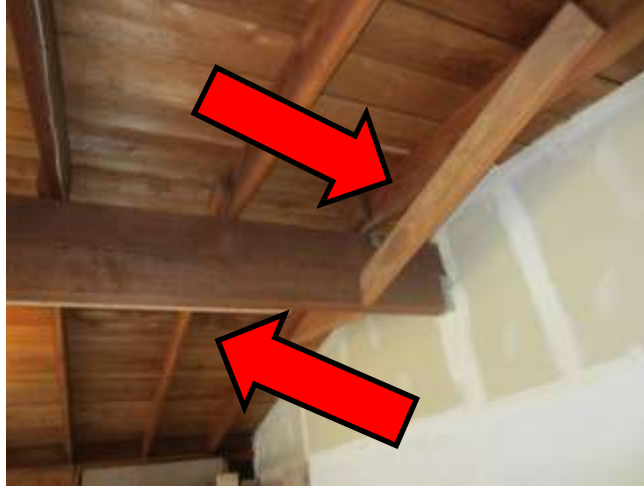
Rafter supports added
2 x scabbled onto side of beam

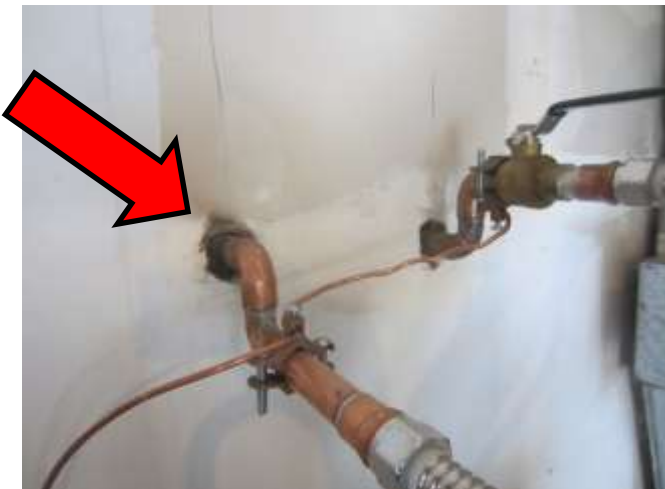
Holes in drywall

- Holes in drywall at water heater should be sealed. The metal collar at the flue should be attached to the drywall

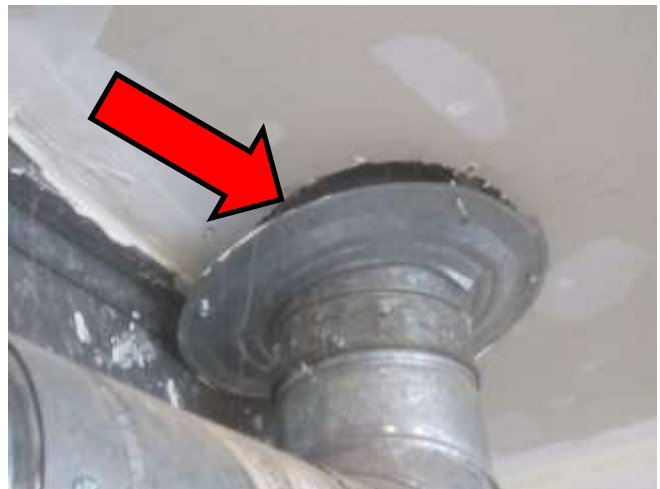
Loose flue collar

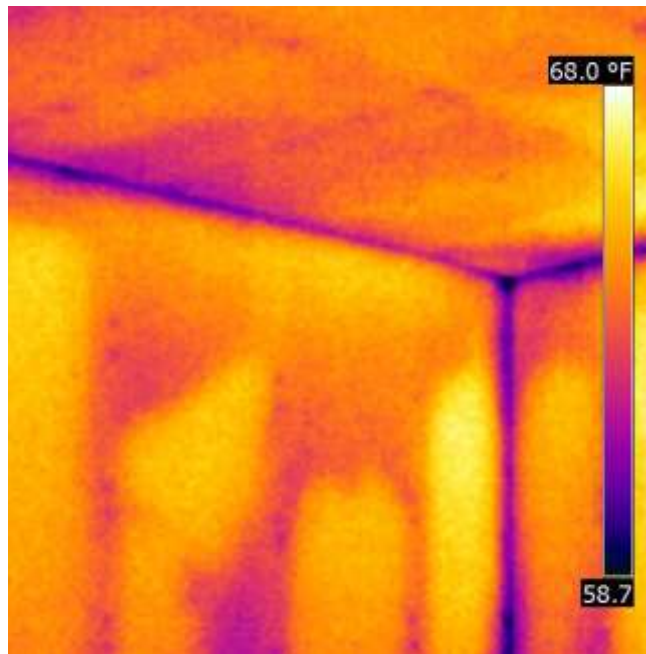
Insulation appears to have settled in wall cavities

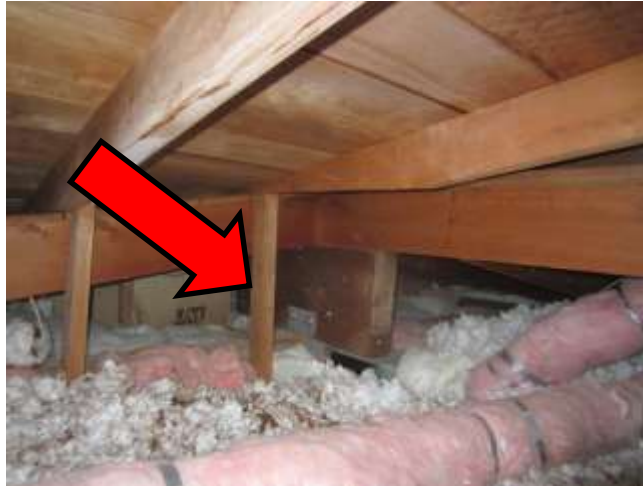
Beam appears to have been added
Beam connector was not common at the time of
original construction
