Property Description: (3) story townhouse  
Property age/ size: 2,781 s.f., built 2007 per listing  
Occupancy Status: Vacant

Inspection Date: 08/29/2011  
Inspection Time: 12:30 P.M. – 3:50 P.M.  
Weather Conditions: Clear, 70 deg F +-

Hergert Inspection LLC

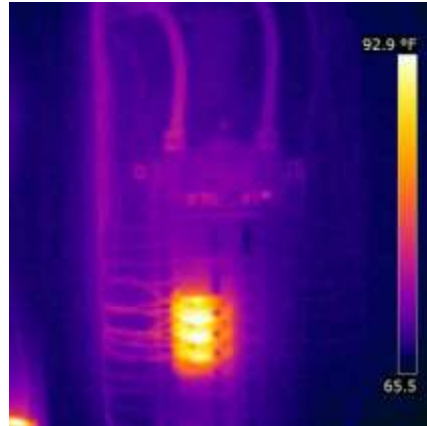
No evidence of over-heating  
(arc fault breakers shown in yellow  
run hotter than others)

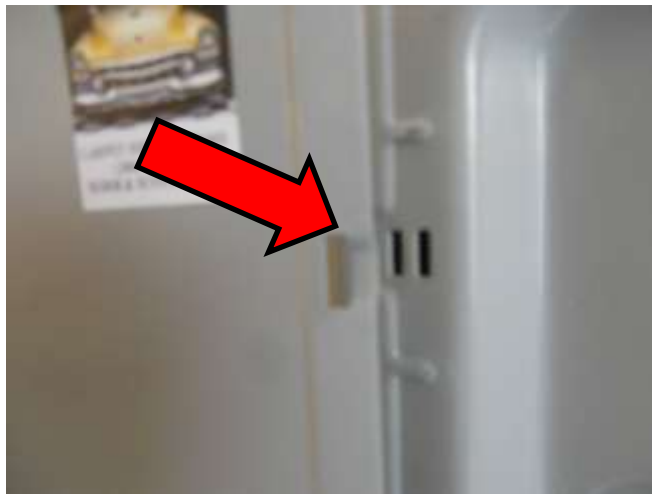
Location: Garage  
Manufacturer: Siemens  
- Electrical panel cover hinge missing  
Type: Dual bus bar  
Panel Rating: 200 AMP  
Main Disconnect: 200 AMP  
Serv. wire Size/ Rating: 200 AMP  
Sub-panel: No  
Grounding: Copper to exterior ground rod, limited visibility  
Panel Clearance: 30" wide, 3' in front as required

Hinge missing at electrical panel

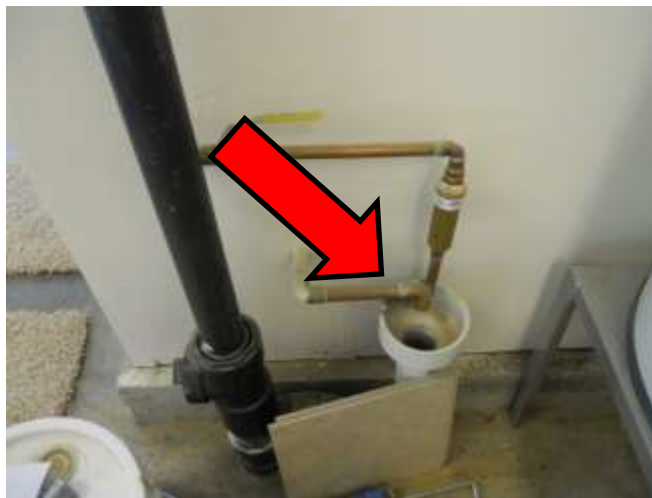
Drip (primer) valve for TMP discharge into P trap  
Valve is to drip water to keep water in P trap to  
prevent sewer gases from escaping

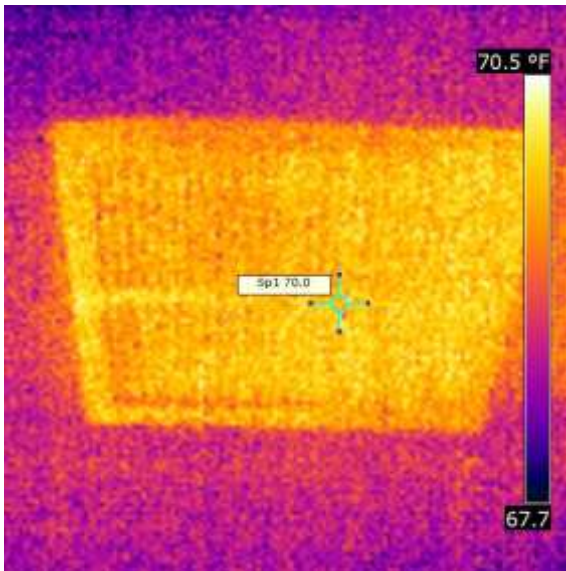
- Rating: 40-70 deg F  
@ return air: - *Not verified as heating system inoperable*  
@ nearest register: - *Not verified as heating system inoperable*

Temperature measured at return air

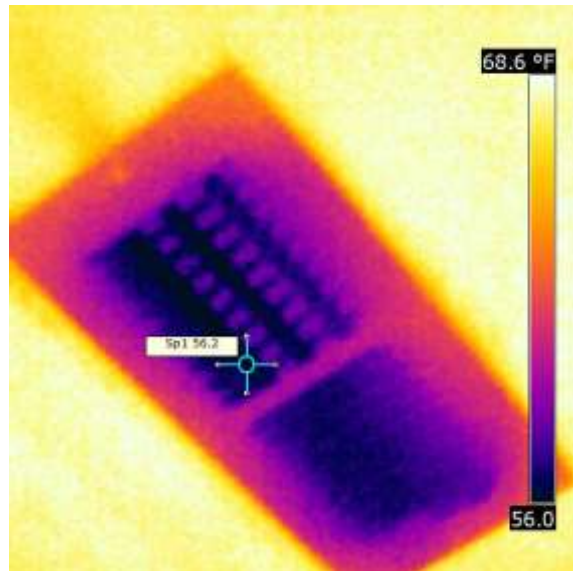
Temperature measured at register

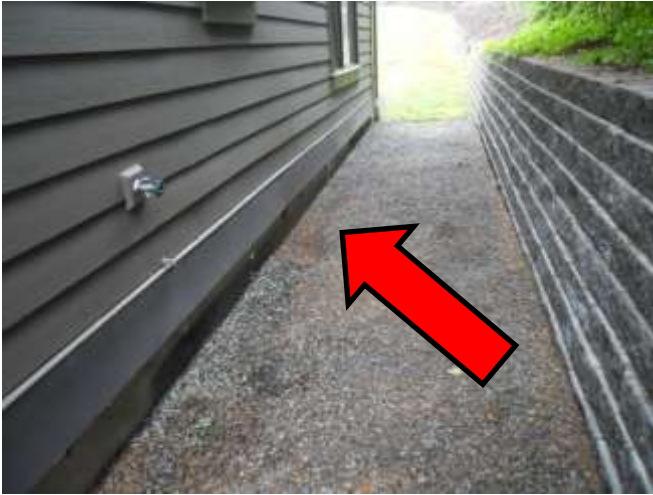
- Grade at structure: - *Marginal grade away at East area of South wall*  
- Ground is saturated at S.E. corner of building. Possible solution would be an interceptor type drain.
- Earth to wood contact: - Earth to wood contact at several area including deck posts. Ground should be 4-6 below wood
- Vegetation contact: - *Vegetation in contact with structure (WDO conducive condition)*
- Roof drain discharge: Underground discharge

Reverse grade to structure

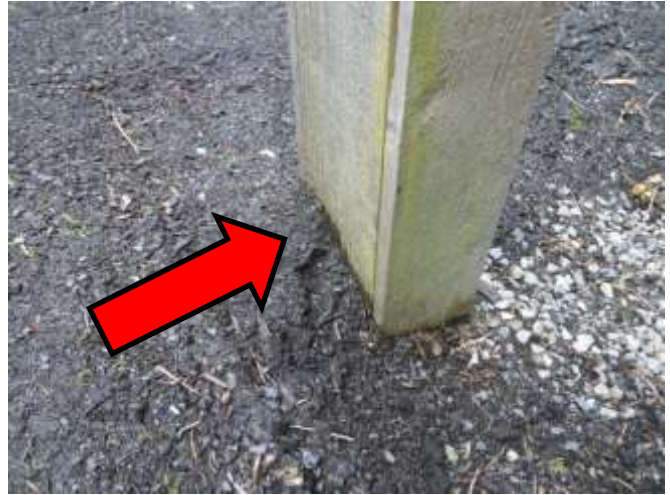
Ground in contact with wood  
Potential wood rot condition

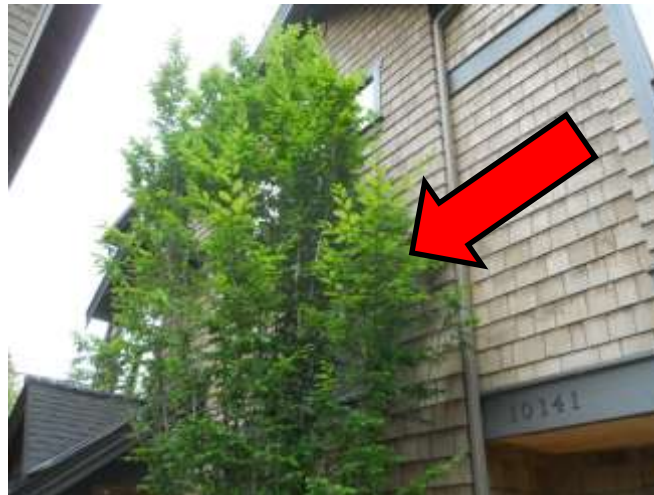
Vegetation in contact with structure  
WDO conducive condition

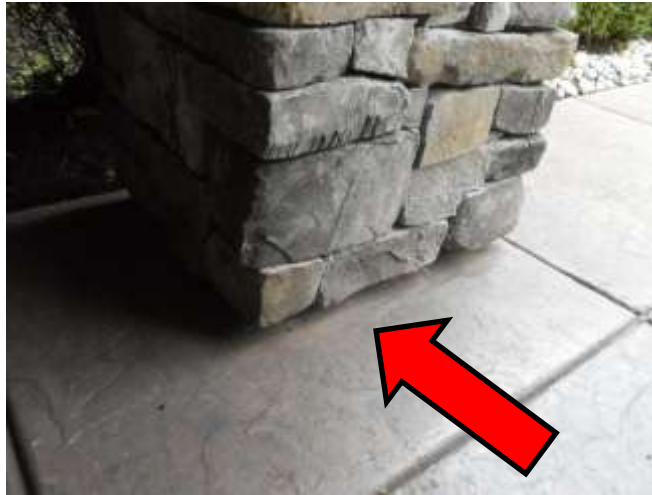
Type: Concrete  
Condition: Satisfactory  
- Evidence of settlement at side patio. Masonry veneer at post is not secure to patio (wobbles). Recommend fill voids with mortar and/or cultured stone  
Trip Hazard: None

Gap at N.E. patio pier  
See prior comment in Site section

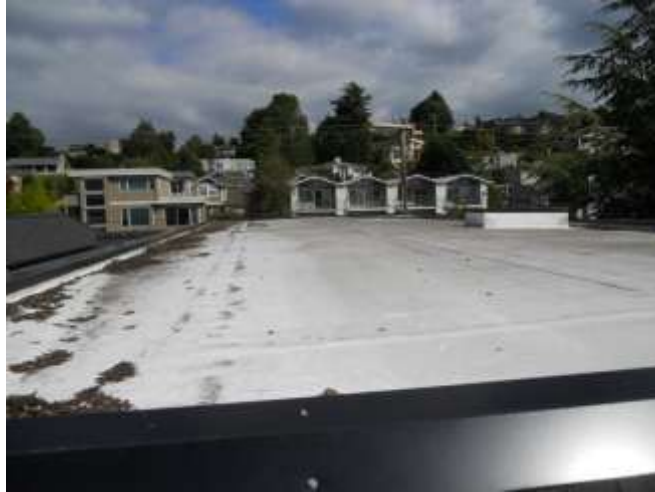
Membrane roofing  
Scuppers need to be clear of debris

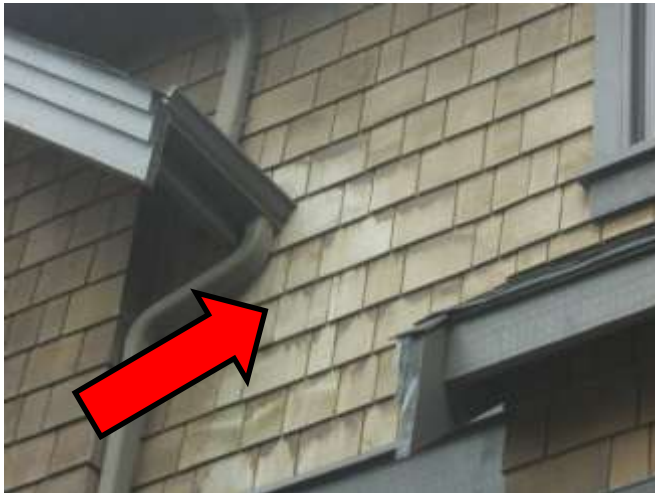
- Gutters and roof scuppers should be cleaned off all debris. Particular concern is gutter to left of garage that shows evidence of spillage onto siding below

Siding stain shows evidence of spillage

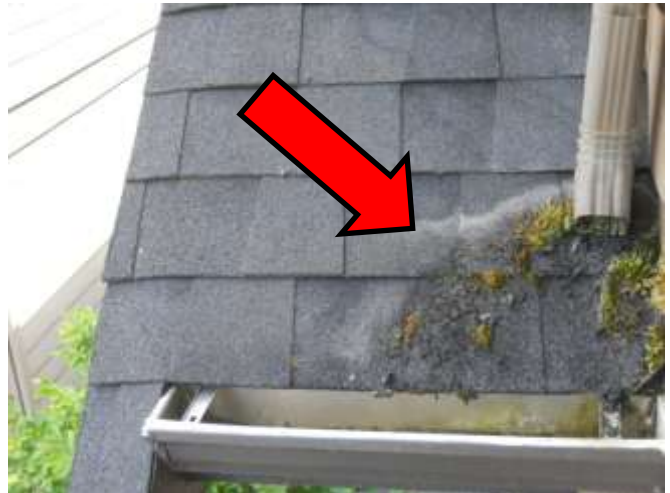
Gutter above and left of garage

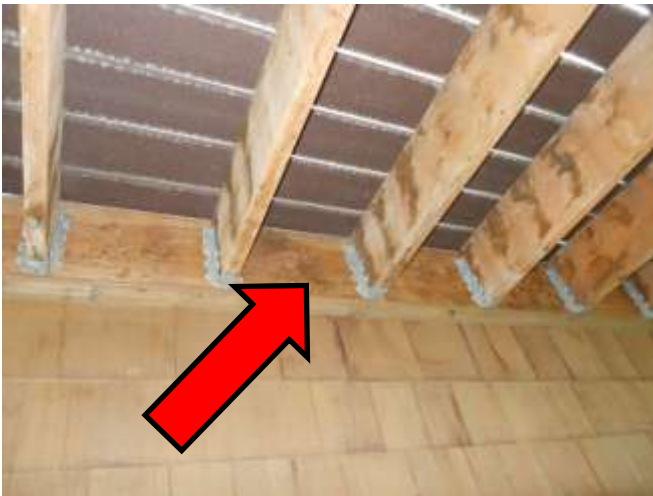
- Structure: Pressure treated joists  
Decking: Composite  
Condition: Satisfactory  
Connection to Structure: - Deck ledger should be lag bolted to structure to prevent separation of deck(s) from house  
Trip Hazard: None  
Barricades: - *Barricades at all decks do not appear to meet code requirements. 36" high, no sphere greater than 4" can pass thru space*  
- Substantial paint/finish deterioration at all deck rails; several areas not properly caulked to prevent moisture intrusion into barricade

No evidence of lag bolt connection of deck to house

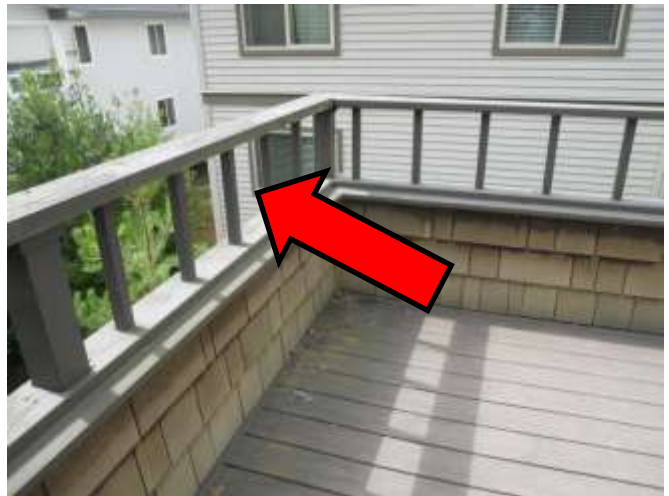
Rails do not appear to comply with code

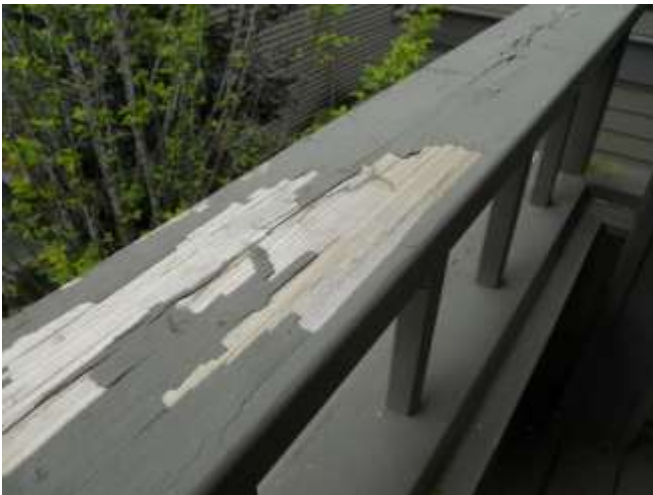
Substantial weathering of deck rails

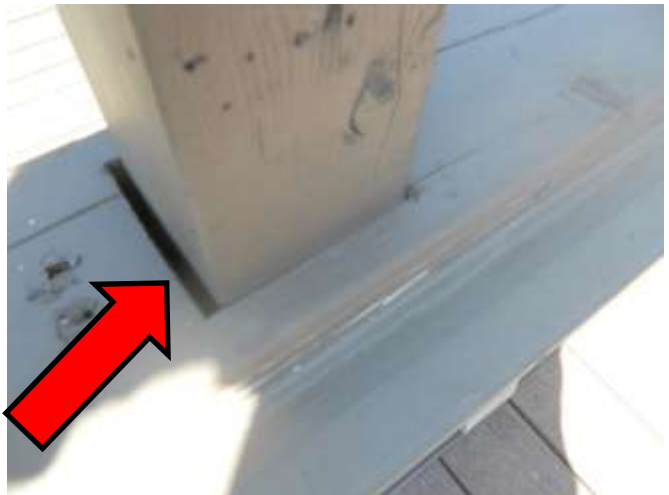
Gaps at posts at deck rail could lead to wood rot

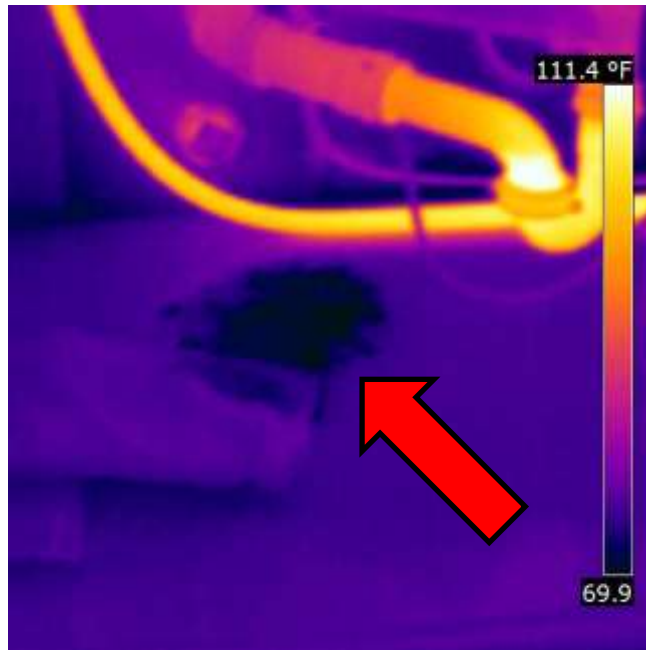
Functional flow: Appears adequate  
Hot/ Cold: Tested  
Drainage: Appears adequate  
Visible leaks: - Leak beneath Kitchen sink  
Disposal: - Debris in garbage disposal  
Caulking: Satisfactory  
Fixtures: No visible defects

Leak at Kitchen sink

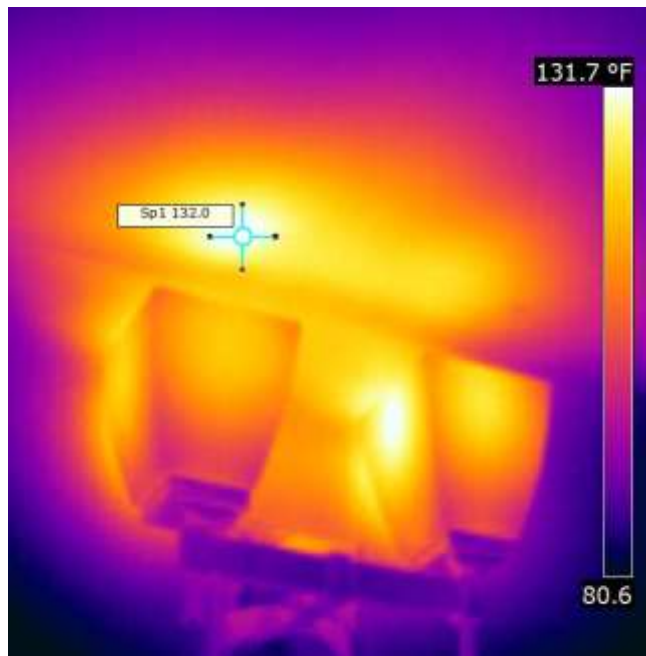
Switches/Lights: - Light fixture appears to be installed upside down (likely will leave heat marks on ceiling)  
Outlets: All visible tested. Bathroom outlets are GFCI protected - *Reset in main bathroom*  
Smoke detector: Tested

Light fixtures face upwards close to ceiling

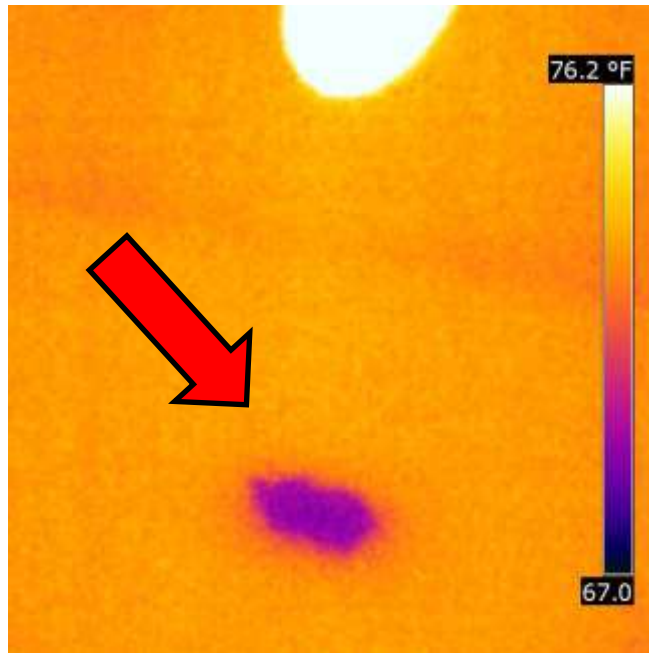
Functional flow: Appears adequate  
Hot/ Cold: Tested  
Drainage: Appears adequate  
Visible leaks: - Leak beneath right sink  
Caulking: - Re-caulk inside corner of tub-shower wall and at tile near floor  
Toilet Secure: Satisfactory  
Tub/Shower surround: Satisfactory  
Fixtures: - Sink valves and spouts are not secure; left sink stop disconnected

Leak at bathroom sink
