Property Description: (1) story single family house w/ attached carport  
Property age/ size: 1,880 s.f., built 1966 per listing  
Occupancy Status: Vacant

Inspection Date: 07/31/2011  
Inspection Time: 10:00 A.M. – 12:30 P.M.  
Weather Conditions: Overcast, 65 deg F +-

Hergert Inspection LLC

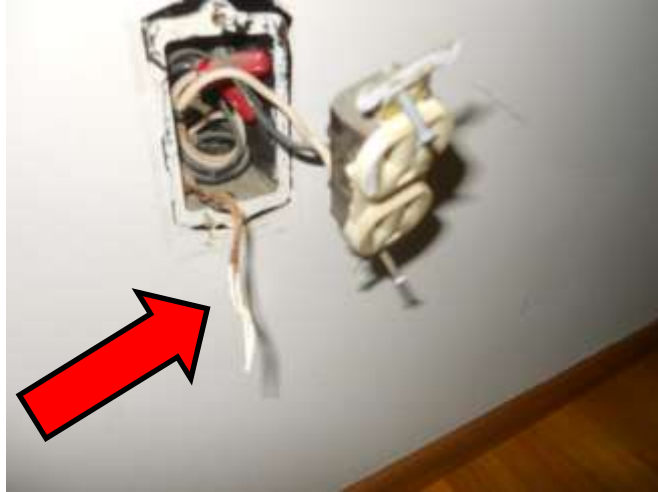
Type: Copper romex  
Breakers: No visible defects  
- All outlets in house are not grounded. Ground wire was visible at (2) outlets.  
Recommend review and repair by a licensed electrician

Outlet in bedroom  
Ground wire not connected to outlet

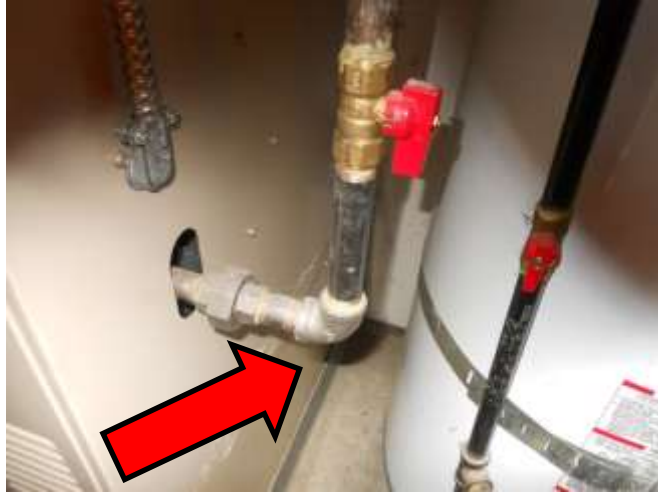
Secure: Inspected  
clearances: Per requirements where visible  
- Gas pipe to furnace should have drip leg to prevent debris in gas line from entering furnace valves

Drip leg not installed at gas piping

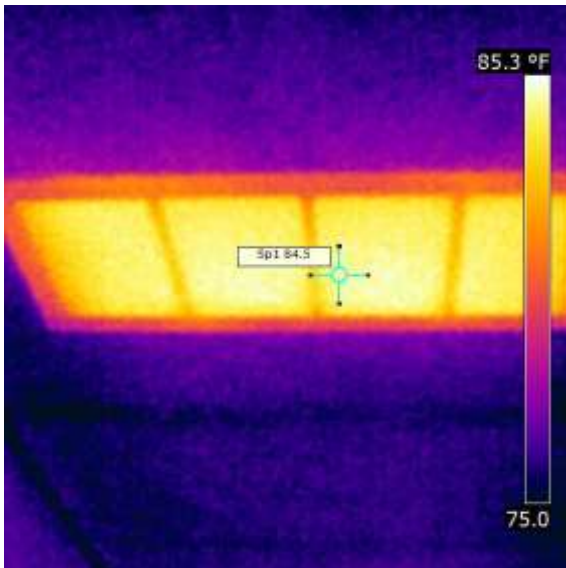
Rating: 45-75 deg F  
@ return air: 85 deg F  
@ nearest register: 151 deg F  
Heat Gain: 66 deg F. Heat gain is within specifications of furnace

Temperature measured at return air

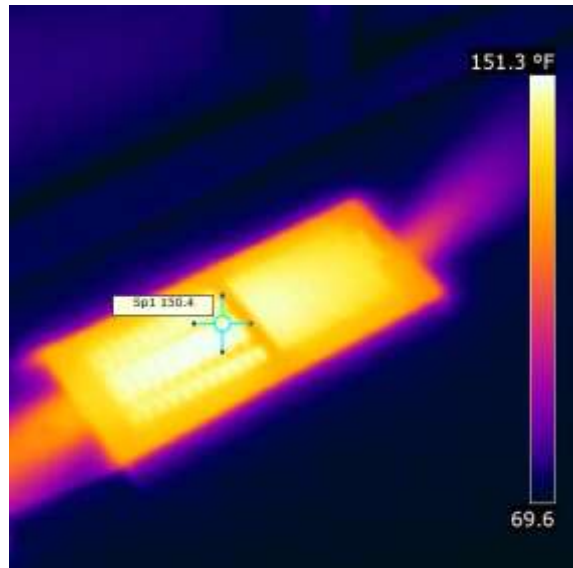
Temperature measured at heat register

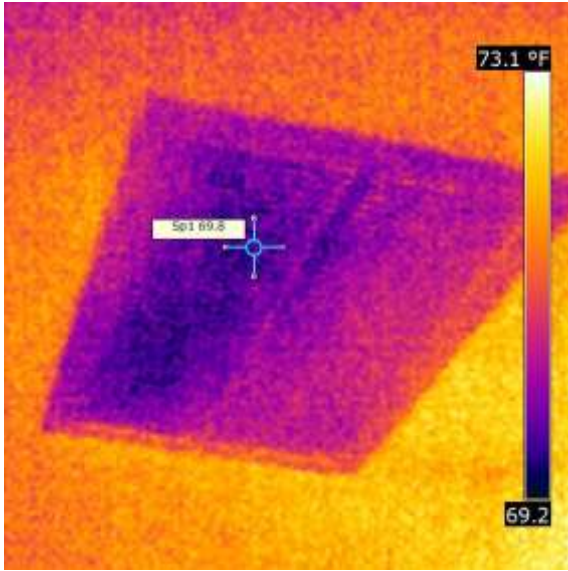
Return air in cooling mode  
69 deg F

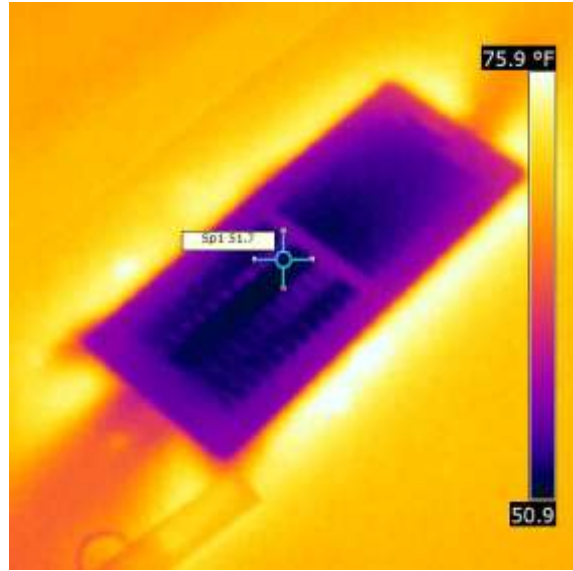
Register in cooling mode  
51 deg F

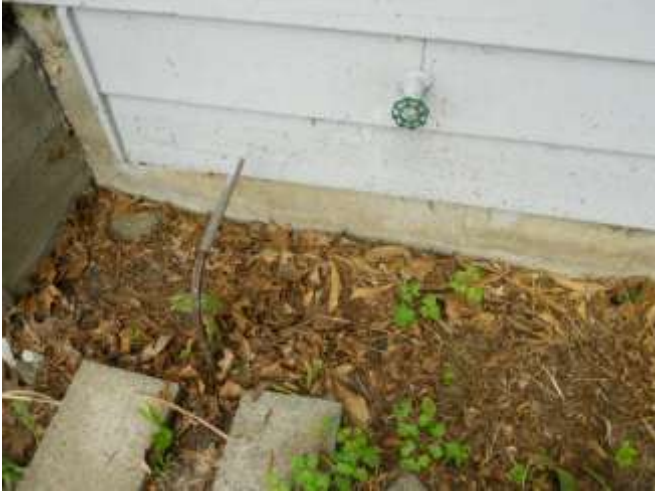
Ground slopes towards house at Master bedroom

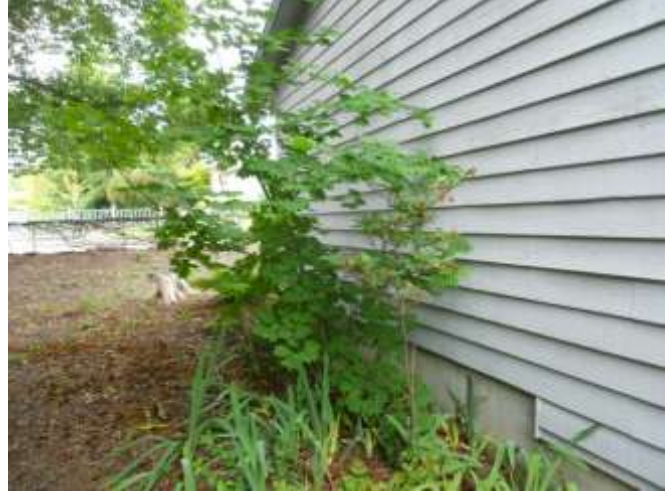
Vegetation in contact with house

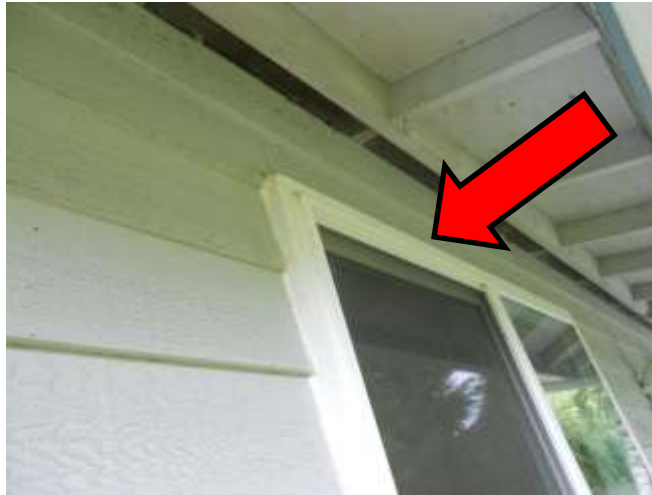
Type: Cedar  
Condition: Satisfactory  
Window/Door Flashing: *- Metal head flashing not installed on top window trim, however does not appear to result in any problems. Windows are adequately protected from rain by the roof overhand*  
Caulking: Satisfactory

Window trim does not have head flashing

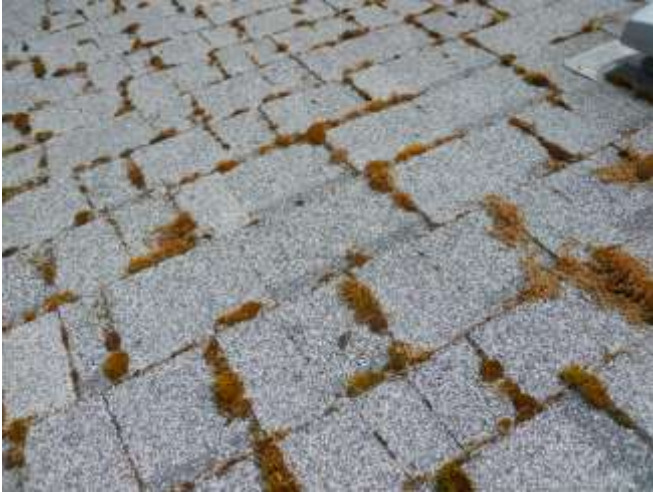
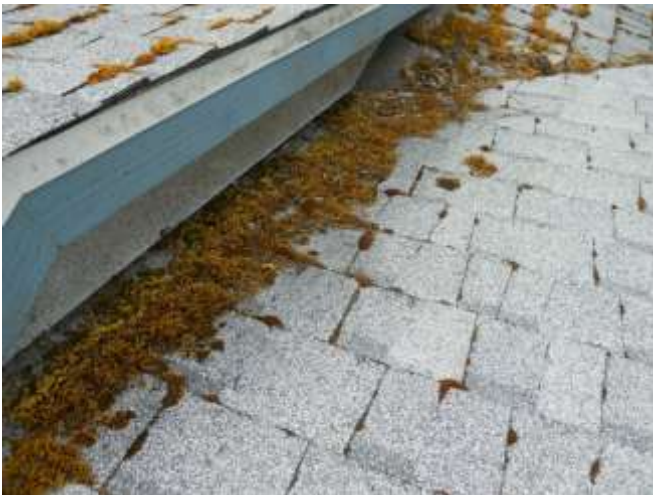
Moss build up

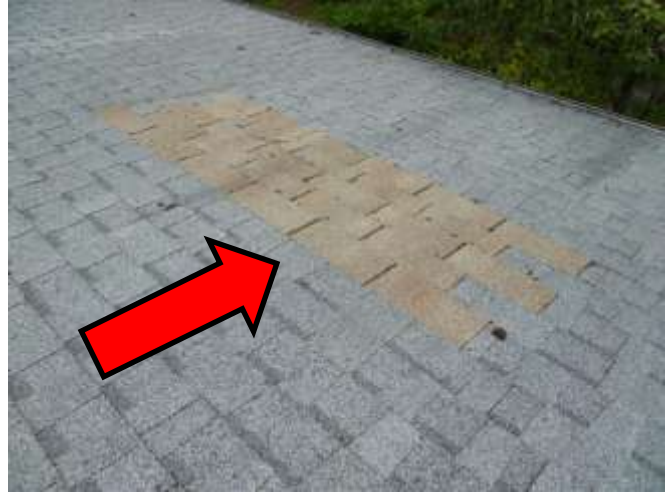
Roof repair at Kitchen

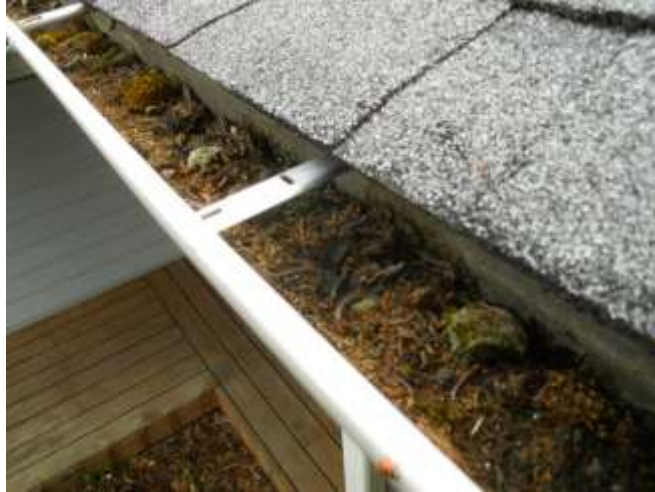
Type: Continuous metal  
Condition: Satisfactory  
- Gutters are full of debris

Debris in gutters

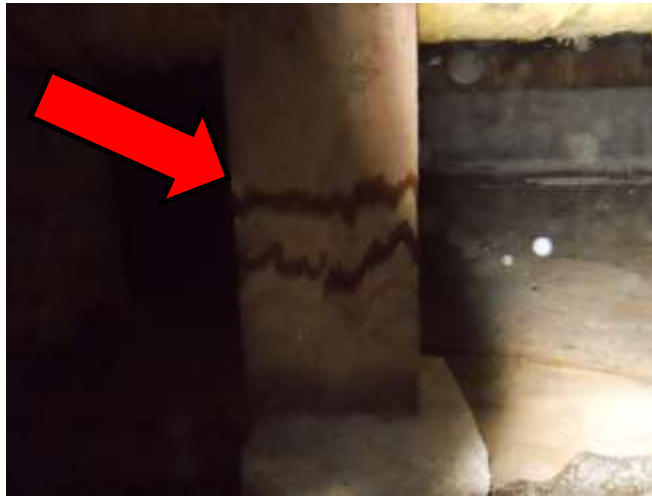
Ventilation: Appears adequate  
Vapor Barrier: As required  
Moisture Intrusion: - Evidence of significant prior water in crawl-space. Recommend continue to monitor during periods of heavy rain  
Sump Pump: None visible

Moisture stains suggest up to 1.5 feet of water in crawlspace

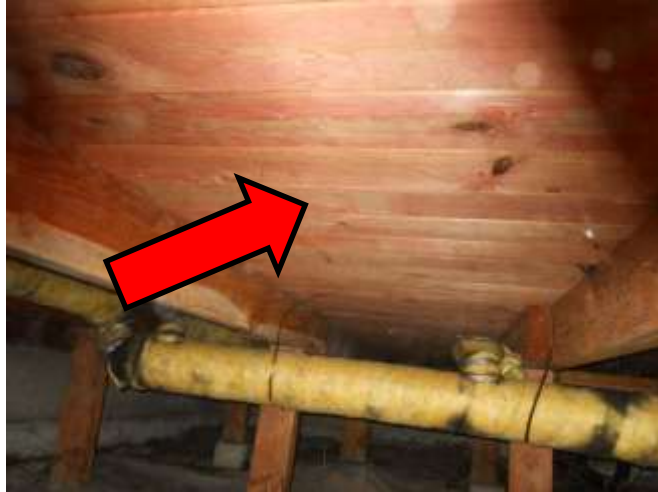
No insulation in crawlspace

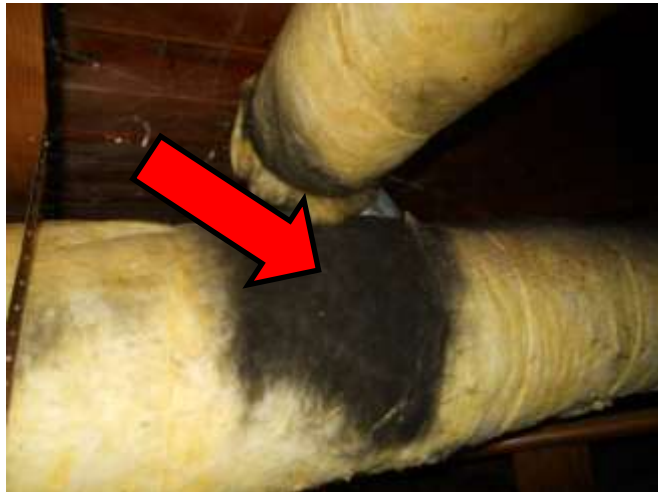
Duct Work: - Evidence of significant air leakage at heat ducts  
Ventilation Ducts: No visible defects  
Gas Piping: No visible defects

Dark areas indicate air leakage

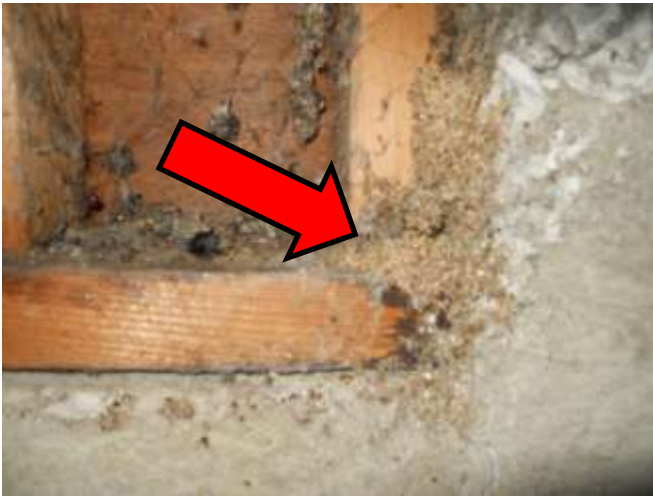
Older frass near foundation crack/stepdown by Master Bedroom

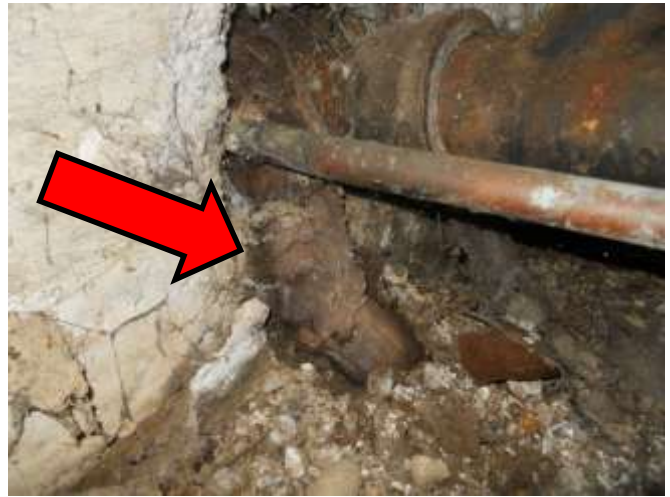
Tree root at entry of plumbing lines

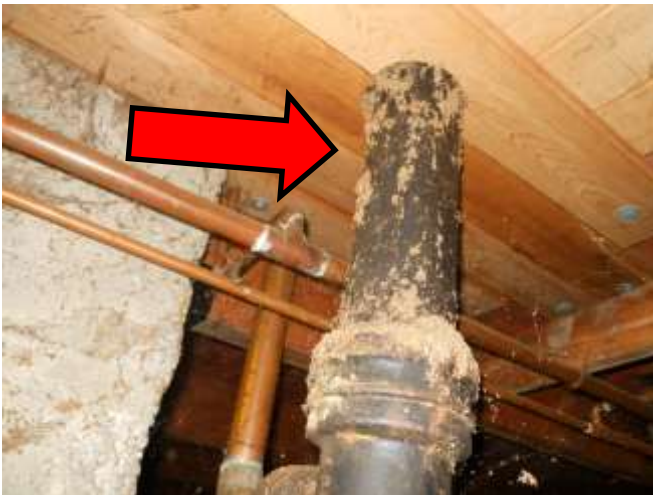
Frass at Master bathroom waste line  
No ants were visible

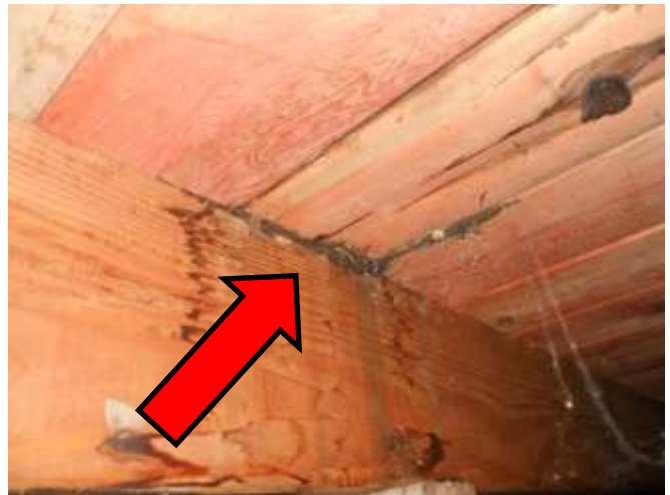
Visible Evidence: - Substantial spider webs in crawlspace. Areas of potential ant frass, however no ants were located. Recommend clean spider webs and continue to monitor  
- Wood rot at floor boards near Master bathroom shower. Recommend inspect this area for moisture once plumbing leaks are repaired inside of the house (and shower is in condition to test)

Wood rot at Master Bathroom shower area

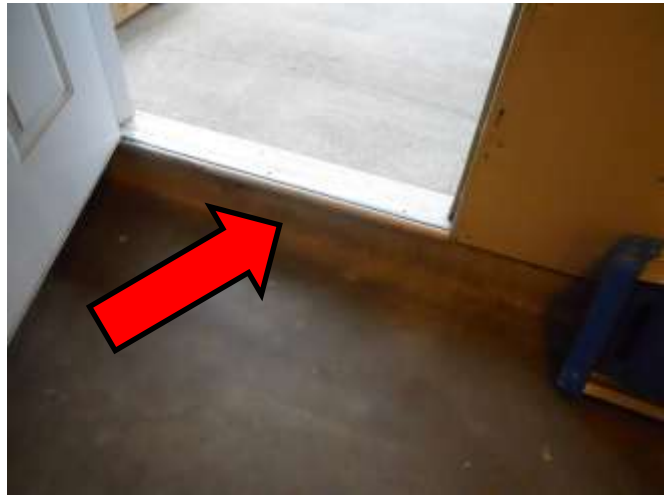
Safety barricade to mech.: - *Not required as not used as a garage*  
- *Trip hazard at door to exterior. Recommend installation of landing at door*

Trip hazard at exterior door

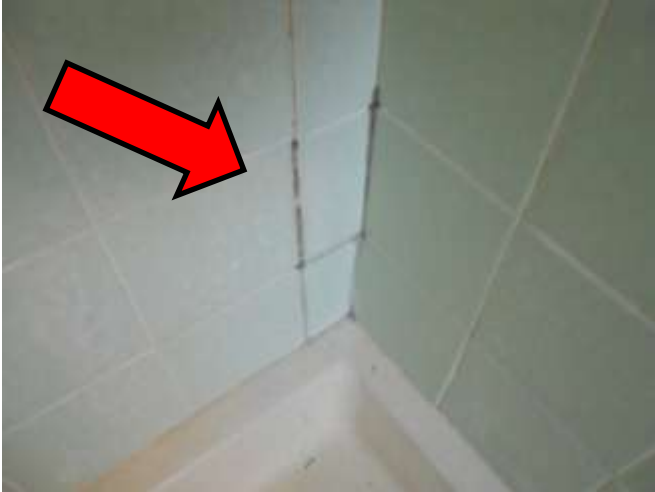
Prior repair to tile in shower

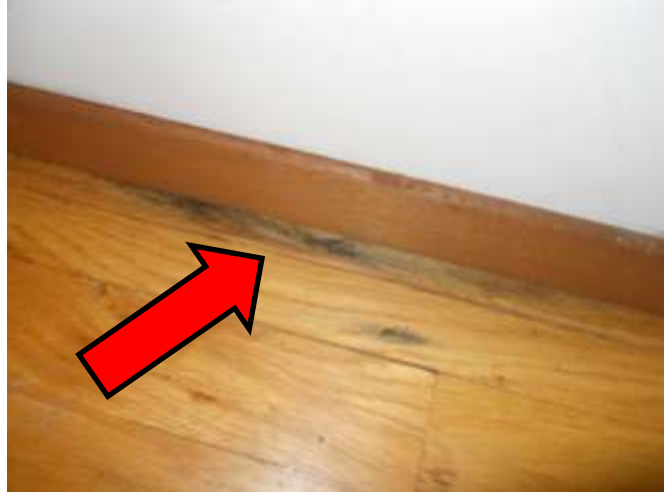
Visibility: Room is vacant  
Structural Movement: No visible evidence  
Moisture Infiltration: No visible evidence  
Walls: Satisfactory  
Ceiling: Satisfactory  
Flooring: - *Minor wood rot at hardwood floor by shower wall. See comments below*  
Cabinets: Satisfactory  
Countertops: Satisfactory  
Mirrors: Satisfactory

Moisture damage to hardwood adjacent to bathroom

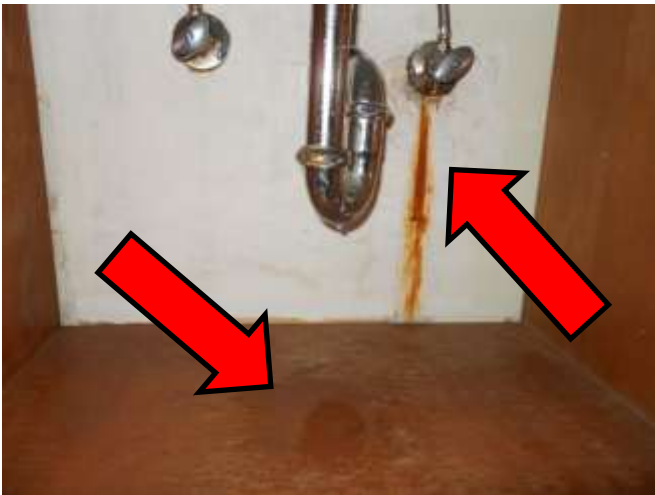
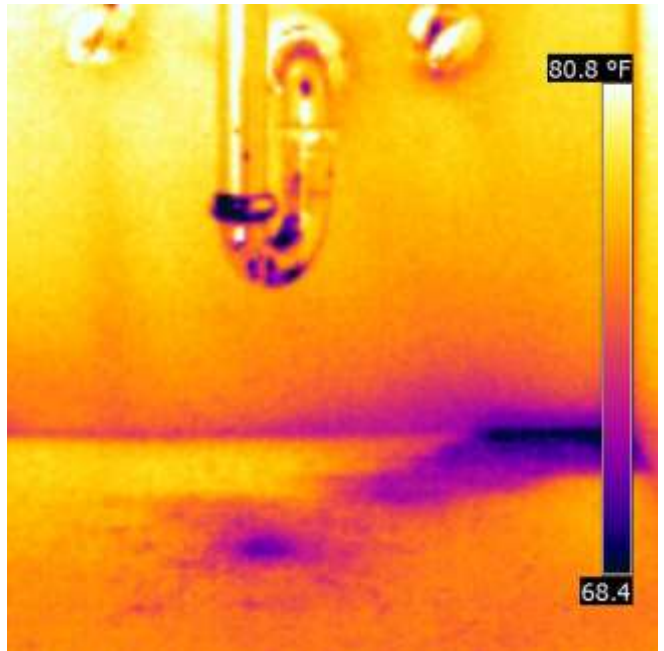
Leaks at bathroom sink and valve

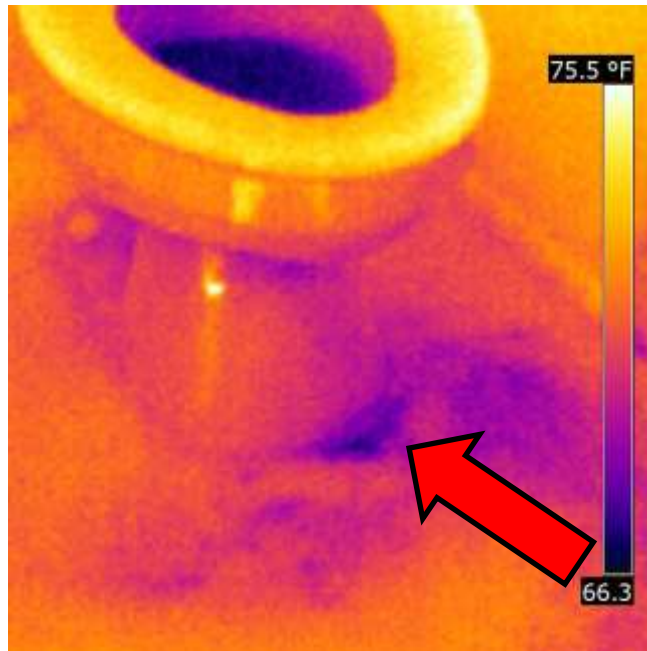
Moisture at base of toilet  
Unable to determine if this was caused by a failed seal  
at the toilet or spray from  
the limited testing of the shower

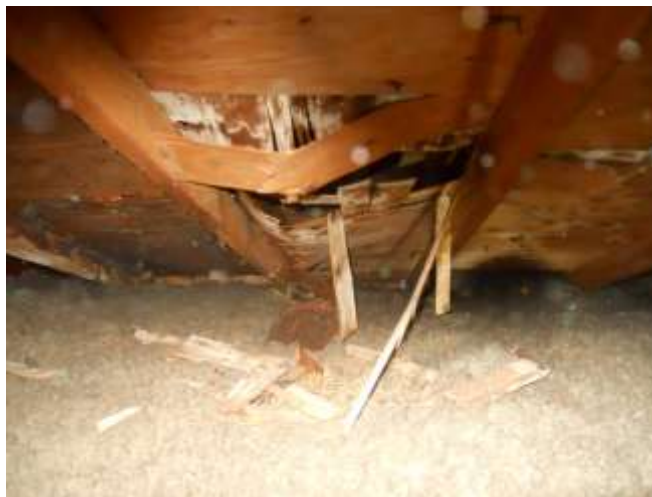
Sheathing at garage has (2) layers  
Lower sheathing has a hole cut in
