Property Description: (2) story home with basement
Property age/ size: 2,310 s.f., built 1920 per listing
Occupancy Status: Vacant

Inspection Date: 09/02/2011
Inspection Time: 11:30 A.M. – 2:00 P.M. +-
Weather Conditions: Clear, 70 deg F +-

Hergert Inspection LLC

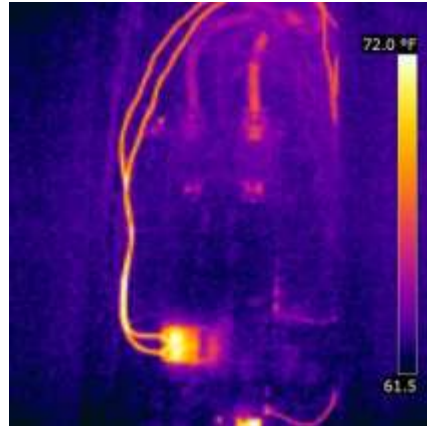
No evidence of overheating

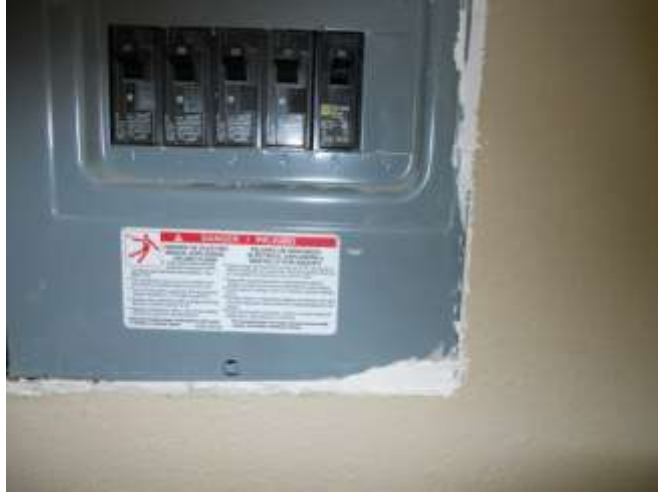
Unable to open sub panel cover

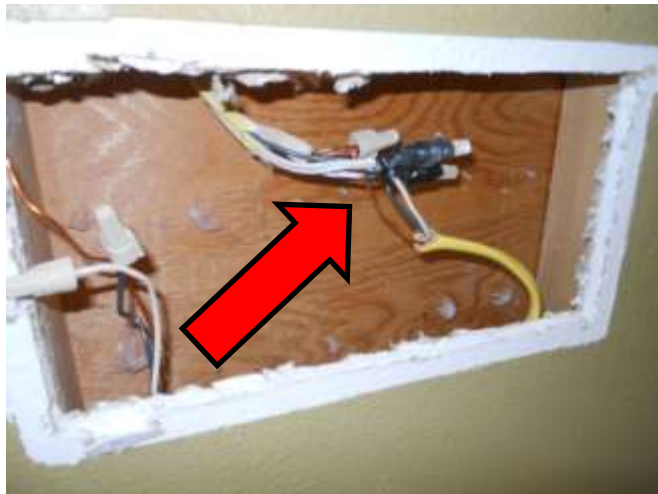
Wire splice at Living Room heater space does not appear to meet electrical code (should be in junction box)

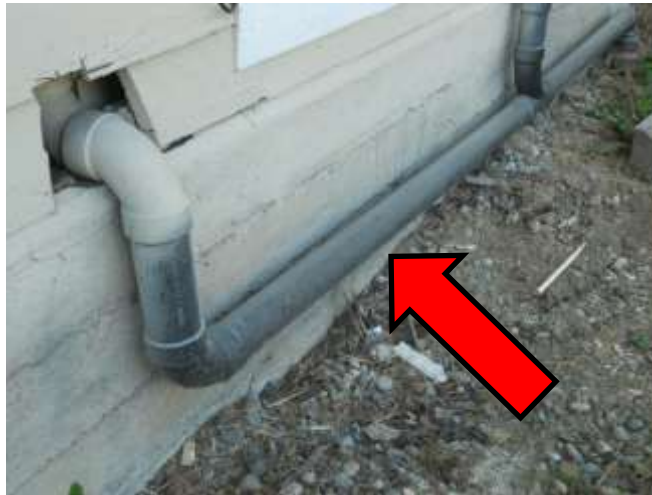
- ABS pipes should not be exposed to the exterior. Recommend cover pipes with dirt and surround with framing as needed

Exposed ABS waste lines

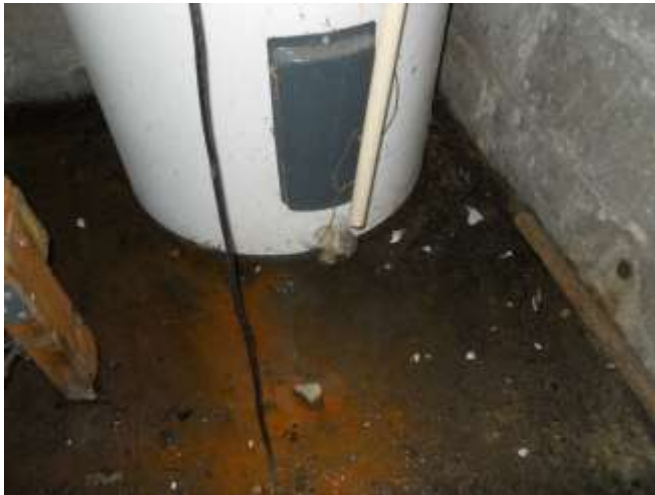
Est. Useful Life new: 12 years
Est. age of heater: 14-15 years +-
- Water heater was not active at inspection. Substantial water leaks from TMP line.
Water heater is far beyond its anticipated useful life expectancy

Moisture beneath water heater

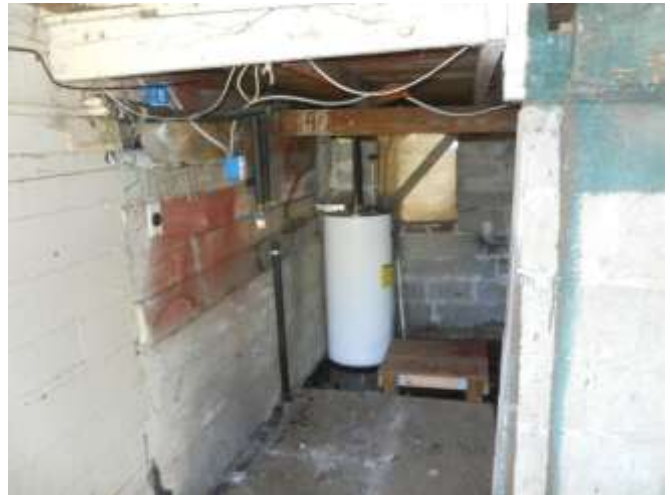
Water heater room should be protected from exterior temperatures (add wall ?)

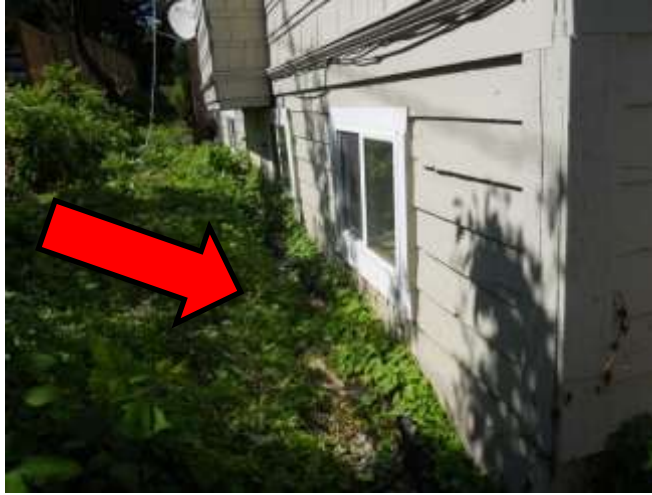
- Grading at South and Southwest side of house slopes towards foundation. A drainage system was added that does not appear to have been completed in a workmanlike manner and is conducive to failure. This grading defect is the likely cause of the moisture infiltration in the basement.

Side yard slopes towards house

Recommend remove all vegetation and re-grade side yard to slope away from house. Install rigid perforated pipe French drainage system. Discharge should not be located at the front walkway (as it is currently located) due to slip hazard during freezing temperatures

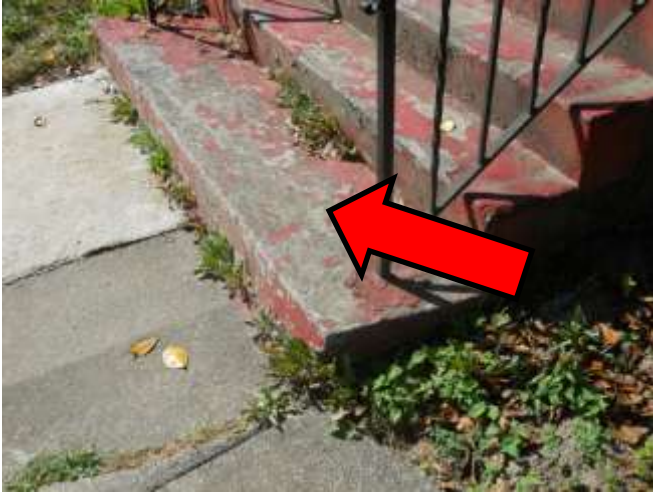
Type: Concrete
Condition: - *Substantial settlement at front steps. Trip hazard at top and bottom of stairs. Recommend repair (possibly by slab-jack method)*
Trip Hazard: - *See comment above*
Handrails: As required
Barricades: As required

Trip hazard at lower step

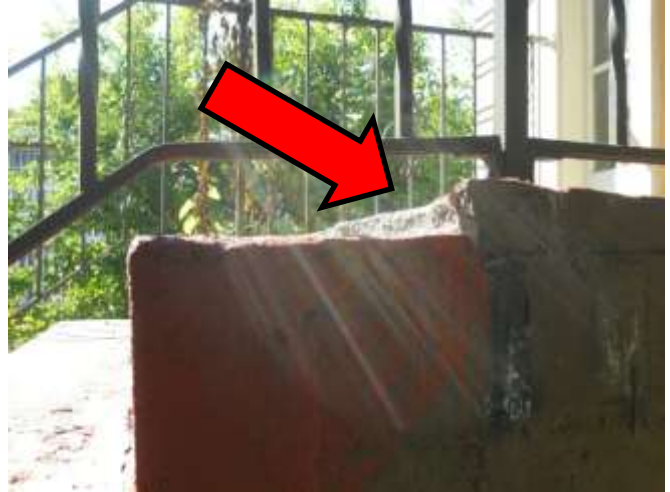
Trip hazard at upper step

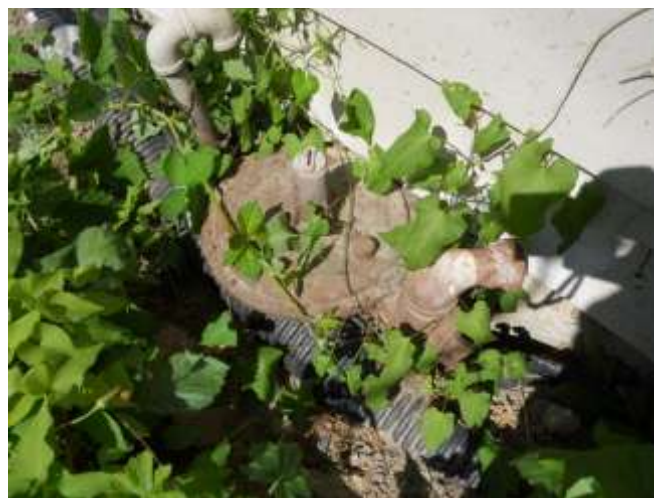
Gas valve located at side yard
Appears inoperative
Call for locates prior to any side yard excavation !

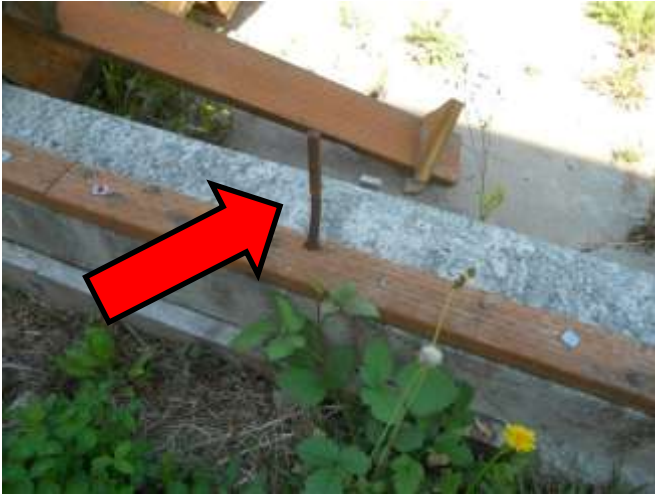
Safety hazard at foundation bolts

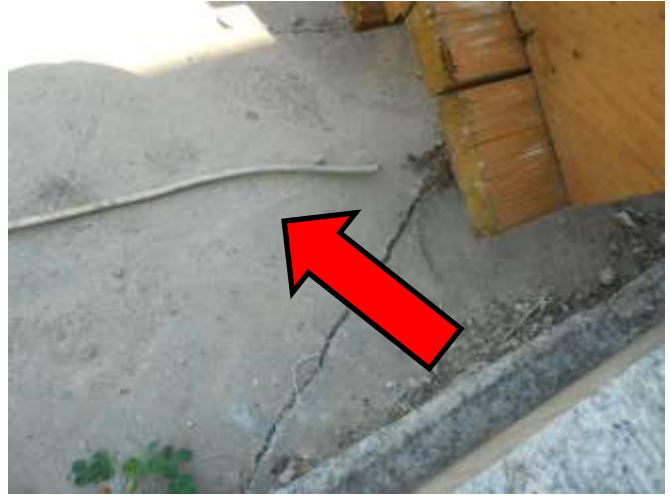
Exposed wire to future garage

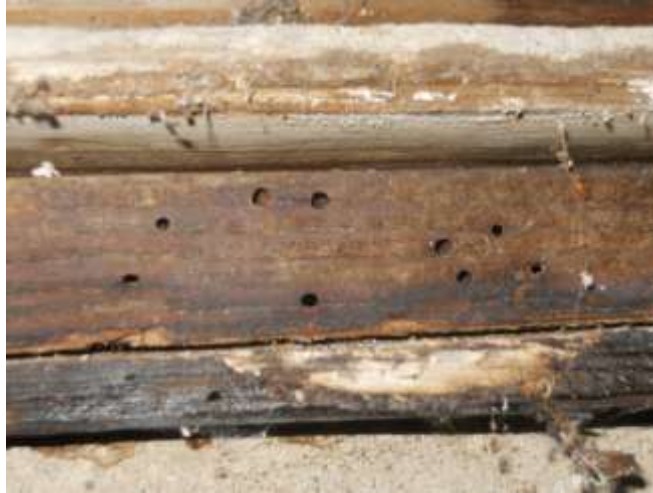
- Structural Movement: No visible evidence
- Mudsill below West side of Master bedroom is deteriorated by beetle damage.
Mudsill disintegrated when inspected
- Exterior doors: Satisfactory
- Windows (ext. cladding): Satisfactory

Beetle emergence holes at rear mudsill

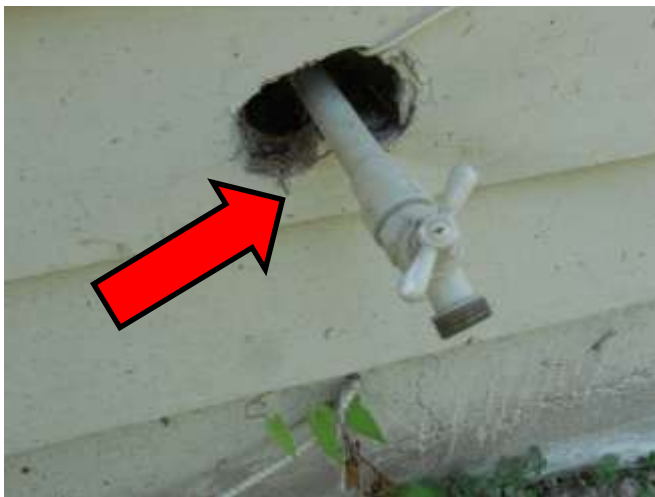
Substantial gap at siding

- Type: Wood
- Condition: Satisfactory
- Seal all holes and repair missing siding as needed
- Window/Door Flashing: Satisfactory
- Caulking: Satisfactory

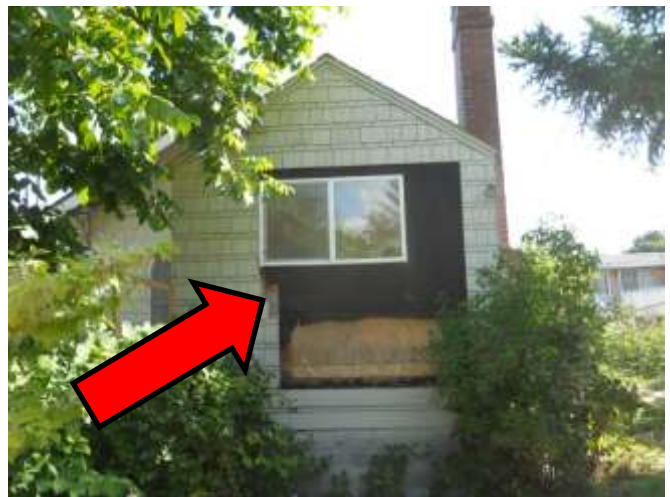
Missing siding

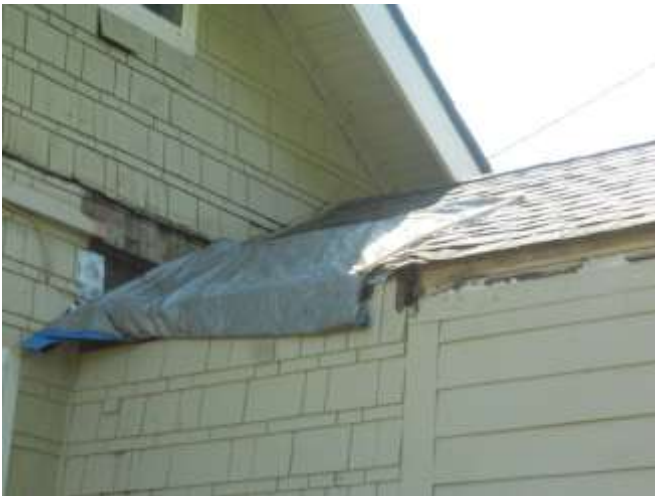
Estimated Pitch: 8:12 +- and 2:12 +-
Material: Composition
Layers: 1+
How Inspected: Traversed main roof and from rear yard
Condition: - Roof is covered with tarp above Master bedroom. Roofing, flashing, and adjacent siding should be repaired by a licensed contractor
Ventilation: Eave vent
Plumbing Vents: Satisfactory
Flashing: Satisfactory

Tarp and missing siding at Master Bedroom

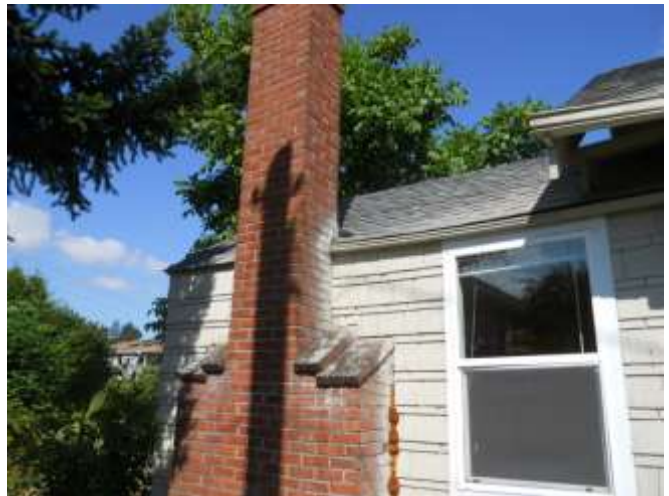
Chimney appears abandoned
Cap on top of chimney

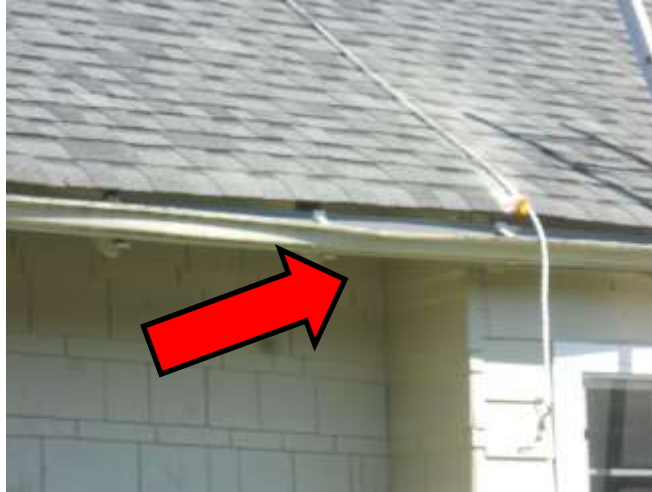
Type: Continuous metal
Condition: - Gutters are loose and bent in several areas

Bent gutter (typical)

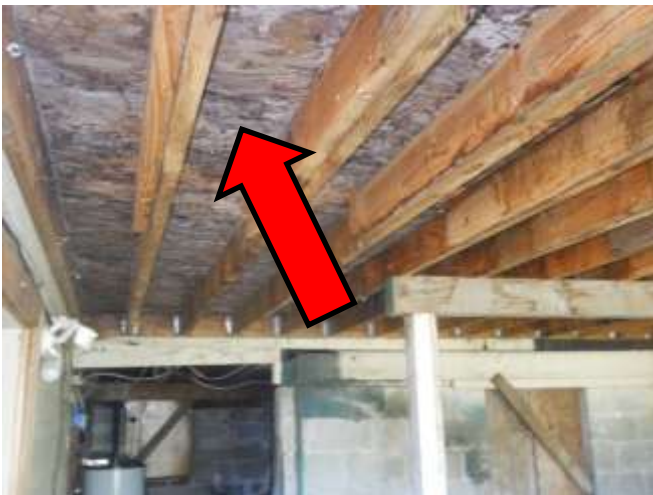
Structure: Pressure treated joists
Decking: OSB
Condition: ***- Deck support system, decking, and rails are all in an unsafe condition. Do not walk on deck. Repair of deck would likely be costlier than to remove and re-build***
Connection to Structure: Hangers
Trip Hazard: None
Handrails: n/a
Barricades: n/a

OSB used as deck surface

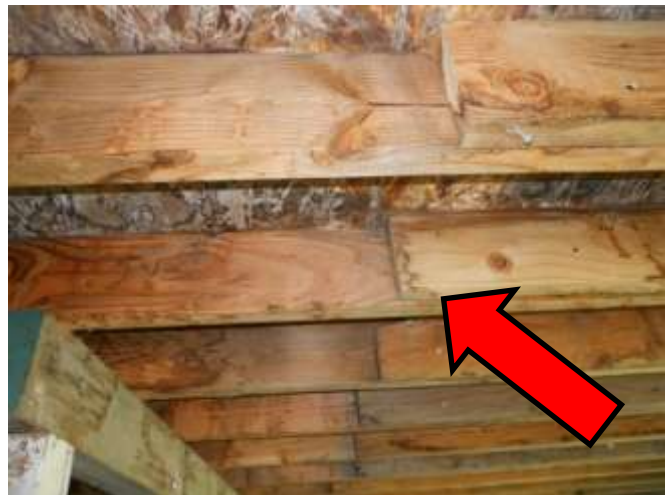
Joists are spliced but not supported

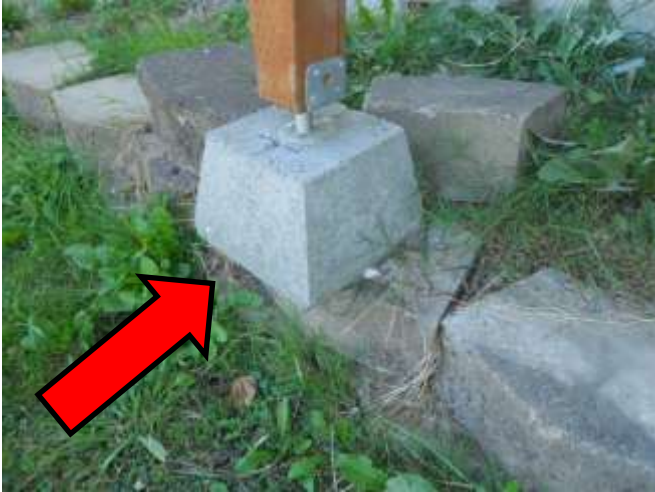
Pier pad placed on retaining wall block

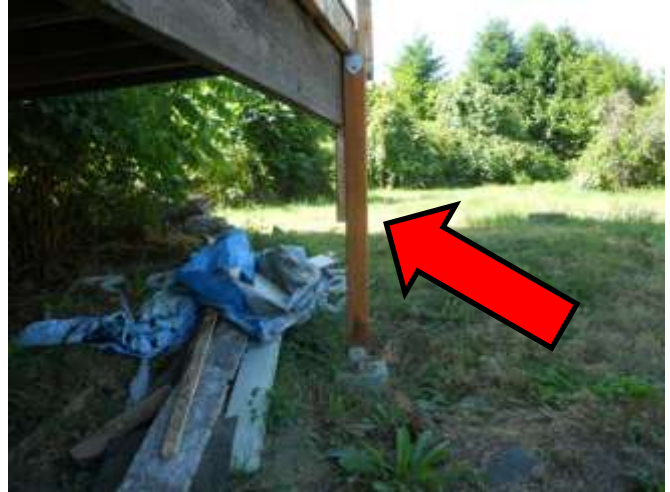
Post out of plumb and not secured

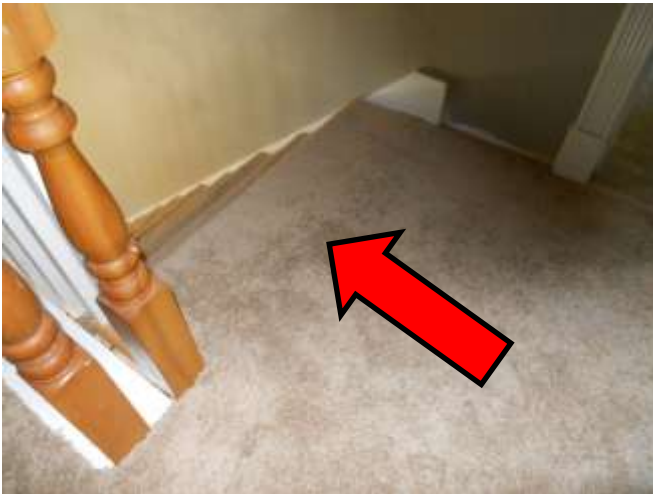
Handrails: - *Handrail would not meet code due to intersection of rail with wall*
Barricades: As required
Balusters: As required
Trip Hazard: - *Minor trip hazard at carpeting tack strip at floor 2*

Trip hazard at carpeting tack strip

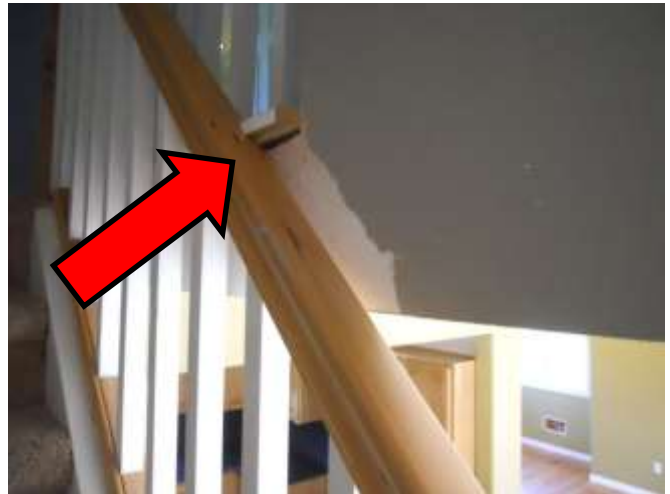
Handrail is not considered "continuous"

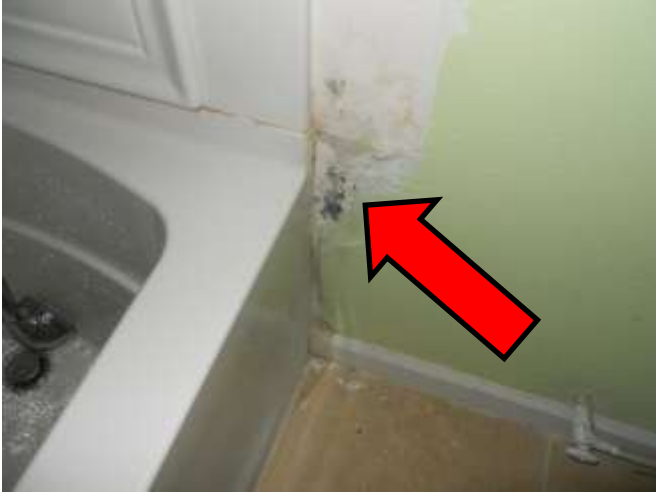
Functional flow: Appears adequate
Hot/ Cold: - *Water heater inoperative; not tested. Cold valve is in off position*
Drainage: Appears adequate
Visible leaks: None visible
Caulking: Satisfactory
Toilet Secure: Satisfactory
Tub/Shower surround: - *Tub and shower surround has been cut at top. Shower water is entering from above and getting behind wall*
Fixtures: No visible defects

Moisture damage at shower wall

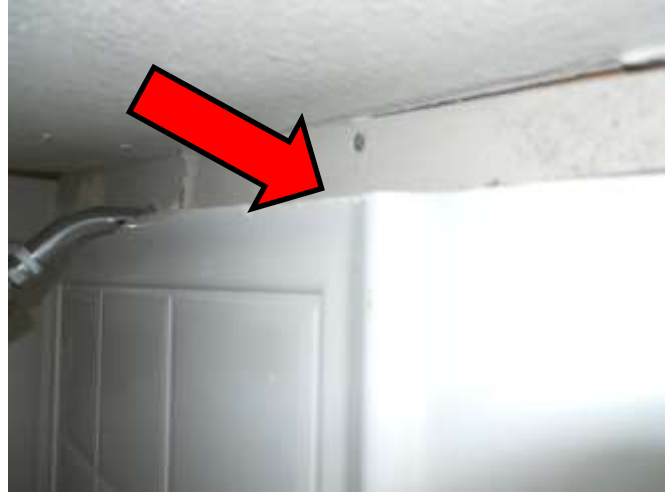
Upper edge of surround is open

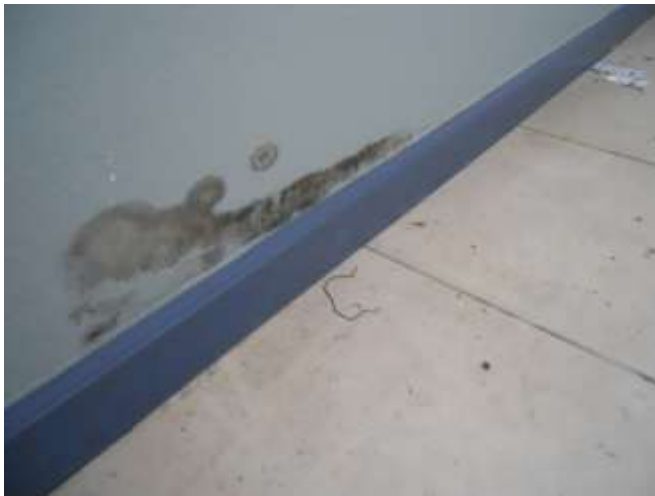
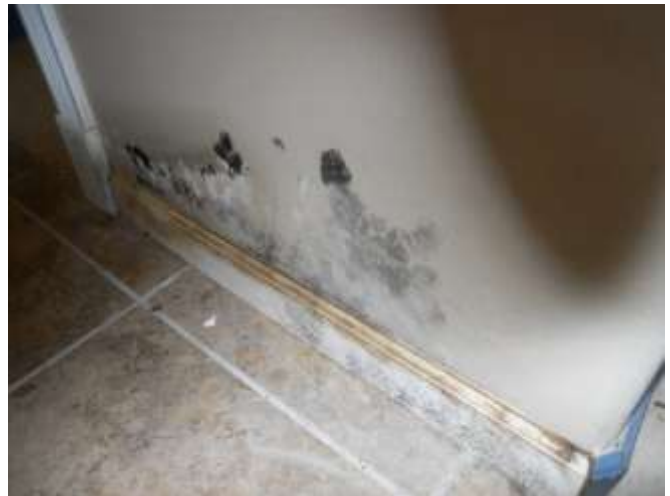
Mold like substance at wall

Visibility: Room is vacant
Structural Movement: No visible evidence
Moisture Infiltration: ***- Evidence of prior moisture infiltration in entire basement area. Moisture stains on door and mold like substance on several walls. Unable to verify in this condition is active. Moisture infiltration would have occurred after the remodeling***
Walls: Satisfactory
Ceiling: Satisfactory
Flooring: Satisfactory

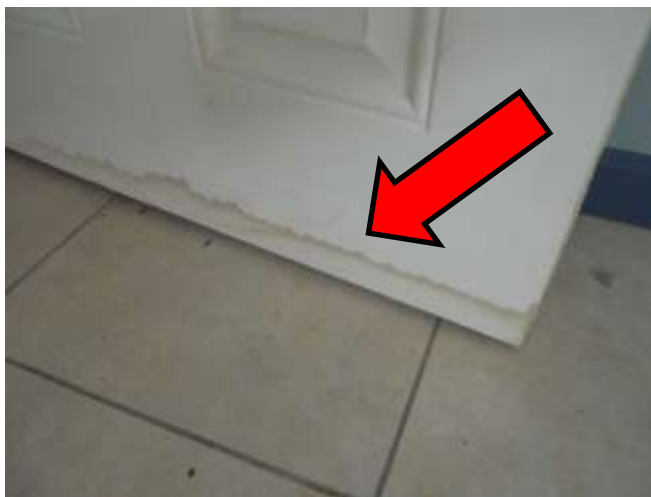
Moisture stains at base of door
