(425) 652-6515
Kevin@Hergert.com
Wa. Home Inspector 619
WSDA Inspector 79988
WSDA Control # 1295AQ-038

Property Description: (1) story single family home
Property age/ size: Built 1958, 1,214 s.f. per listing
Occupancy Status: Vacant; in process of remodeling/ repairs

Inspection Date: 11/08/2011
Inspection Time: 1:00 P.M. – 4:00 P.M. +-
Weather Conditions: Clear 55 deg F +-

Hergert Inspection LLC

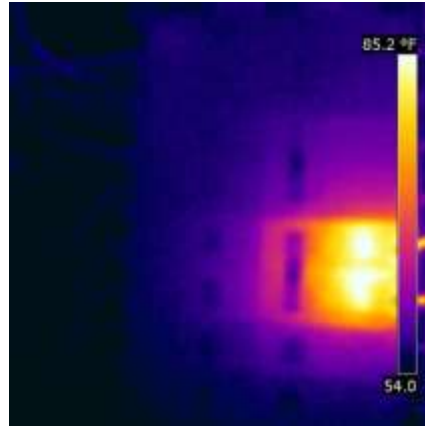
No evidence of over heating

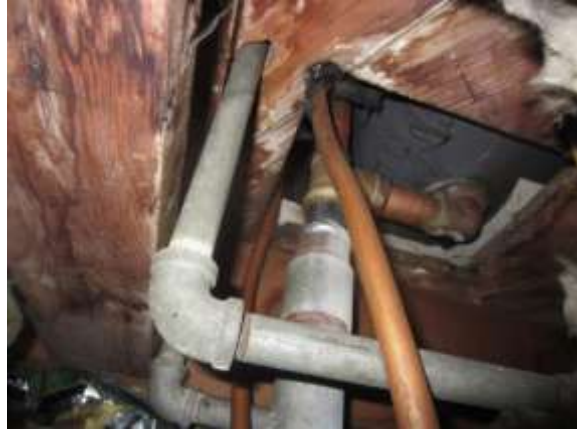
- Supply: Public water
- Supply Pipe: Galvanized where visible
- House Piping: Copper and galvanized where visible
- Pipe Condition: Satisfactory where visible
 - Galvanized pipes tend to rust from the inside out, reducing functional flow. No problems in functional flow in bathrooms. Kitchen and Utility areas not tested
- Main Water Shut off: @ garage

Copper and galvanized supply pipes

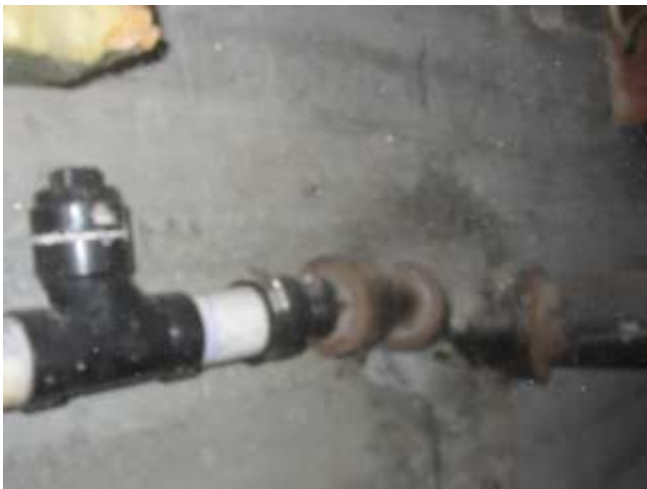
(3) types of plumbing waste pies

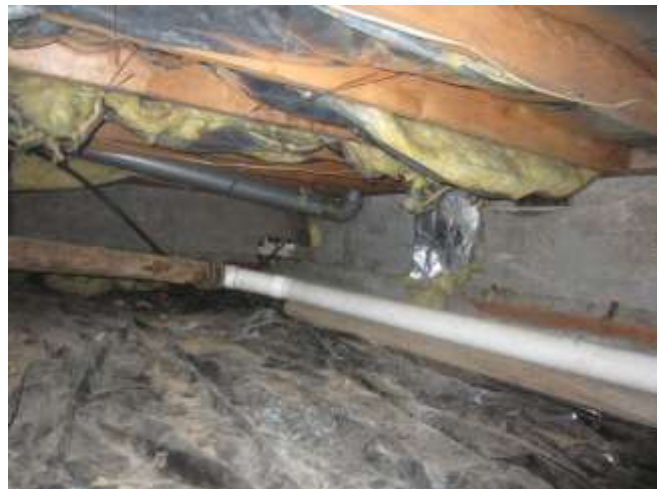
Sewer discharge pipe in not properly supported
Support is from a wood member below

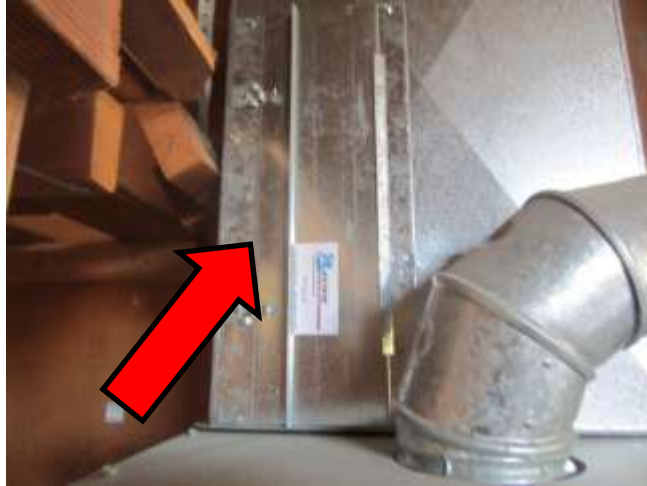
Furnace filter compartment

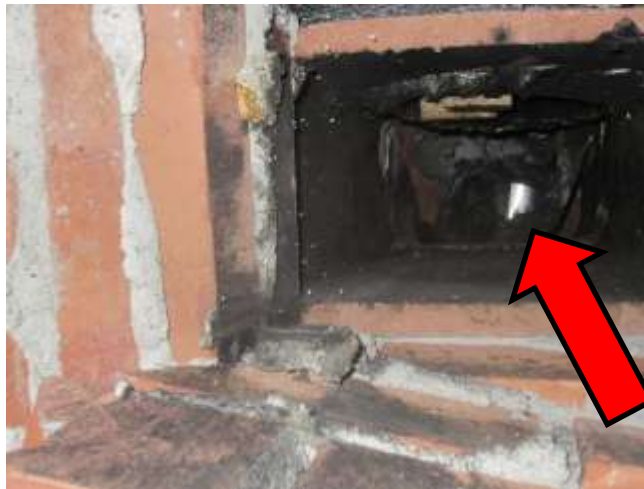
Furnace flue discharges into chimney
Chimney is lined where visible

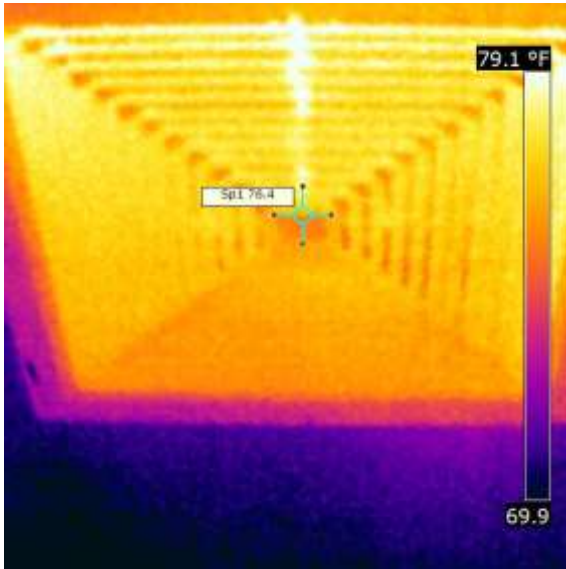
Rating: 35-65 deg F
@ return air: 79 deg F
@ nearest register: 125 deg F
Heat Gain: 46 deg F. Heat gain is within specifications of furnace

Temperature measured at return air

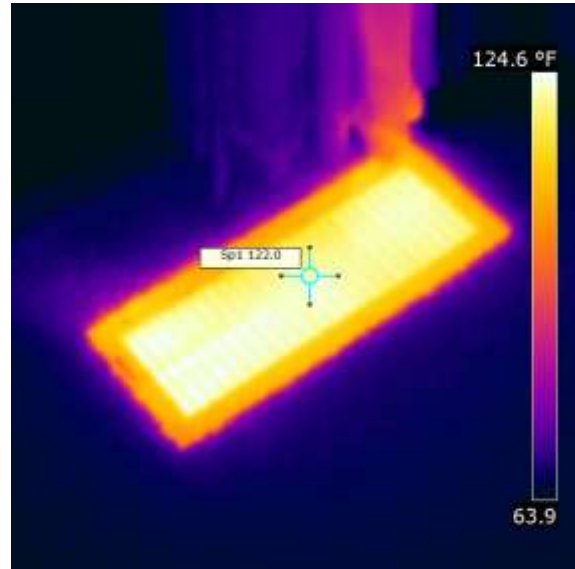
Temperature measured at heat register

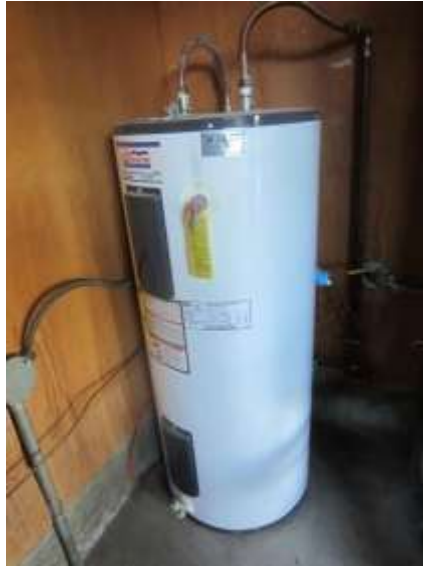
Est. Useful Life new: 12 years
Est. age of heater: 13 years +-
- Water heater is beyond its anticipated useful life expectancy

TMP valve: As per required
Earthquake Straps: - Recommend installation of earthquake restraints

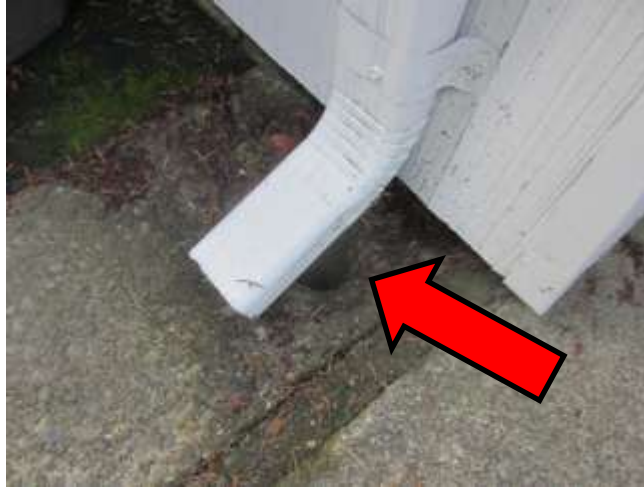
Grade at structure: Adequate grade away
Earth to wood contact: Clearance as required
Vegetation contact: Negligible
Roof drain discharge: Surface and underground discharge
- The downspout by the Utility room does not discharge into the underground system.
This configuration would indicate that the underground system is not functioning

Downspout is directed away
from underground drainage system

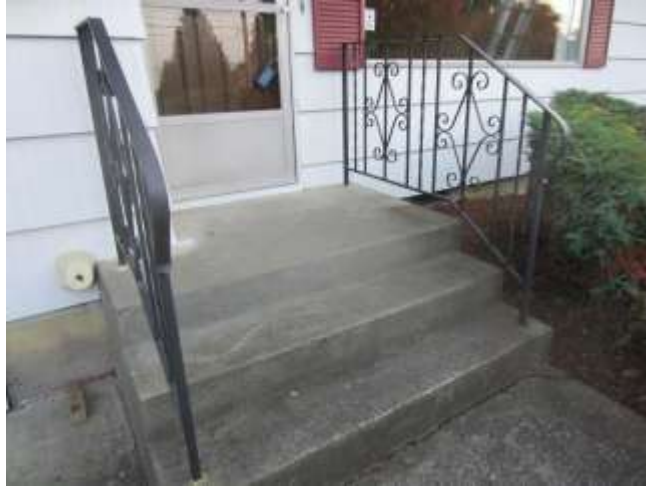
Appropriate handrail at front steps

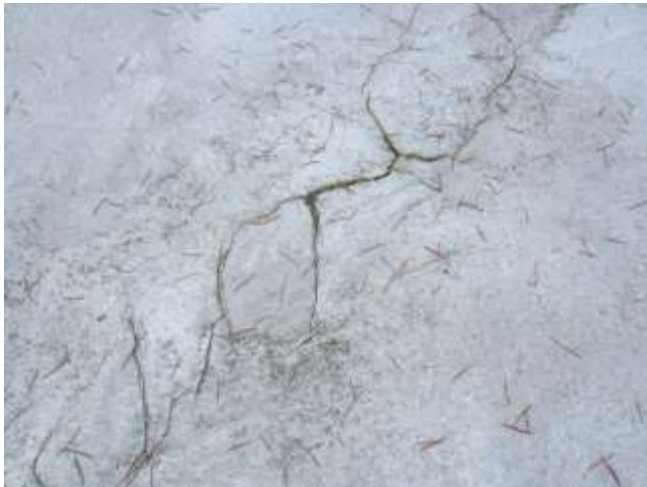
Cracks at valley

Estimated Pitch: 4:12
Material: Rolled
Layers: 1+
How Inspected: Traversed roof
Condition: - Recommend patch roof repairs as needed. Special attention to rear valley
- *Rolled roofing should have been installed perpendicular to fall line of roof*
Ventilation: Eave and roof vent
Plumbing Vents: Satisfactory
Flues: - Recommend installation of rain cap on fireplace flue. Furnace flue not properly attached and sealed
Flashing: Satisfactory

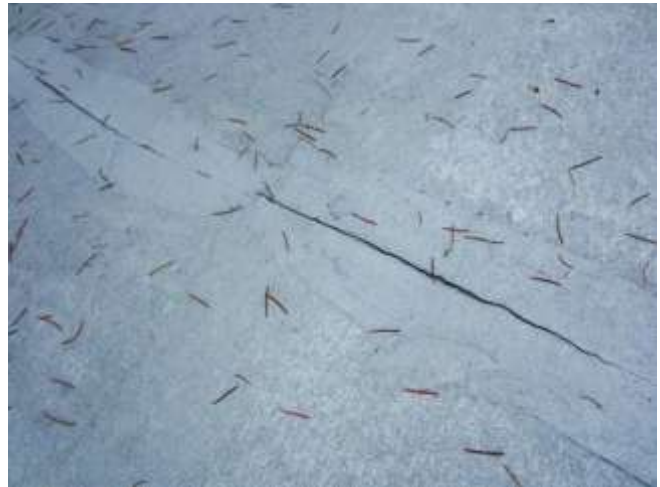
Crack and prior patch
at rear area above Master Bedroom

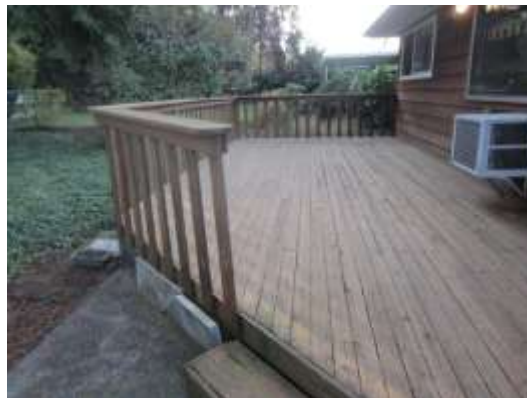
Rear deck

Structure: - *Not visible*
Decking: Cedar
Condition: Satisfactory
Connection to Structure: - *Not visible*
Trip Hazard: None
Handrails: Not required
Barricades: Not required

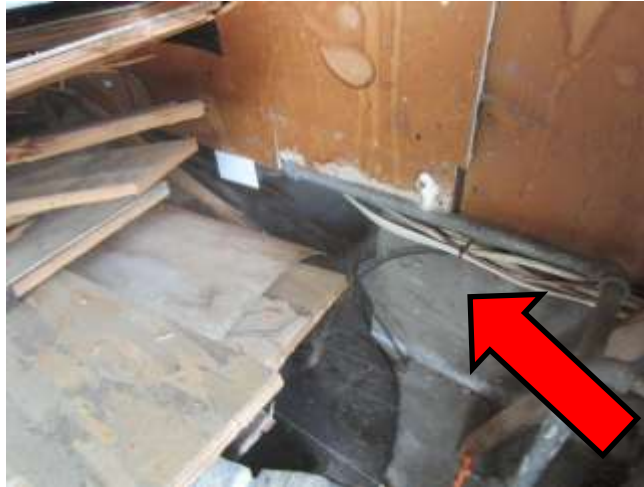
Visibility: Space is vacant
Access location: Exterior access
- It appears that there may be an access to below the front steps at the front of the garage. Unable to access due to debris
How viewed: Traversed entire crawlspace

Possible access to below front porch

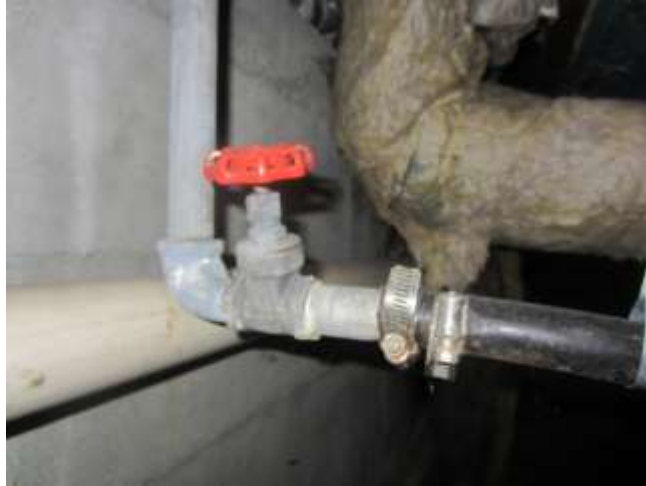
Valve to poly pipe near rear foundation wall
Presumed to be for rear yard hose

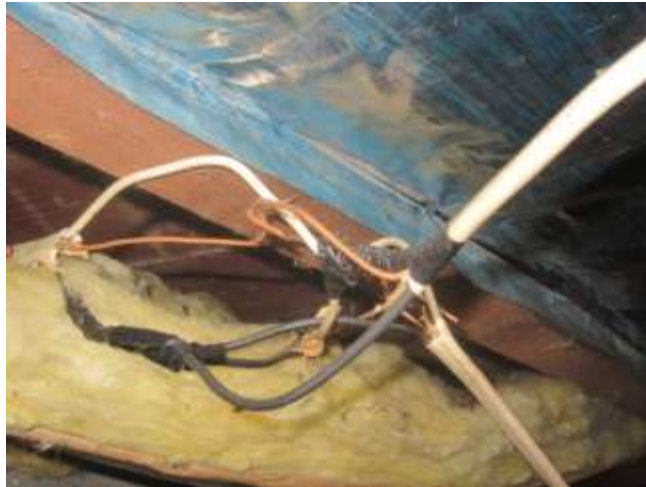
- Outlets: None visible
Wiring/ junction boxes: - Numerous electrical wires are loose and not connected in junction boxes

Improper wire splice

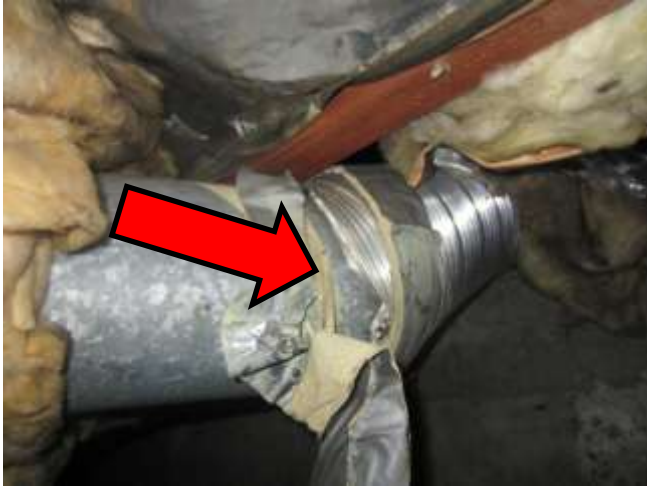
Leakage at heating duct

- Duct Work: - Recommend verify the connection of all heat ducts. The heat duct to the Master bedroom is loose with significant air leakage
Ventilation Ducts: No visible defects
Gas Piping: No visible defects

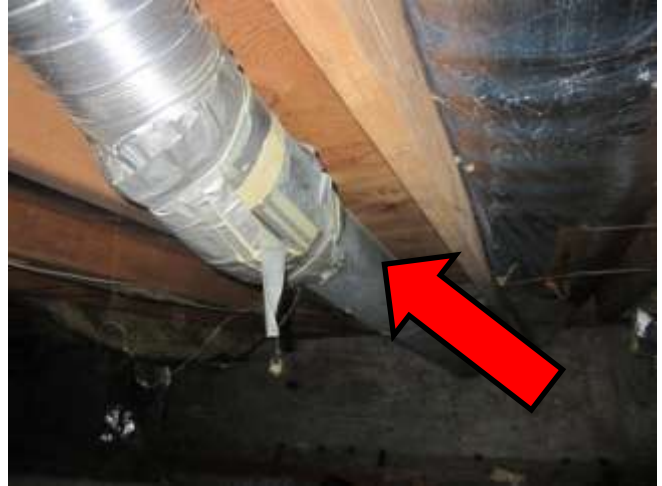
Under-floor: Satisfactory
Domestic Water Pipes: Satisfactory
Heating Supply: *- Several heating ducts are not properly insulated*

Un-insulated heating duct

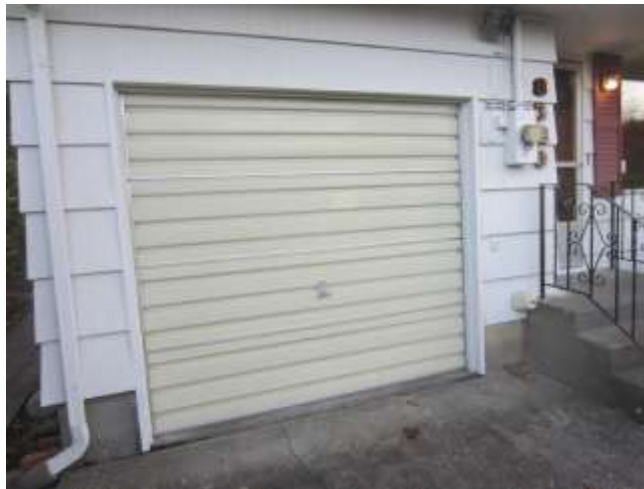
Type: Plastic/Fiberglass roll-up
- Low quality garage door is a potential security breach
Springs & Fasteners: No visible defects
Auto Reverse: Tested
Photocell reverse: Tested
Remote openers: Not present

Garage door

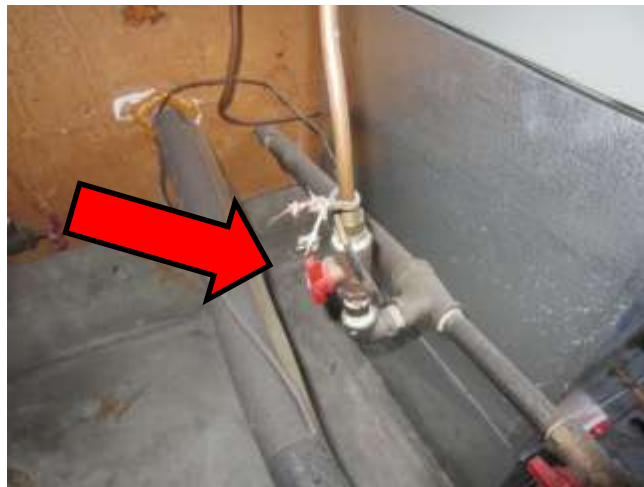
Type: Gas insert
Tested: Ignition tested
- Gas shut off not within reasonable access to fireplace (in garage)
- Flue damper to have clip to prevent full closure
- Recommend install (weather) cap on top of chimney

Gas shut off for fireplace is located in garage

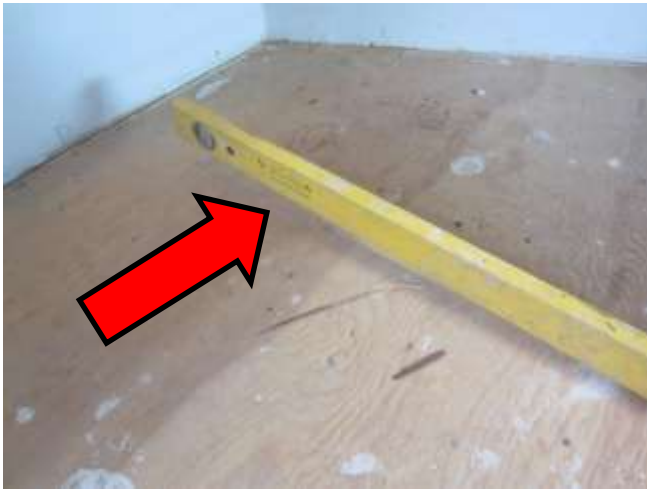
Floor height inconsistency is greater than 1"

- Visibility: Rooms are vacant
- Structural Movement: No visible evidence
- Moisture Infiltration: No visible evidence
- Walls: Satisfactory
- Ceiling: Satisfactory
- Flooring: - Recommend install single sheet of plywood to span from foundation supported area to unknown (deck) supported area to reduce floor seam visibility
- Cabinets: Satisfactory
- Countertops: Satisfactory

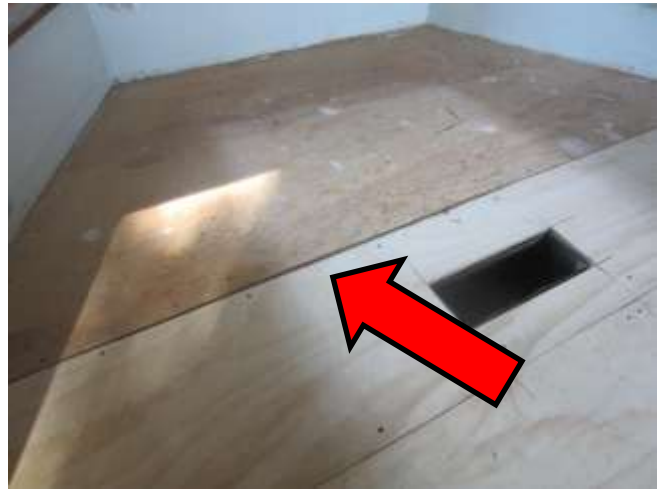
Seam at nook

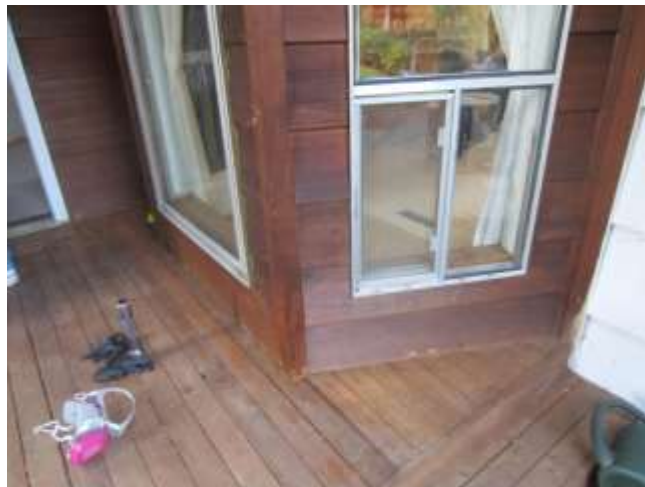
Foundation: No visible defects
- See comment in Kitchen section regarding nook support
Mudsill: No visible defects
Joists: No visible defects; limited visibility
Post-Beams: Satisfactory
Structural Movement: No visible evidence

Nook area structural support is not visible
(even from crawlspace)

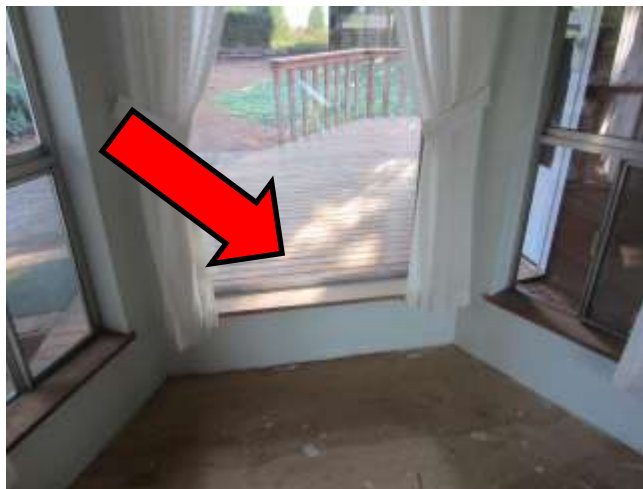
Glazing: No visible defects
Tempered: - Large window at nook should be tempered (safety hazard)
Operation: Tested
Screen: No visible defects

Windows below 18" from finished floor should be tempered

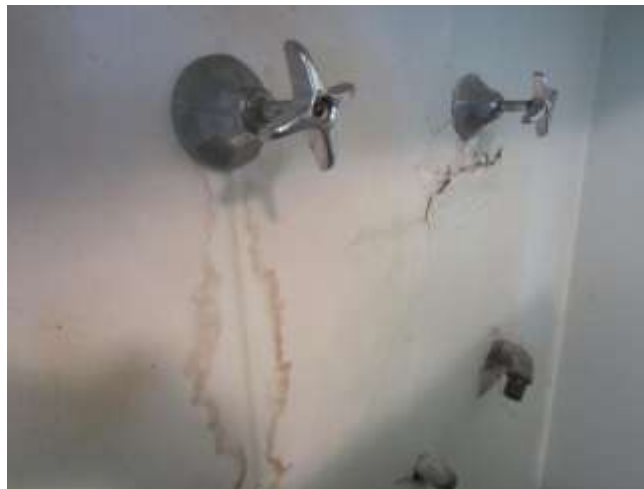
Functional flow: - *Unable to verify*
Hot/ Cold: - *Unable to verify*
Drainage: - *Unable to verify*
Visible leaks: - Evidence of prior leaks at washer connection. Unable to test as there are no caps on the pipes

Moisture stains at washing machine valves

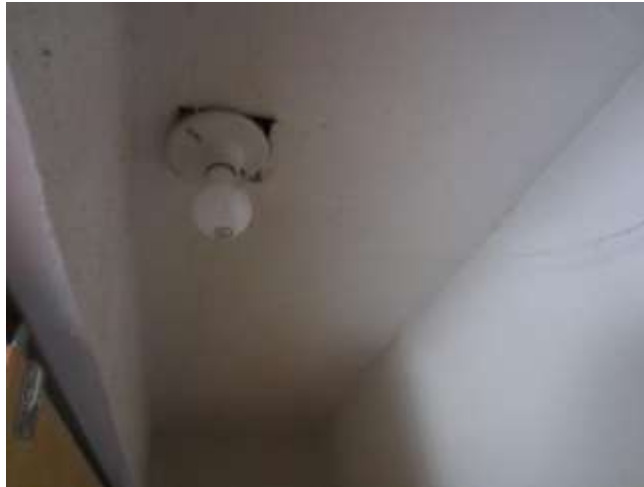
Fire hazard from exposed bulb

Switches/Lights: All visible tested
- Recommend replacement of light fixture in closet. Exposed bulb is a fire hazard
Outlets: All visible tested. Bathroom outlets are GFCI protected
- Open ground at several electrical outlets
Smoke detector: No
