(425) 652-6515
www.Hergert.com
Kevin @ Hergert.com
Wa. Home Inspector 619
WSDA Inspector 79988
WSDA Control # 11262AQ-06

Property Description: (2) story single family home
Estimated property age: Built 1988 per King Co.
Occupancy Status: Occupied

Inspection Date: 04/04/2020
Inspection Time: 2:00 P.M. - 4:00 P.M. +-
Weather Conditions: Overcast, 50 deg f +-

Hergert Inspection LLC

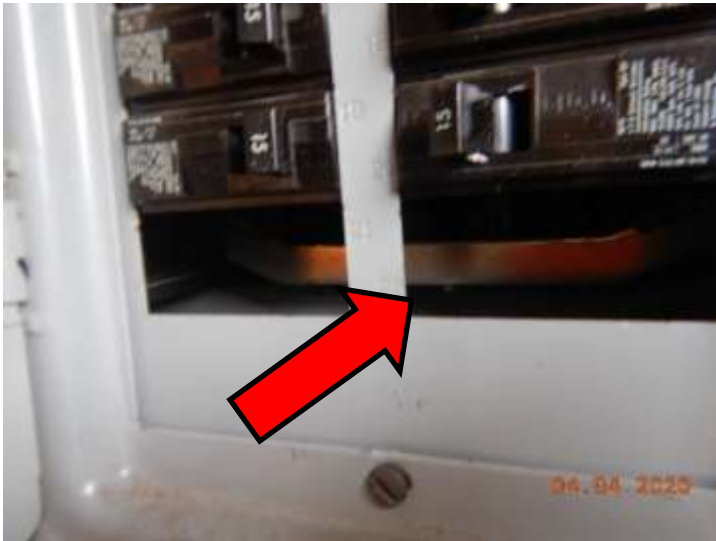
- Knockout covers are missing at the electrical panel cover. Live electrical components are exposed and are a risk for electrocution

Missing knockouts

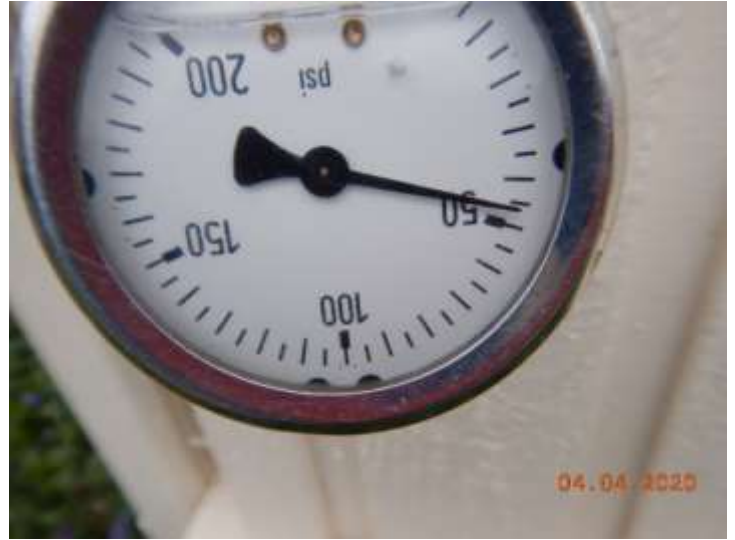
Measured water pressure: 47 P.S.I. Water pressure is adequate and not excessive

Water pressure is adequate and not excessive

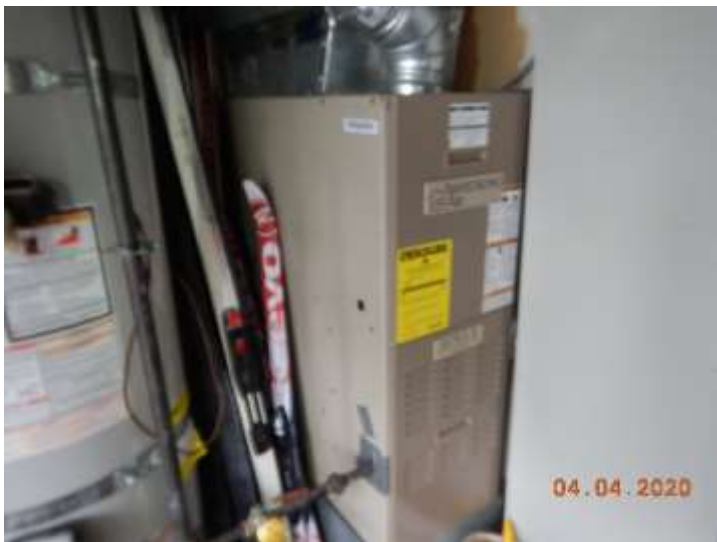
- The heating system for this home is natural gas. The listing stated a geothermal system in error
- The age of the furnace is approximately 17 years. The remaining anticipated useful life expectancy is 8 years
- Recommend furnace to be cleaned, serviced, and shown to be in good working order by a qualified furnace technician. The last service date for the furnace was in 2016 per the tag on the furnace

Furnace

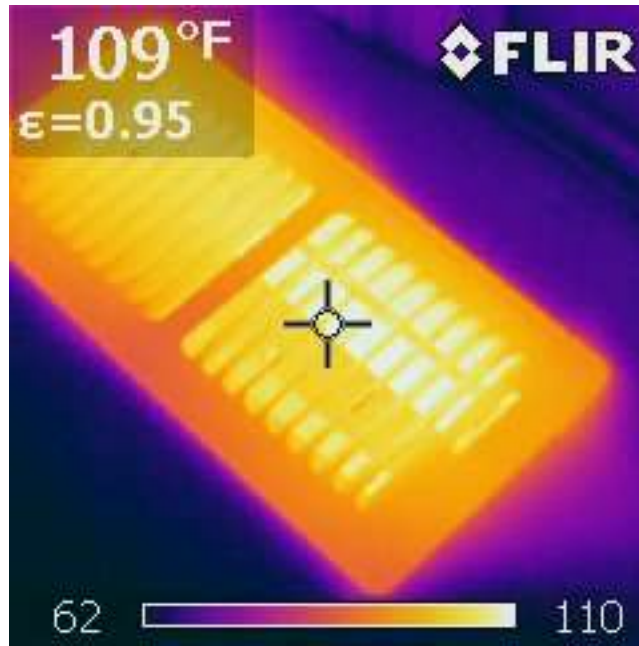
Rating: 40-70 deg F
@ return air: 70 deg F
@ nearest register: 110 deg F
Heat Gain: 40 deg F. Heat gain is within specifications of the furnace

Temperature measured at a heat register

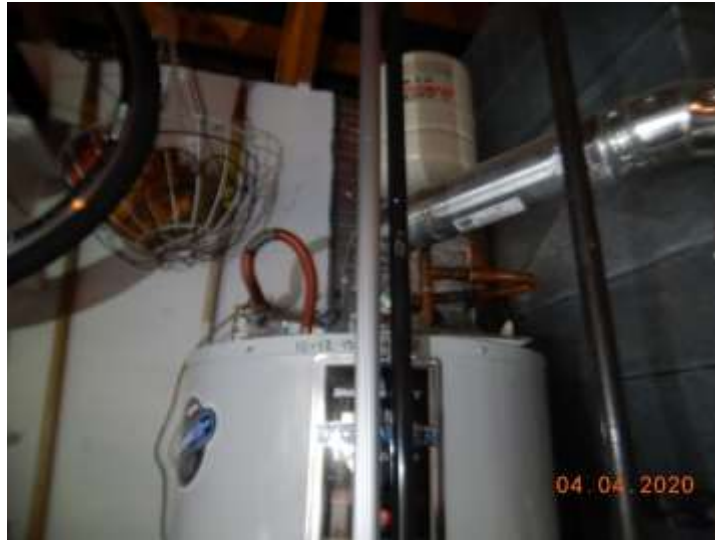
- The age of the water heater is approximately 7 years. The remaining anticipated useful life expectancy is 5 years

Water Heater

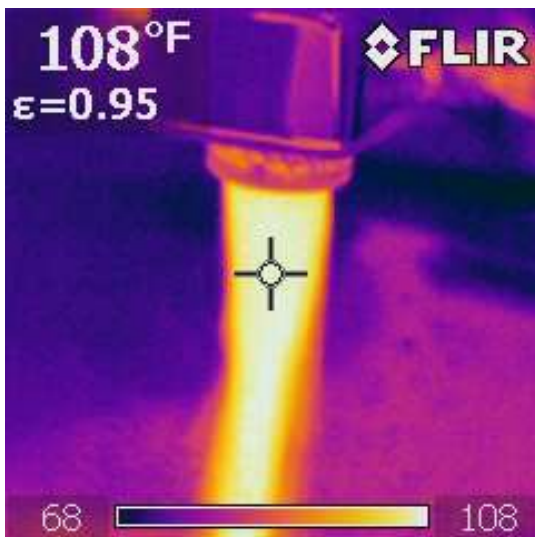
- TPR valve: As per required
- Earthquake Straps: Installed
- Safe water temperature: 120 deg F per industry standards
- Measured temperature: 108 deg F

Hot water temperature

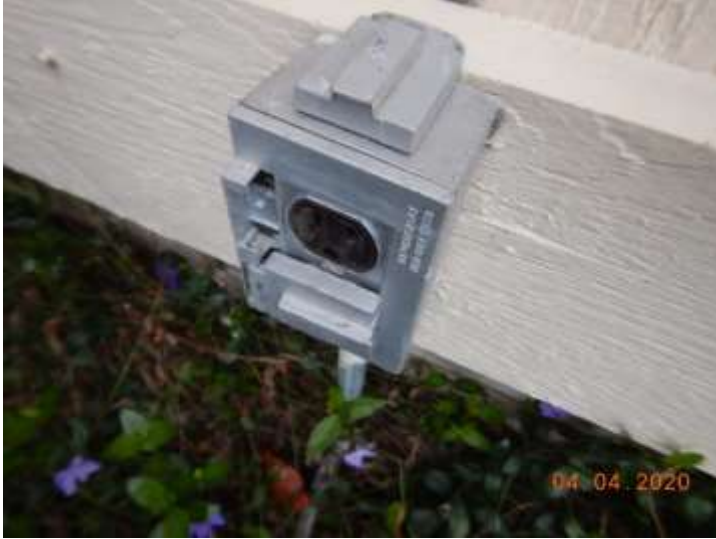
- The electrical outlet located at the East side of the garage is not properly wired; reverse polarity. This outlet is also missing the weatherproof cover and has unprotected wires extending into the adjacent planter bed

Missing weatherproof cover

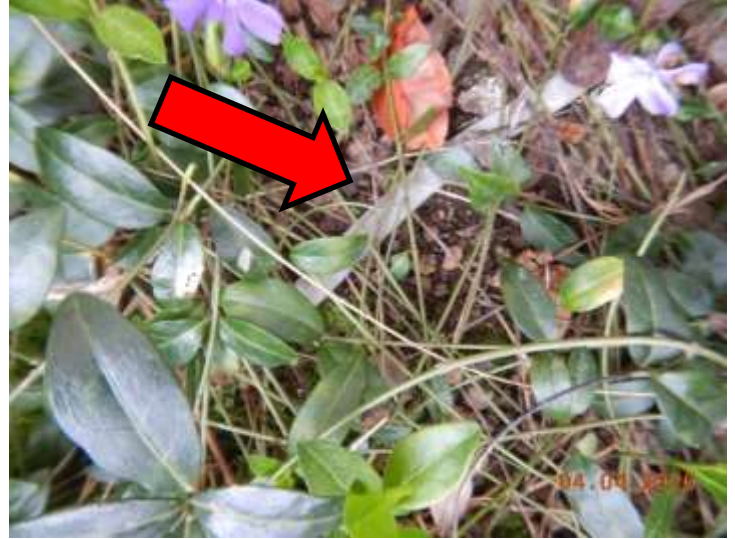
Unprotected wire in a planter bed

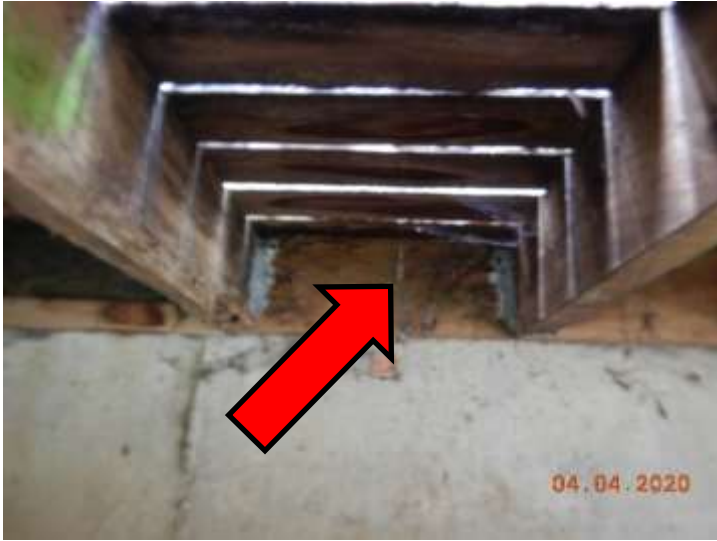
Lag bolts were not visible

- Recommend GFCI protection for the exterior electrical outlets
- Recommend the installation of lag bolts to fasten the deck ledger to the home. Although likely not required at the time of construction of the home, this fastening system is a new “code” requirement to reduce the likelihood of failure of a deck structure

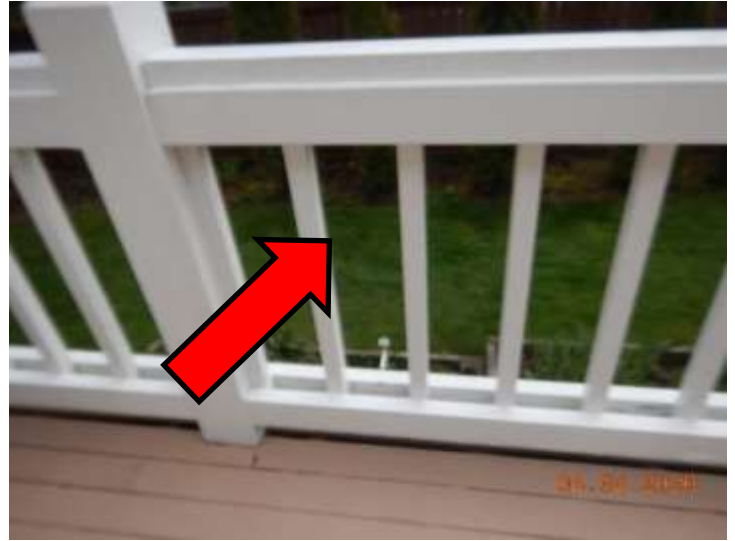
The spacing at the barricade exceeds 4"

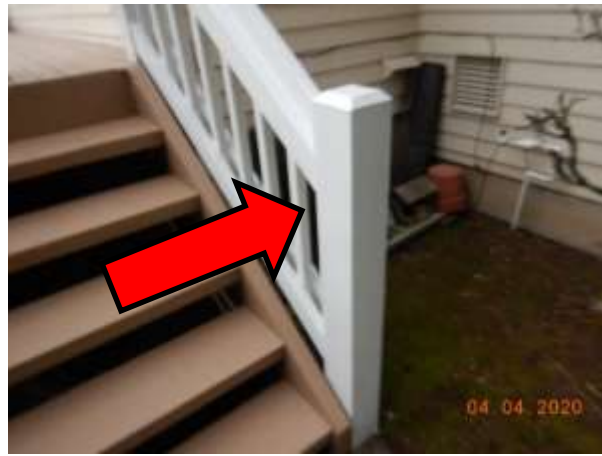
Loose handrail

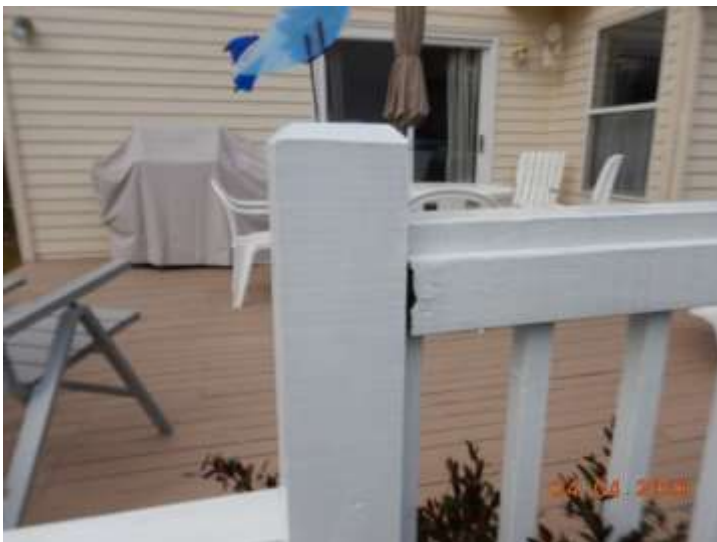
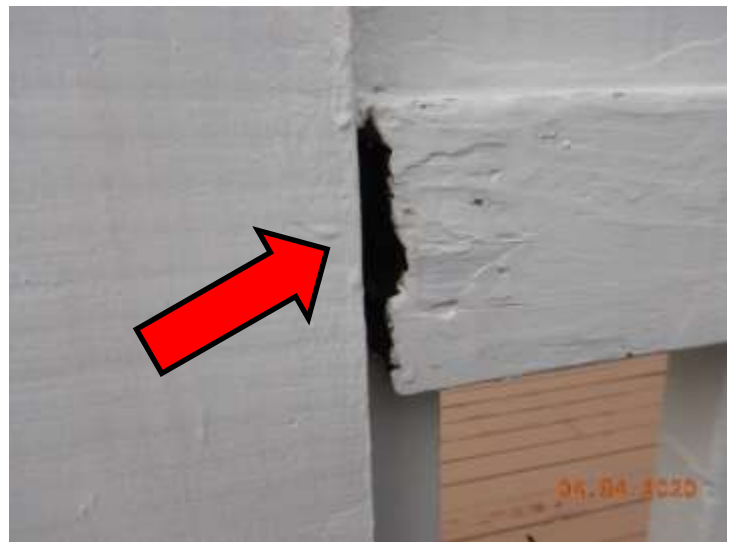
- There is evidence of wood rot at some section of the deck barricade

Evidence of wood rot

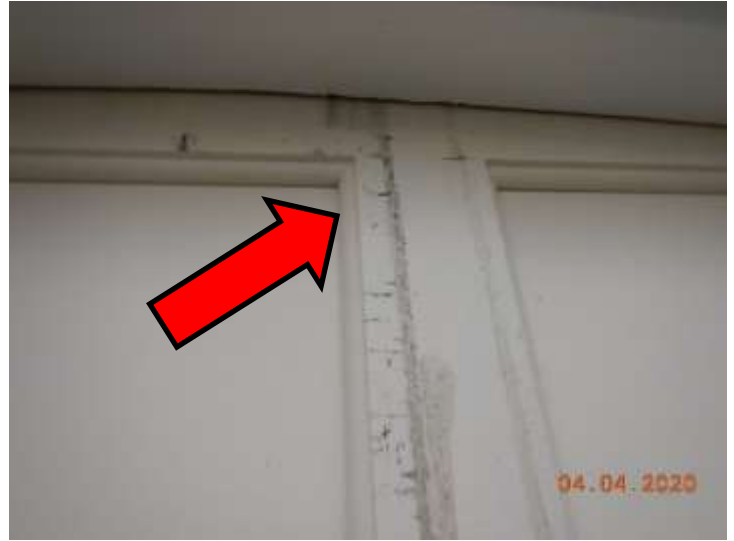
- The West garage door only closes with the button held down. There is evidence that the door is rubbing on the door wrap or the opening mechanism. Recommend servicing

Evidence that the West door is rubbing on the door frame or mechanism

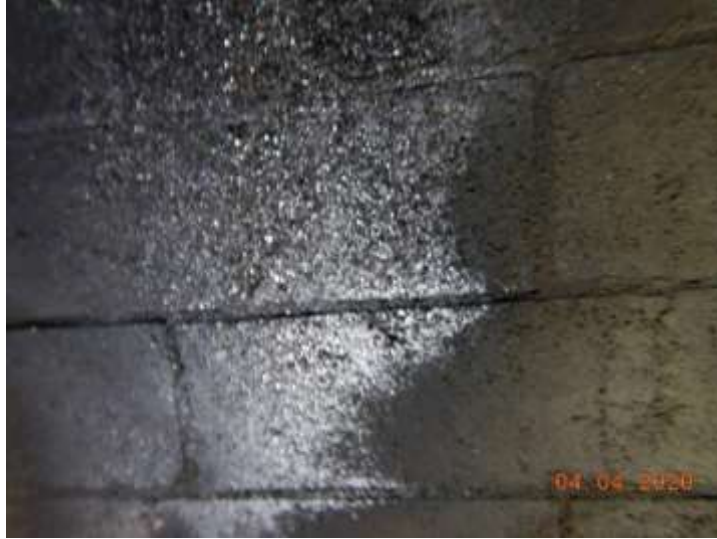
Creosote buildup

Type: Masonry wood burning
Tested: Damper
Condition: - Recommend cleaning the fireplace due to the buildup of creosote

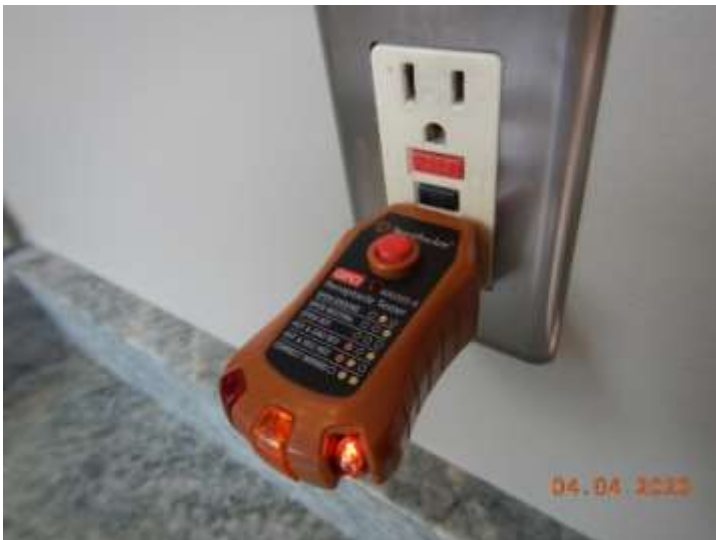
This outlet does not trip when tested

- The sink area GFCI reset outlet does not trip when tested. Recommend replacement of this outlet. Once replaced, verify GFCI protection for the outlet located at the left side of the countertop
- Recommend the installation of a smoke detector within the bedroom
- There is substantive leakage from the shower valve when active

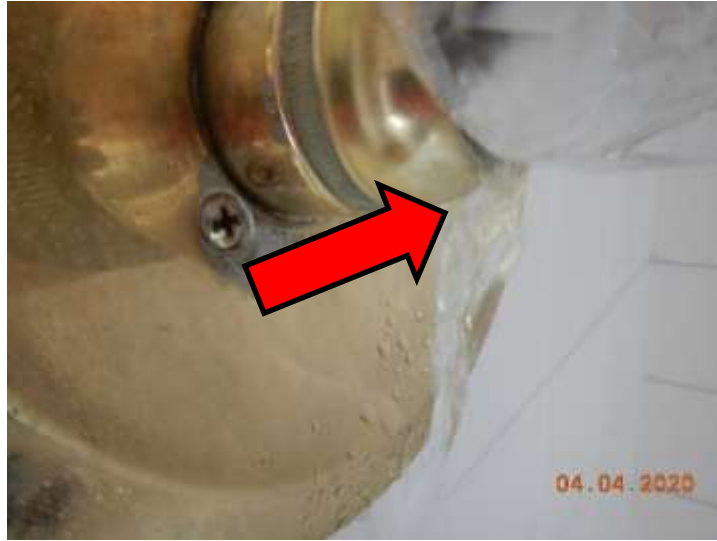
Leakage from the shower valve when active

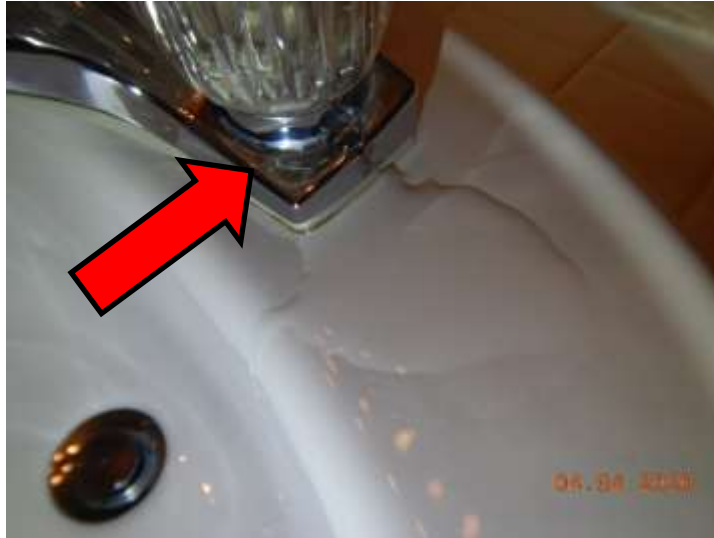
- There is leakage from the cold water valve onto the sink when active

Leakage from the cold water valve
