(425) 652-6515
www.Hergert.com
Kevin @ Hergert.com
Wa. Home Inspector 619
WSDA Inspector 79988
WSDA Control # 11150AQ-029

Property Description: (1) story "split entry" single family home with daylight basement
Estimated property age: Built 1979 per listing
Occupancy Status: Occupied

Inspection Date: 10/04/2019
Inspection Time: 11:00 A.M. - 1:00 P.M. +-
Weather Conditions: Overcast, 55 deg f +-

Hergert Inspection LLC

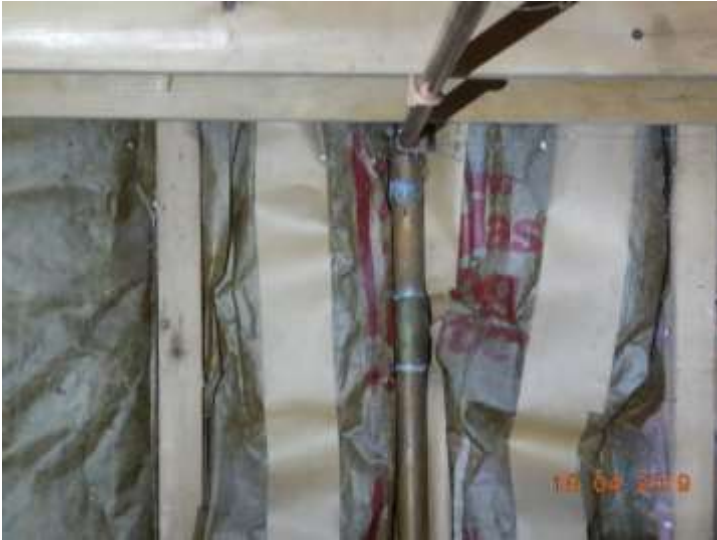
A domestic water shut off valve MAY be located on the other side of the crawlspace in the occupied garage

- Question to Seller: what is the location of the domestic water shut off valve ?

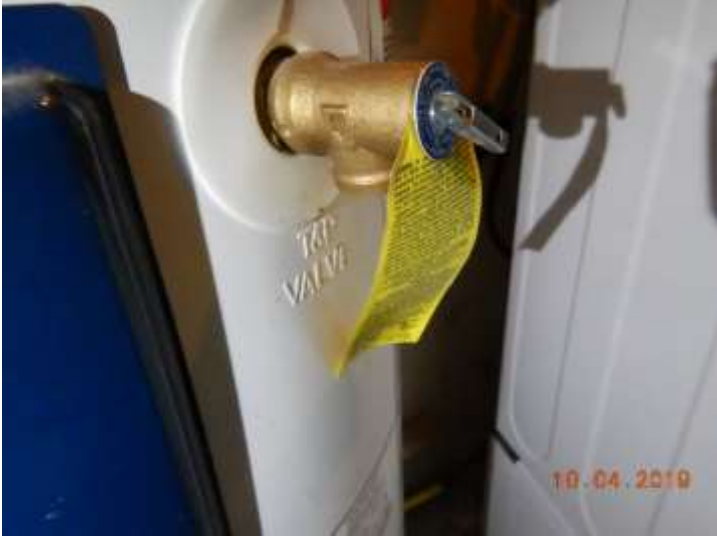
There is no extension on the TPR valve

TPR valve: - The TPR drain line should extend to the exterior
Earthquake Straps: Installed
Safe water temperature: 120 deg F per industry standards
Measured temperature: 114 deg F

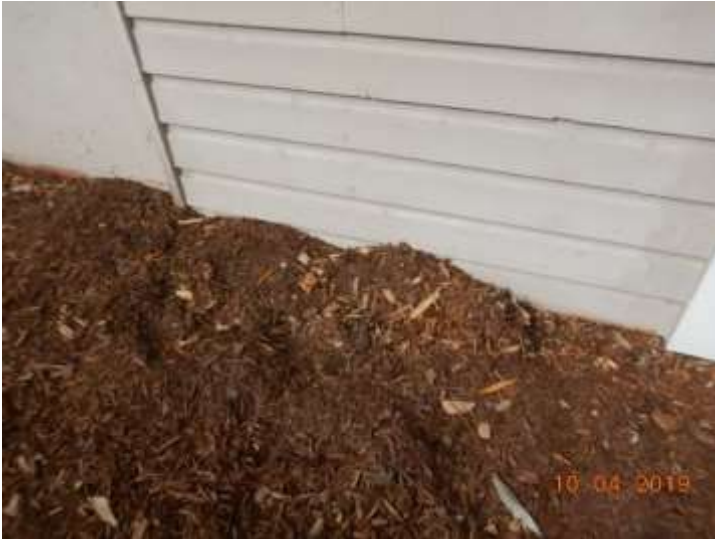
Ground in contact with the siding
(WDO conducive condition)

- Grade at structure: Adequate grade away
- Earth to wood contact: - Ground in contact with the siding (WDO conducive condition). Recommend 4-6" separation between the ground and siding
- Vegetation contact: Negligible
- Roof drain discharge: Underground and surface discharge
- Some of the underground drainage connections are not properly aligned for the downspout discharge. Splash-blocks should be added below those downspouts that do not have an underground drainage connection

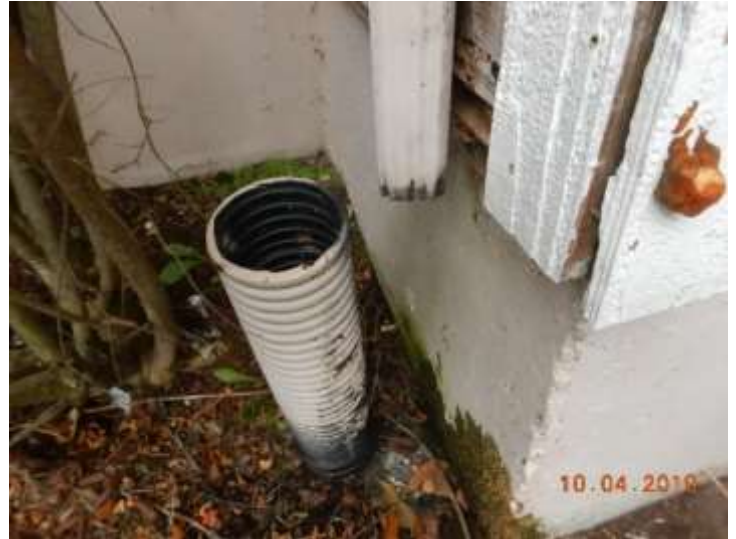
Downspout connection not aligned
(WDO conducive condition)

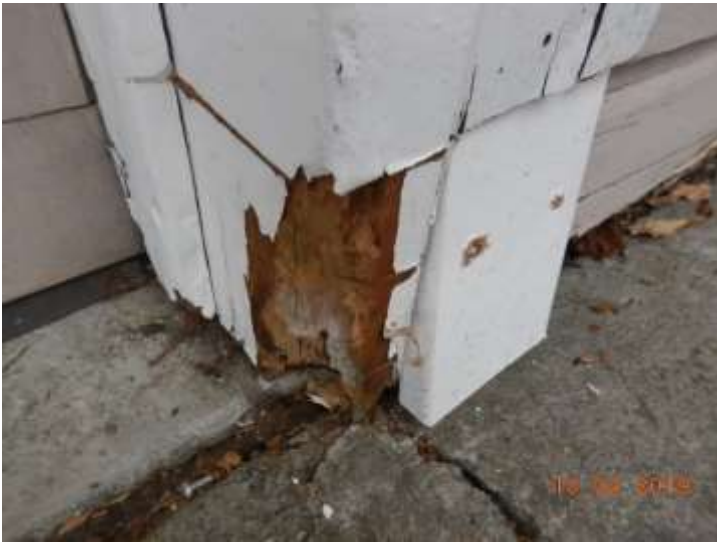
Deterioration of the garage door center divider

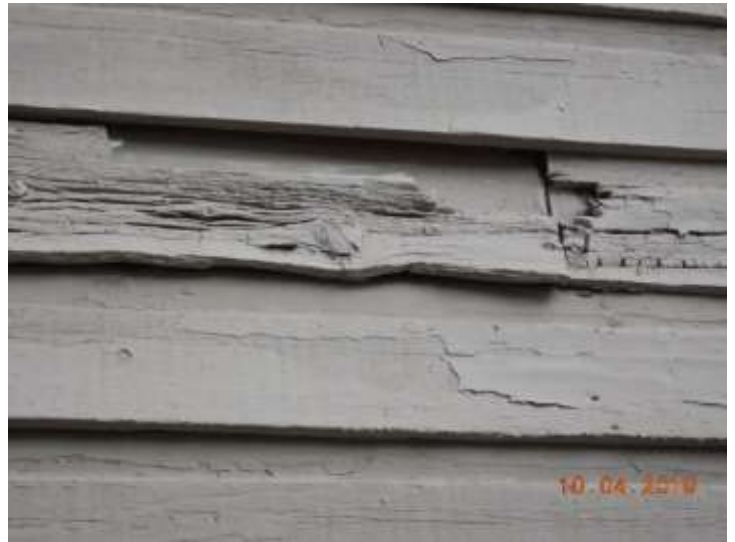
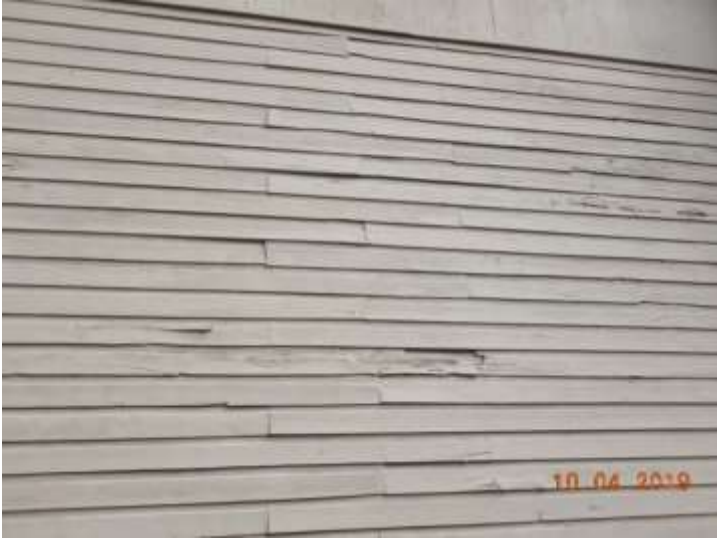
Deteriorated siding at the South facade

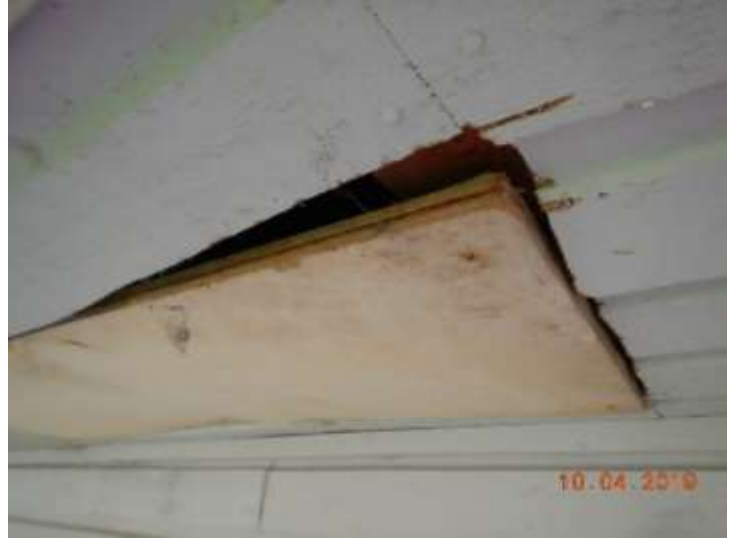
Gaps at the soffit

- The gaps surrounding the plywood cover at the rear soffit should be sealed to prevent pest and moisture intrusion
- The dryer vent should be properly aligned so that the flap will function as designed. The flap is to prevent moisture, cold air, and pest intrusion. Do not screen the vent as a screen will result in blockage from the lint

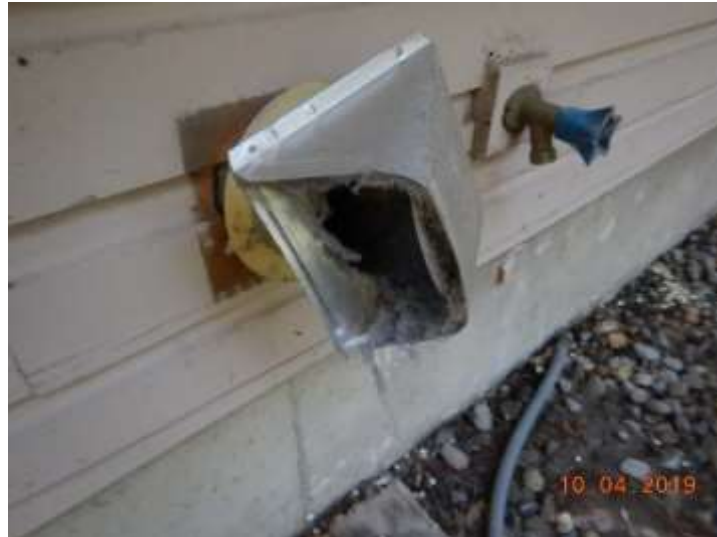
Improperly positioned dryer vent

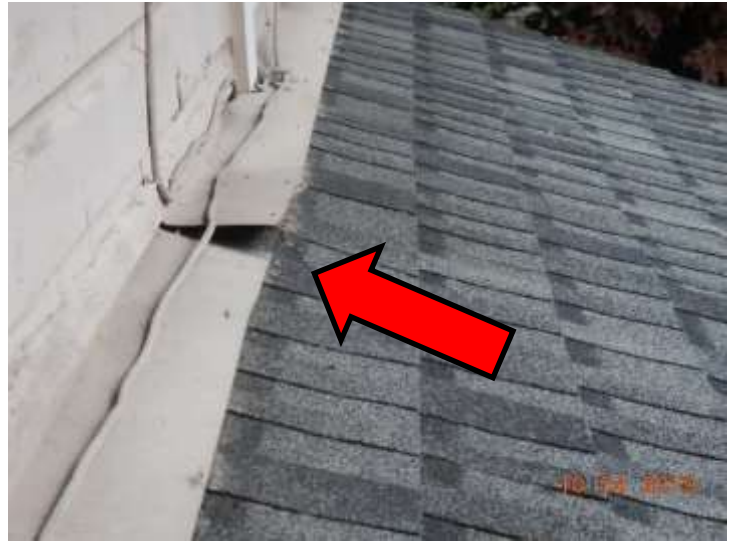
Front roof. The roof to wall metal should be secured to lay flat

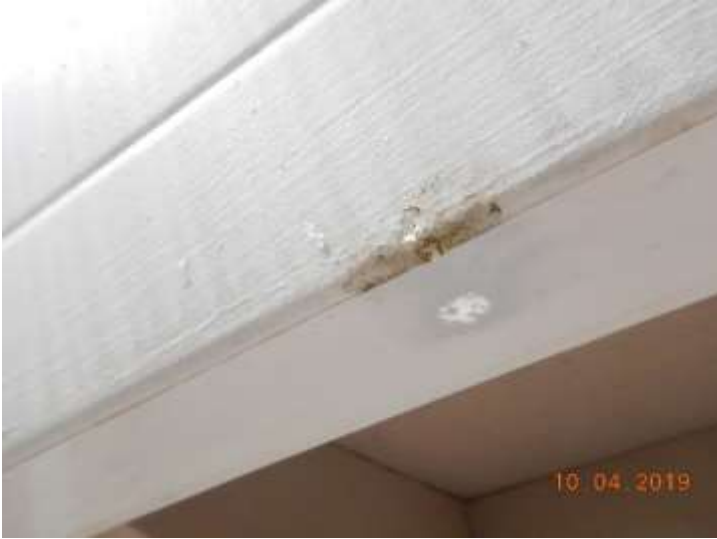
Condition: - There is substantive rusting of the gutters

Hole in a gutter. Tape is placed over the hole to attempt to stop leakage

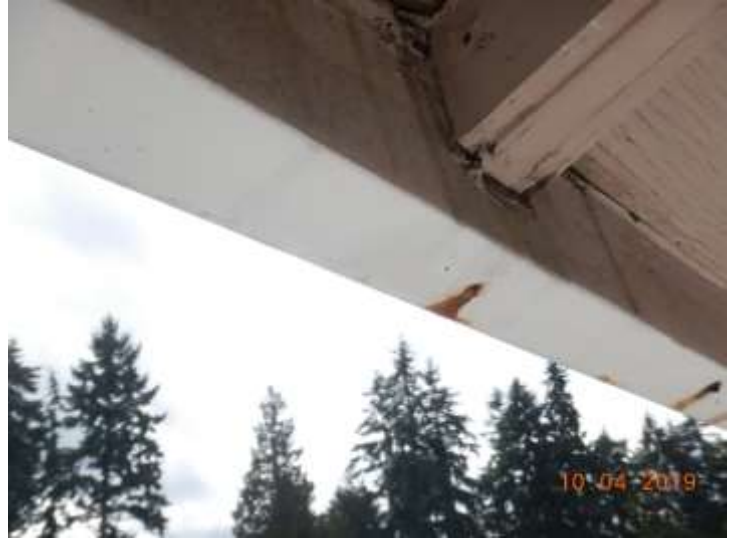
Rust drips areas at the front upper gutter

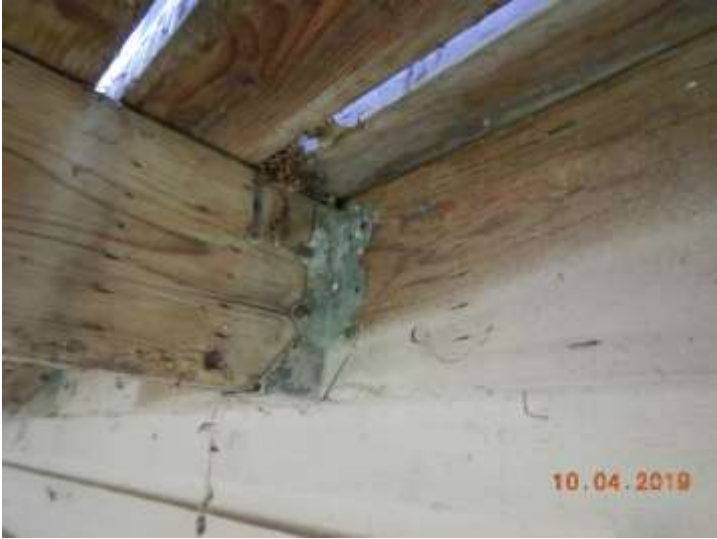
The deck is not lag bolted to the home

Connection to structure: - Recommend the installation of lag bolts to fasten the deck ledger to the home. Although likely not required at the time of construction of the home, this fastening system is a new "code" requirement to reduce the likelihood of failure of a deck structure

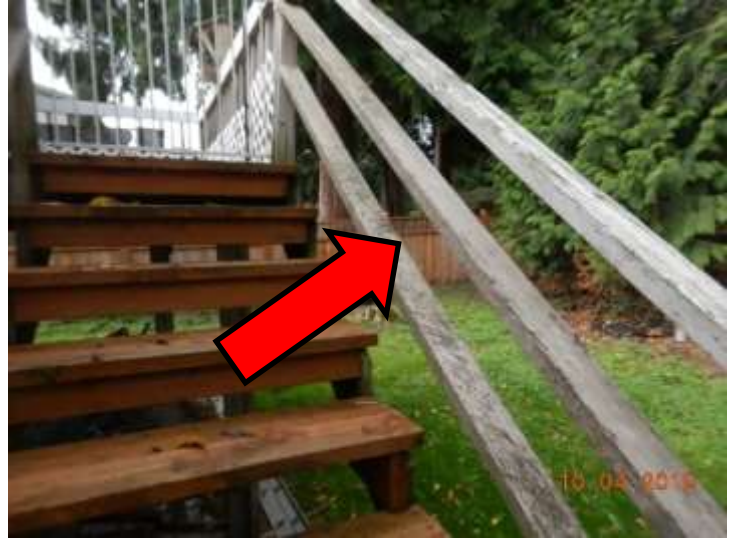
Handrails: - The graspable handrail/stairwell barricade is leaning and is very unstable

The barricade is unstable and is leaning

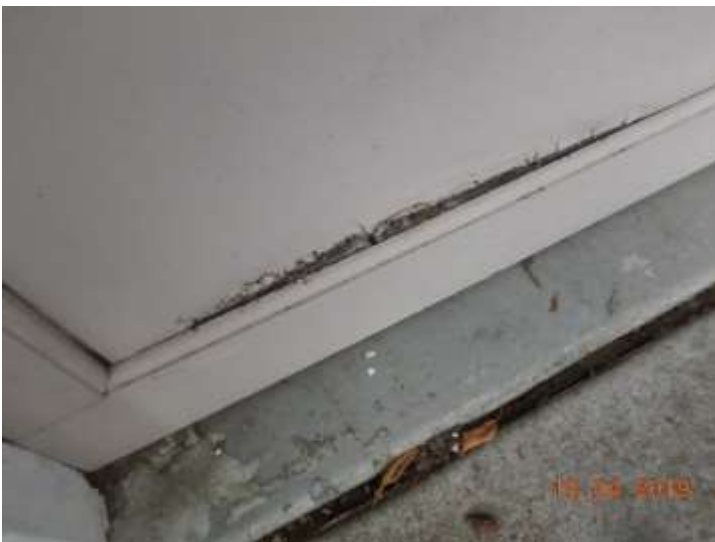
Type: Composite roll up
Door condition: - There are substantial deterioration of the garage door panels
Springs and tracks: The springs and tracks appear to be in satisfactory condition
Garage door openers: Yes (1)
Auto reverse of impact: Reversed when reasonable force was applied
Photo cell reverse sensors: Tested for proper operation

Deteriorated garage door panel

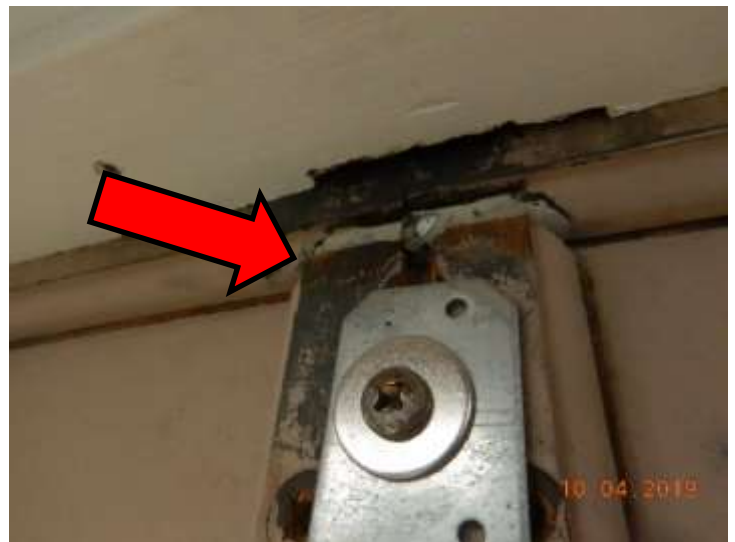
Prior repairs to the failing upper panel

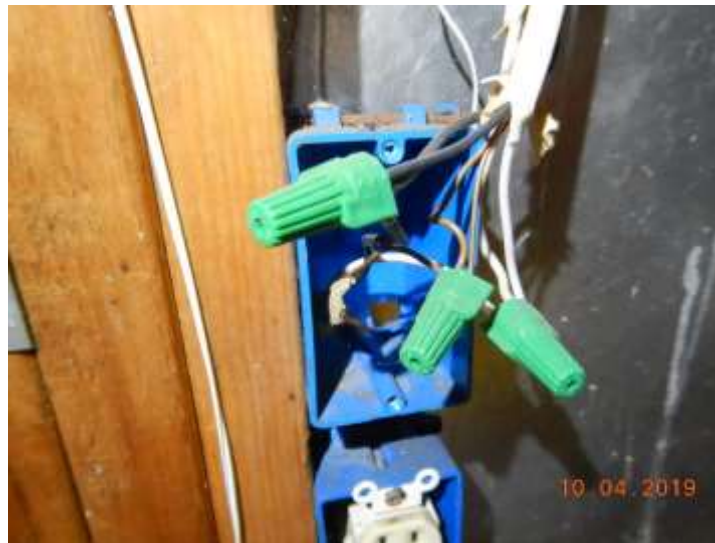
Improper wire splice

- There is an improper wire splice located adjacent to the garage door. The wires should be connected inside the junction box and properly secured in place. Plate covers should be installed where missing

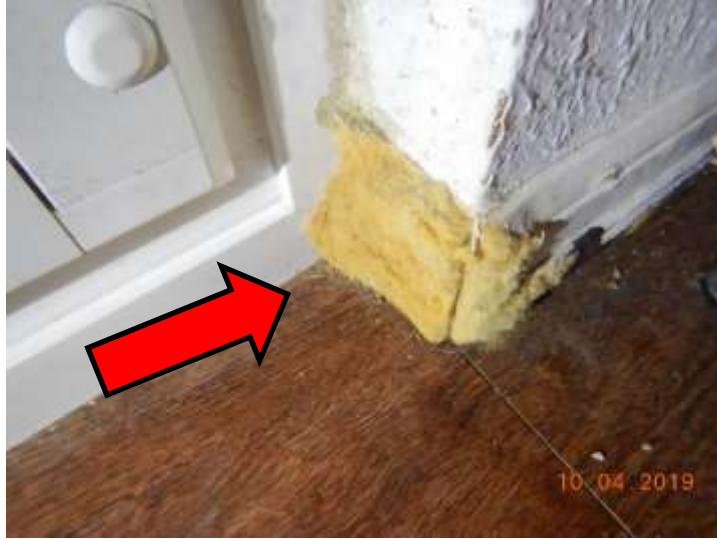
Operation/latching: Tested for proper operation and latching
Door condition: - The baseboards located adjacent to the sliding glass door are moisture damaged. This appears to be related to the use of the adjacent pet door
Millwork condition: Satisfactory

Moisture damaged baseboards

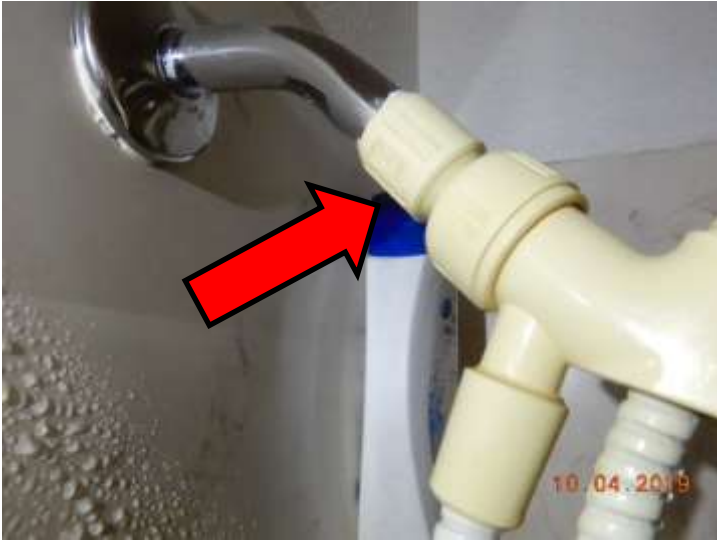
Bathtub-Shower: - There is substantial leakage at the shower head connection to the plumbing pipe at the wall

Leakage from the shower head connection

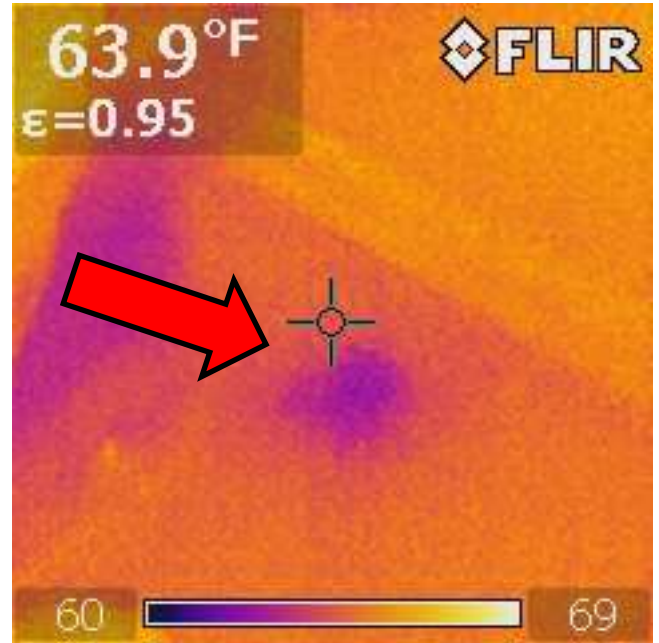
Toilet: - There is leakage from the toilet. The leak appears to be related to the water connection to the toilet

Leakage from the toilet water connection

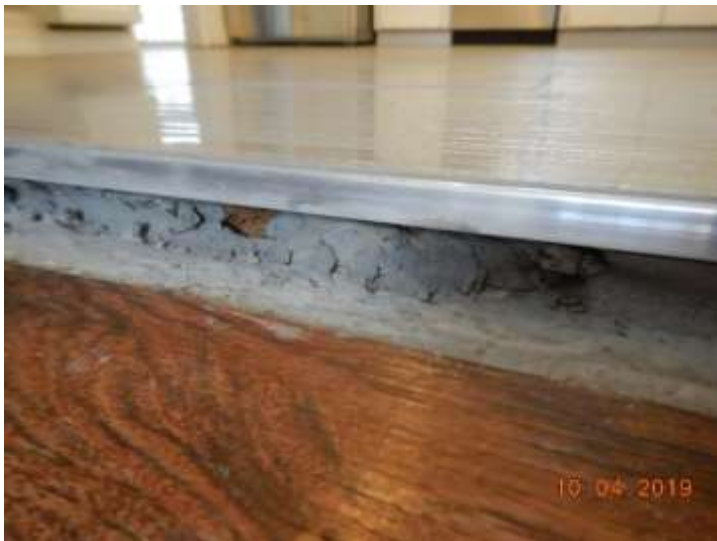
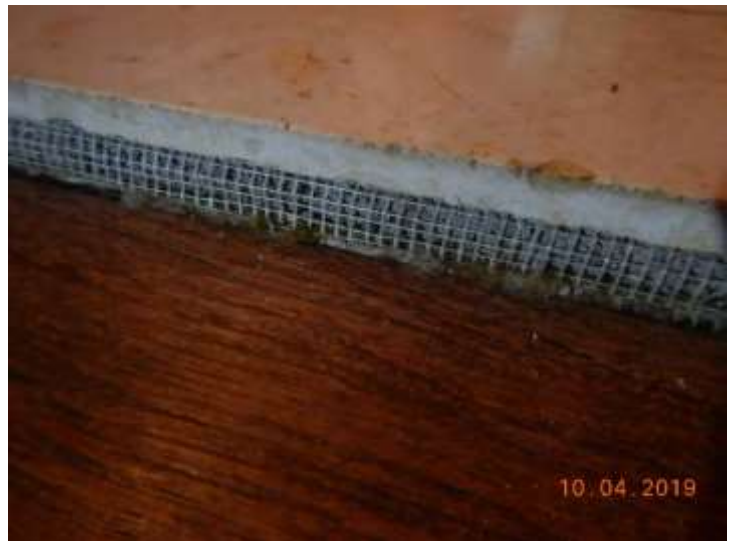
Large vertical height difference @ kitchen

Large vertical height difference @ main bathroom

- Flooring: - Per agent, the flooring throughout most of the home is to be replaced by Seller. Recommend using a thicker hardwood material (most engineered hardwoods are ½” thick, and then install a ¼ round transition strip where adjacent to the newer tile floors
General comment: Flooring covered by rugs or furniture may discolor at a different rate than uncovered flooring. Personal belongings, including rugs, are not moved during an inspection

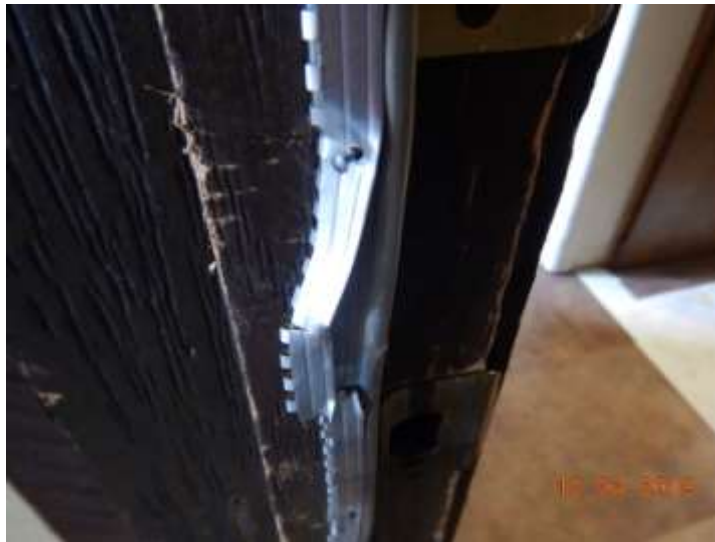
Operation/latching: Tested for proper operation and latching
Door condition: - There is substantial damage to the weather-stripping at the door to the garage
Millwork condition: Satisfactory

Damaged weather-stripping

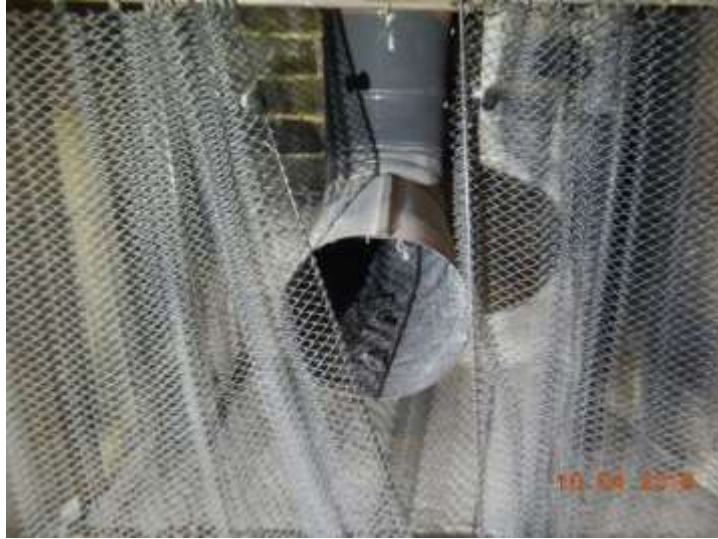
Type: Masonry wood burning
Tested: n/a
Condition: - The fireplace damper appears to have been removed and a pipe for a now removed woodstove installed

Woodstove type pipe

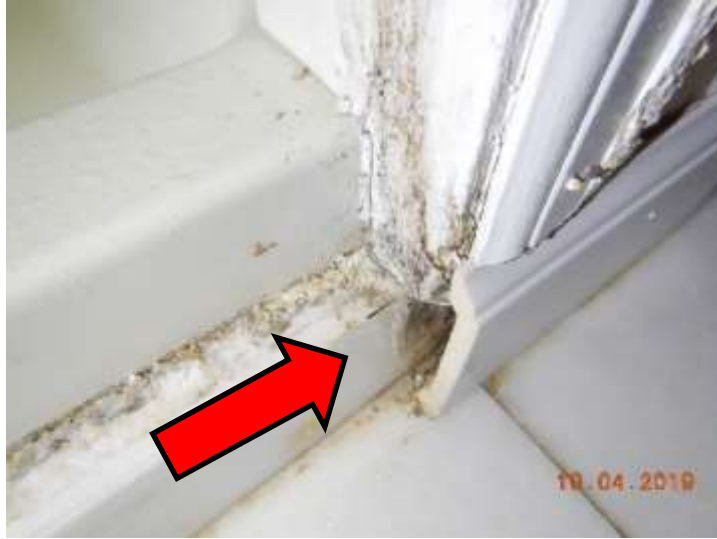
Operation/latching: Tested for proper operation and latching
Door condition: Satisfactory
Millwork condition: - *There is moisture related damage to the millwork where adjacent to the shower*
Bath Hardware: Satisfactory

Moisture related damage to the baseboards and trim

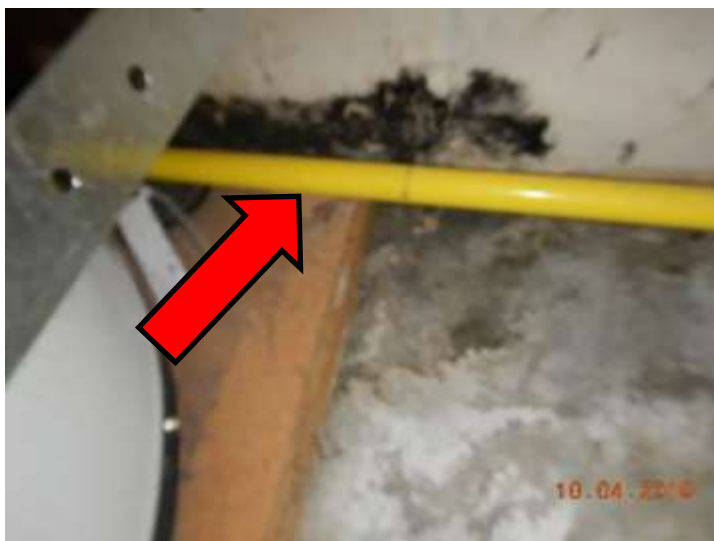
- Visibility: Room is occupied
Structural Movement: No visible evidence of substantive structural movement
Moisture Intrusion: No visible evidence
Walls: - There is evidence of black mold adjacent to the water heater. Active water leakage was not identified
Ceiling: Satisfactory
Flooring: Satisfactory

Evidence of black mold

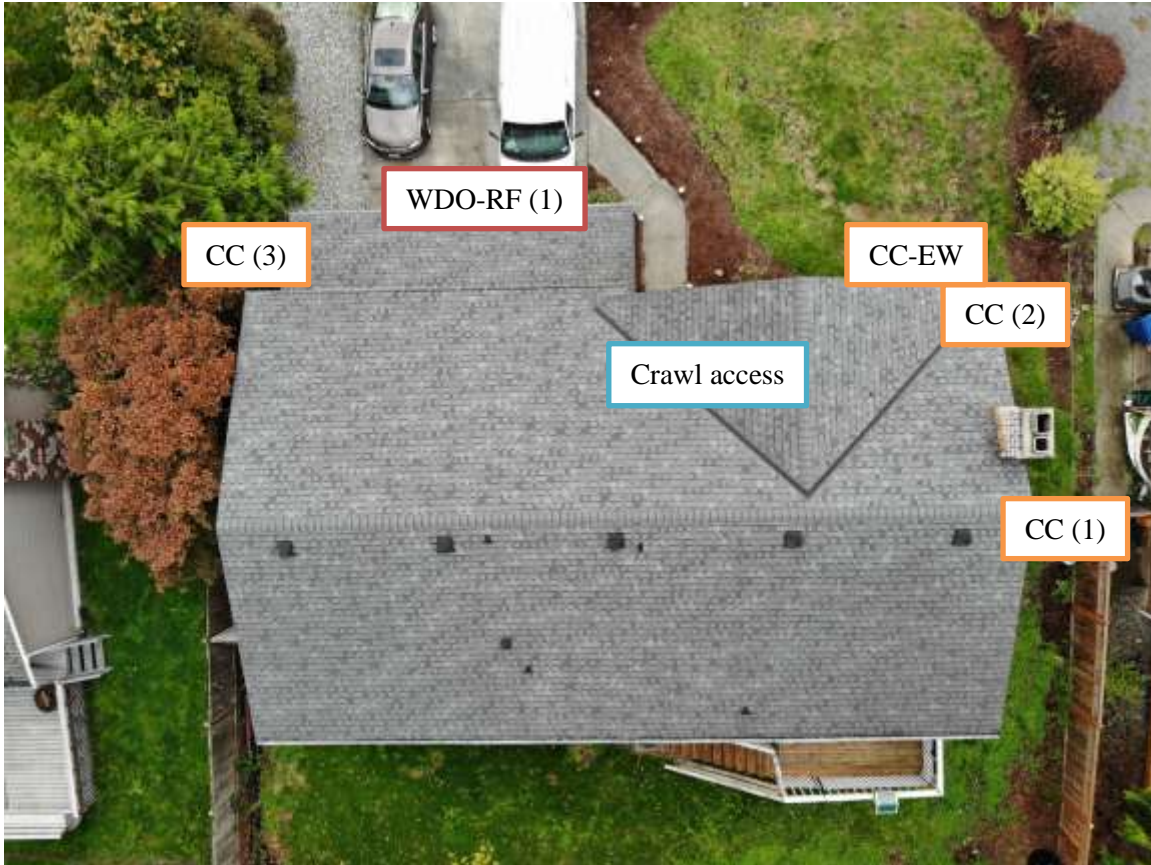
CC-EW Ground in contact with structure
 CC-VC Vegetation contact with structure
 CC-EM Excessive Moisture

CC (1) Substantially deteriorate siding; possible rot
 CC (2) Downspout connection not aligned
 CC (3) No splashblock
