(425) 652-6515
www.Hergert.com
Kevin @ Hergert.com
Wa. Home Inspector 619
WSDA Inspector 79988
WSDA Control # 11168AQ-08

Property Description: (1) story single family home with daylight basement
Estimated property age: Built 1973 per listing
Occupancy Status: Vacant

Inspection Date: 10/08/2019
Inspection Time: 1:30 P.M. - 3:30 P.M. +-
Weather Conditions: Rain, 55 deg f +-

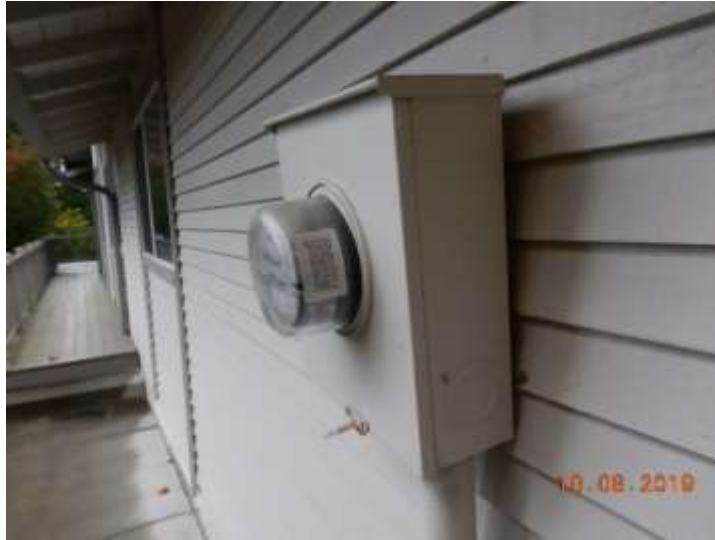
The meter base has slightly pull away from the home, however there is no evidence of issues related to this condition

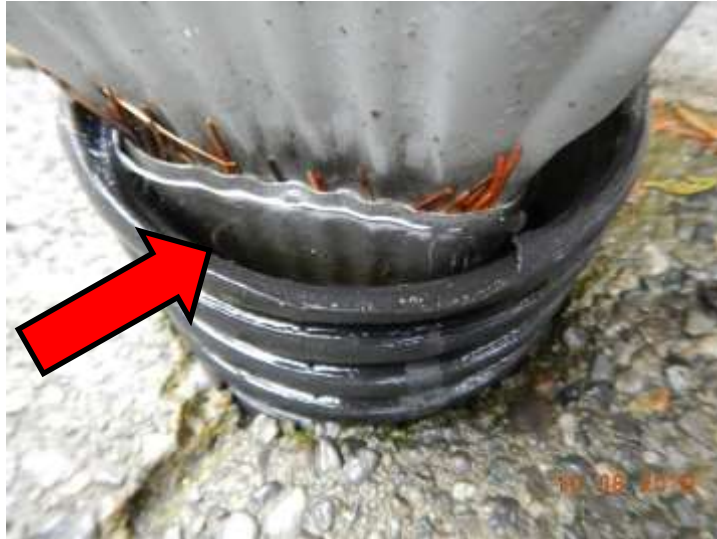
- Grade at structure: Adequate grade away
Earth to wood contact: Clearance as required
Vegetation contact: Negligible
Roof drain discharge: Underground and surface discharge
- The underground drainage system at the corner of the garage/ entryway appears to be clogged. Water discharged from this pipe and ran across the driveway to the other side-yard

Standing water in the pipe after the recent rainfall

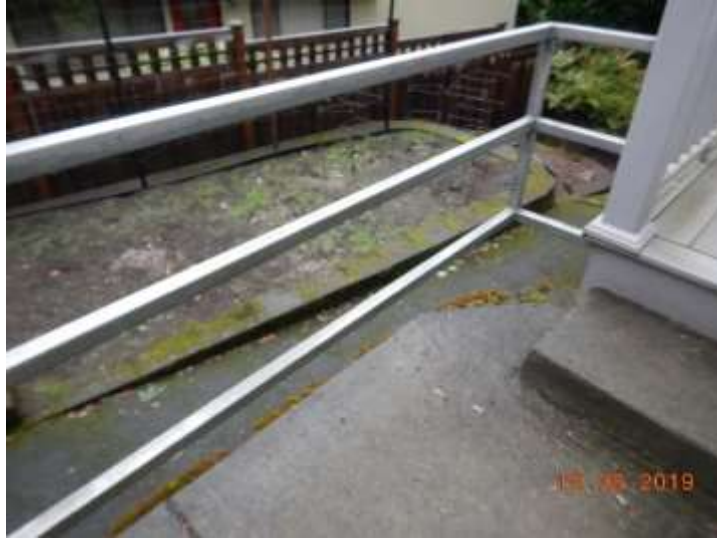
Baluster spacing exceeds 4"

- Type: Concrete
Condition: Satisfactory
Trip Hazard: None
Barricades: - Recommend reducing the side yard walkway barricade spacing to a maximum 4". Although likely not required at the time of construction, this code revision was implemented to prevent injury or hanging death to children

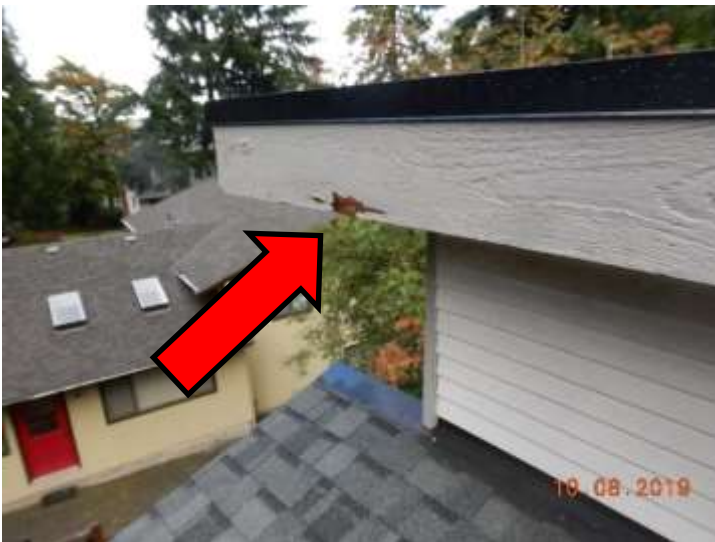
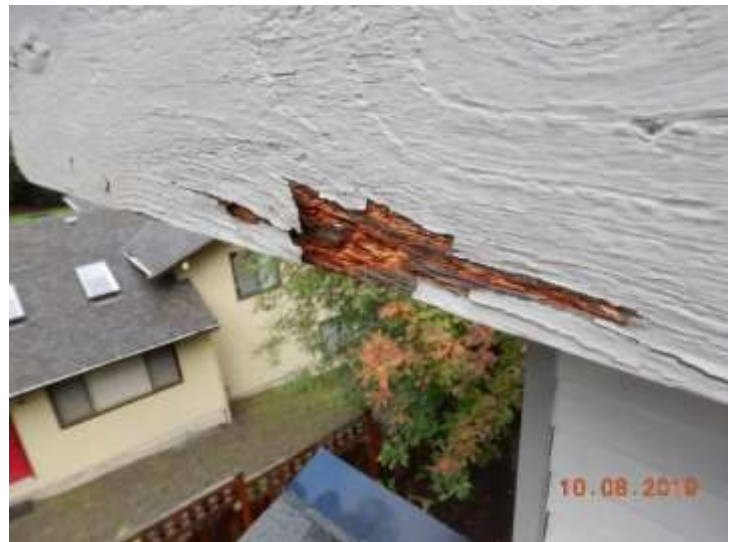
Type: Cedar
Condition: Overall satisfactory
- There is minor deterioration to the upper fascia board located in the vicinity of the Kitchen. Recommend re-painting this board to prevent further deterioration
Window/Door Flashing: Satisfactory
Paint and caulking: Satisfactory
Exterior vents: Satisfactory

Deterioration of a fascia board

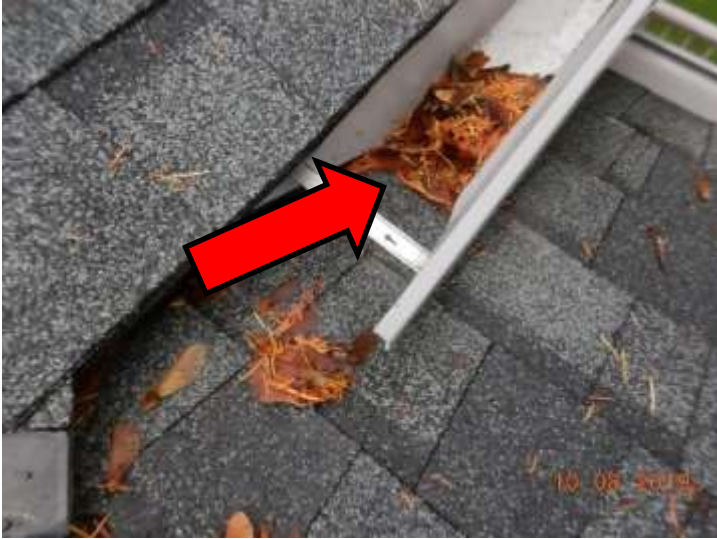
Gutter clogged with debris

- Recommend increasing the size of the available drainage at the gutters where discharging onto adjacent roofs. The existing small drainage areas are easily clogged by debris

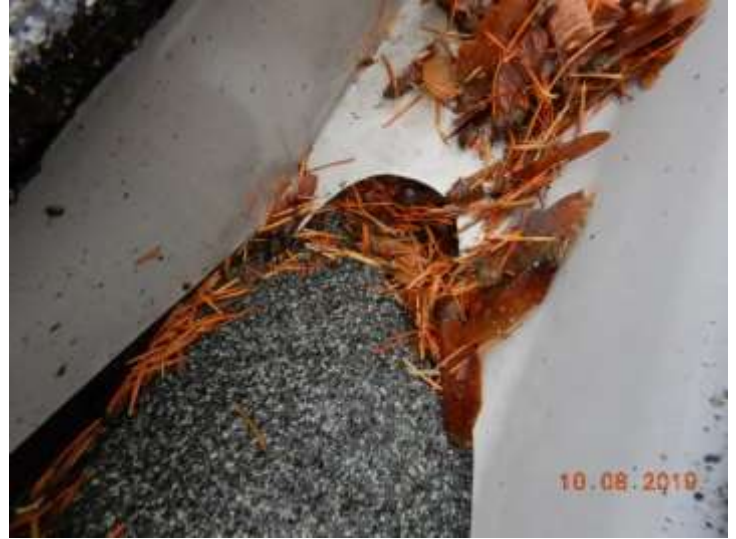
The hole at the end of the gutter is very small (the debris was pulled back by inspector)

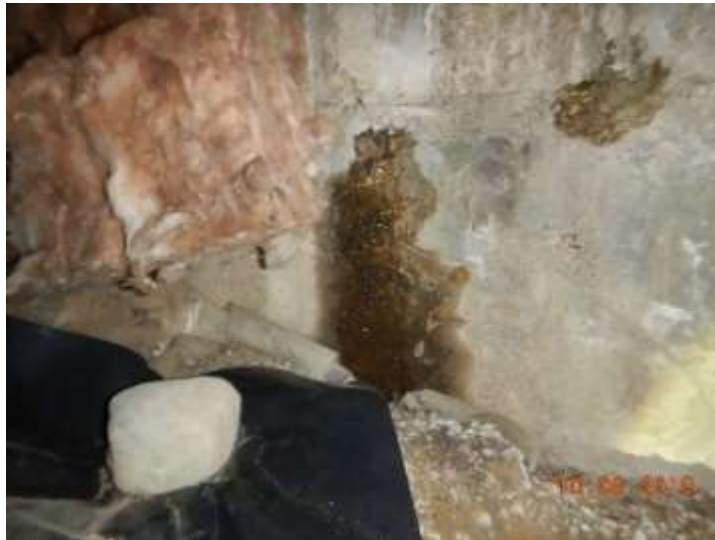
Ventilation: Appears adequate
Vapor Barrier: Appears adequate
Moisture Intrusion: - There is evidence of active moisture intrusion at the crawlspace at the area near the entryway. Recommend sealing this concrete at the interior with hydraulic water stop concrete. This may or may not resolve the intrusion
- There is evidence of active moisture intrusion at the Workspace area near the gas meter location. Recommend sealing the crack at the foundation wall at this location from the exterior with hydraulic water stop concrete. This may or may not resolve the intrusion
Sump Pump: None visible

Moisture at the crawlspace

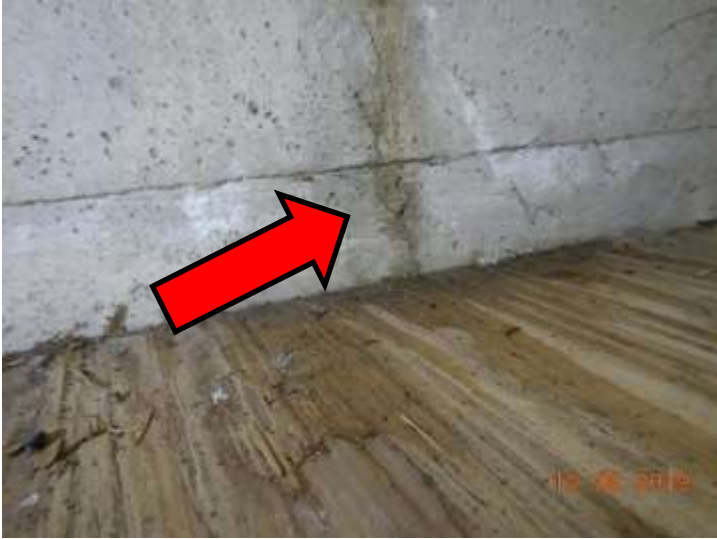
Moisture at the workspace

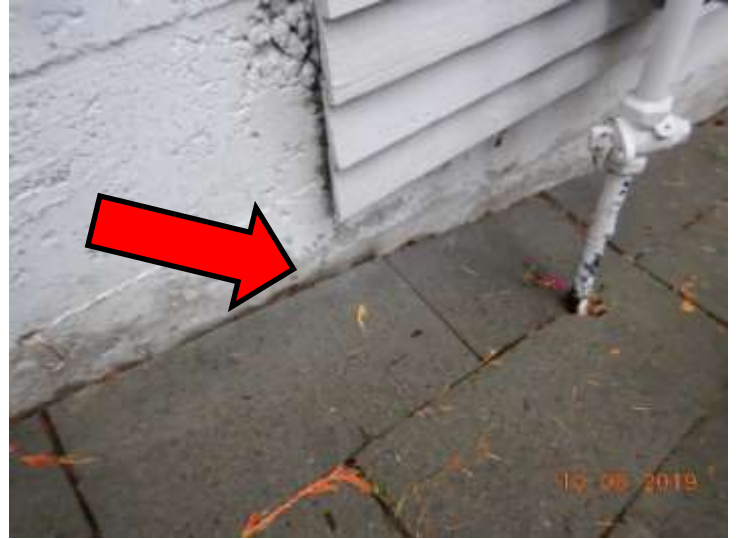
Aproximate location of the moisture intrusion

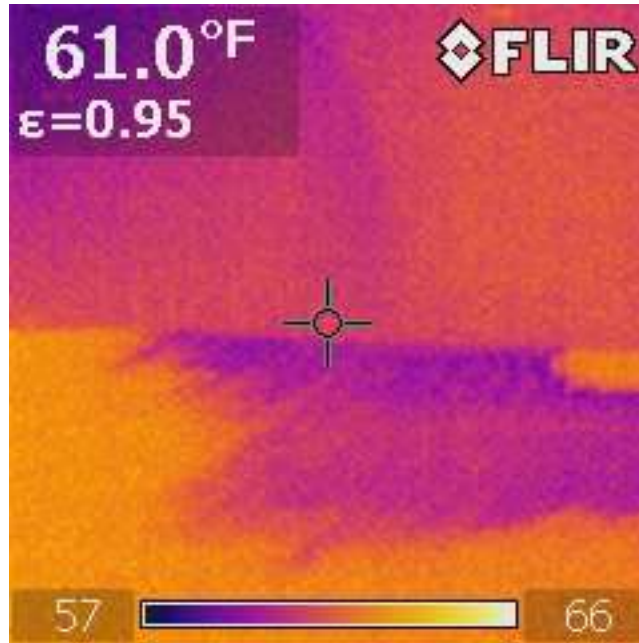
Moisture on the adjacent wood platform

Conducive conditions: - *The moisture intrusion noted above is a WDO conducive condition*

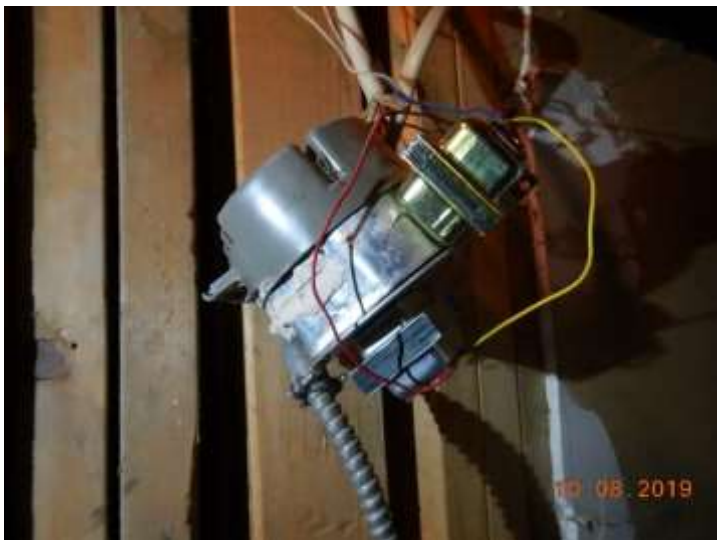
Wiring/ junction boxes: - *There are unsecured electrical wires and electrical boxes in the crawlspace. The wires should be properly secured to the framing. Plate covers should be installed where missing*

Unsecured wiring

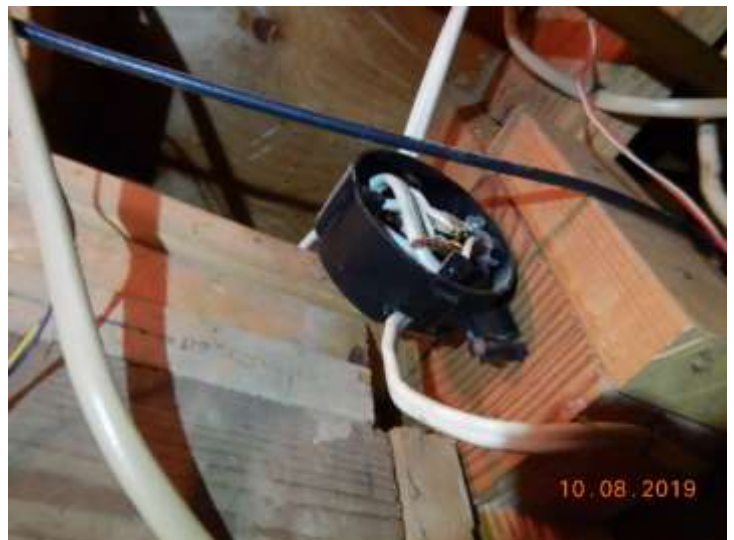
Open junction box

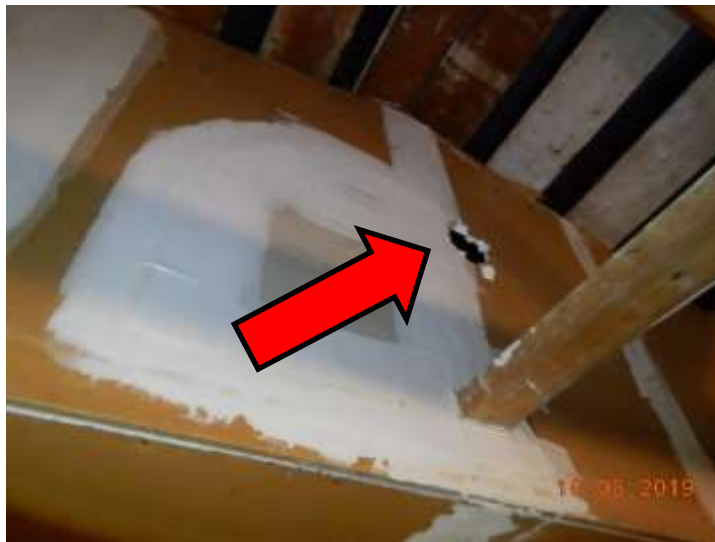
Sources of ignition: All 18" or more above the slab where required
Safety bollard: Not applicable as the furnace and water heater are not located in the garage
Fire separation: - The missing drywall at the upper wall of the garage is a breach in the 1 hour fire separation from the garage to the living spaces

Hole in the drywall

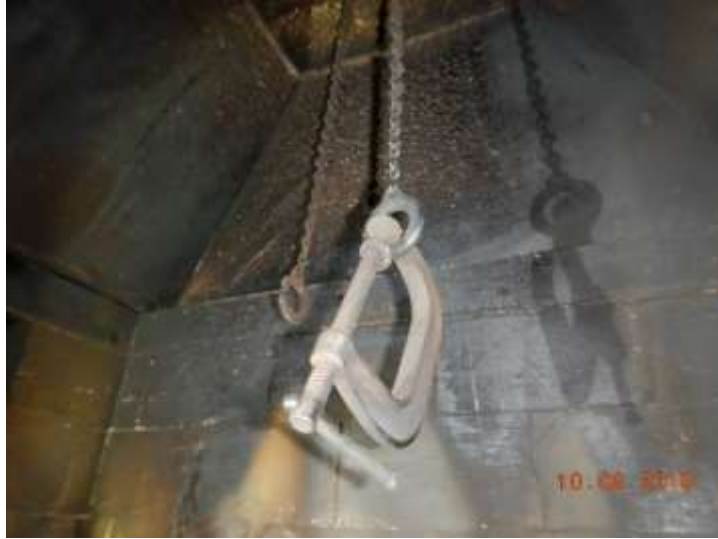
Type: Masonry wood burning
Tested: Damper
Condition: - Recommend cleaning the fireplace due to the buildup of creosote
- A proper fireplace damper handle is not installed

The damper is held in place by a c clip

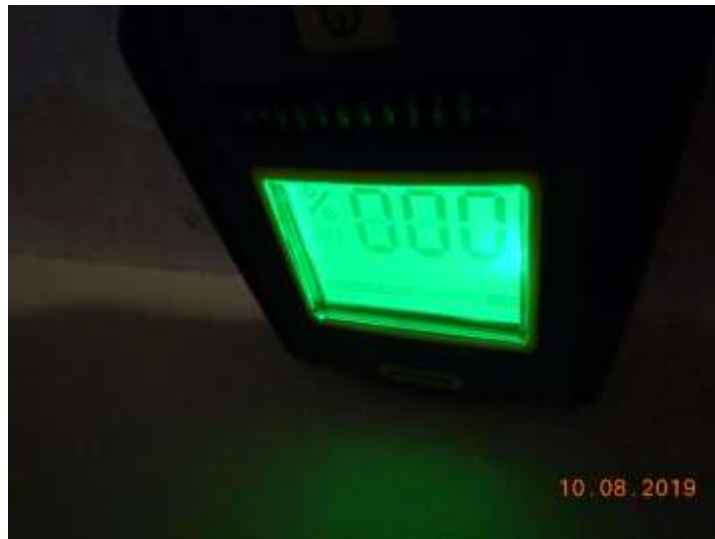
There is no evidence of moisture at the area above the exterior door. A moisture stain is located at this area
