Property Description: (2) story single family home with daylight basement
Estimated property age: Built 1996 per listing
Occupancy Status: Occupied (staged)

Inspection Date: 08/11/2019
Inspection Time: 12:00 P.M. - 2:30 P.M. +-
Weather Conditions: Overcast, 70 deg f +-

Hergert Inspection LLC

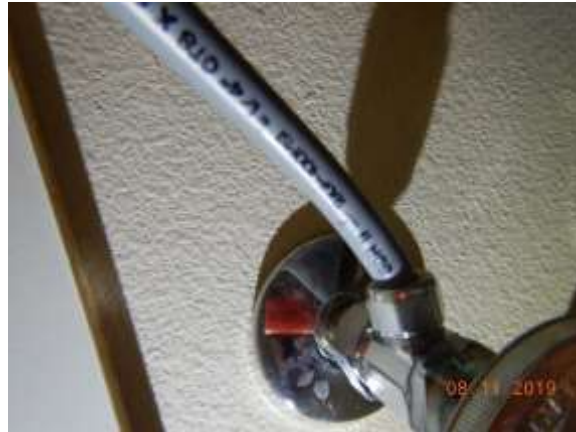
- The supply lines to most of the bathroom sinks are polybutylene pipe. This type of pipe is a known defect as it tends to fail. Recommend replacement (this does not involve changing pipes within the wall)

Polybutylene pipe @ sinks

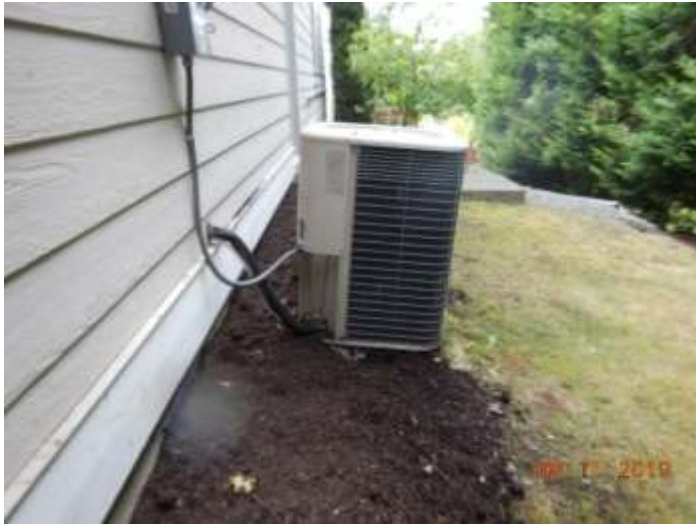
The compressor is not level

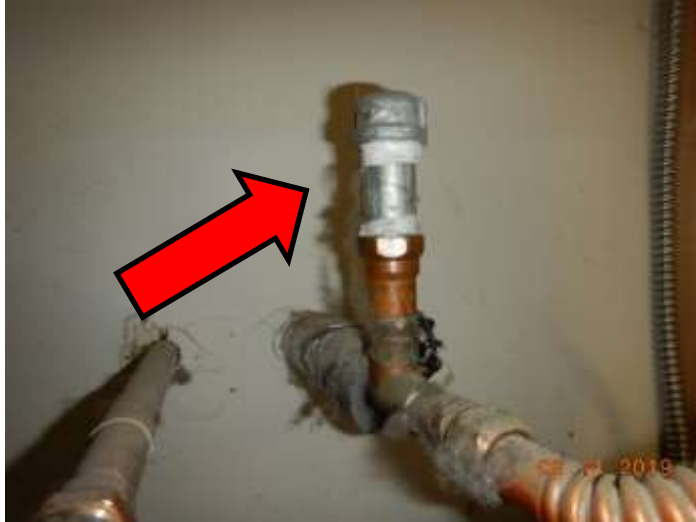
Flue secure: Inspected
Clearances: As required where visible
Draft Hood: Inspected
Water connection: Inspected
Expansion Tank: - New water heater tank installations typically require an expansion tank be installed. The tank absorbs pressure as hot water expands. It appears that a prior expansion tank has been removed
Drip pan: Installed

Appears that an expansion tank was removed from this location above the water heater

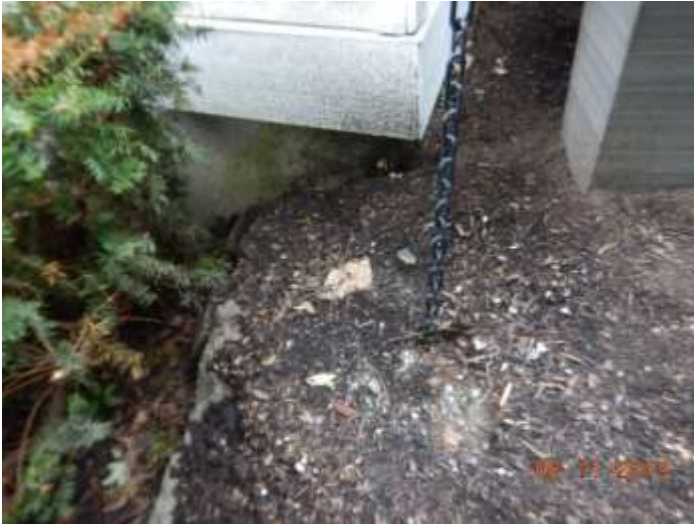
Downspout chain. No splash-block or drain is provided (WDO conducive condition)

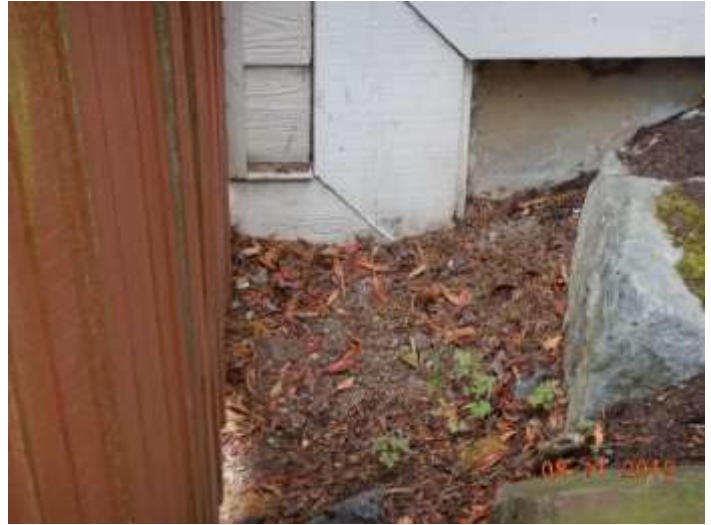
- Grade at structure: Adequate grade away
- Earth to wood contact: - Ground in contact with the siding (WDO conducive condition). Recommend 4-6" separation between the ground and siding
- Recommend installing a drainage system at the front corner of the Living room sitting area that would divert water away from the home and prevent water from splashing back onto the siding
- Vegetation contact: Negligible
- Roof drain discharge: Underground and surface discharge

Ground in contact with the siding (WDO conducive condition)

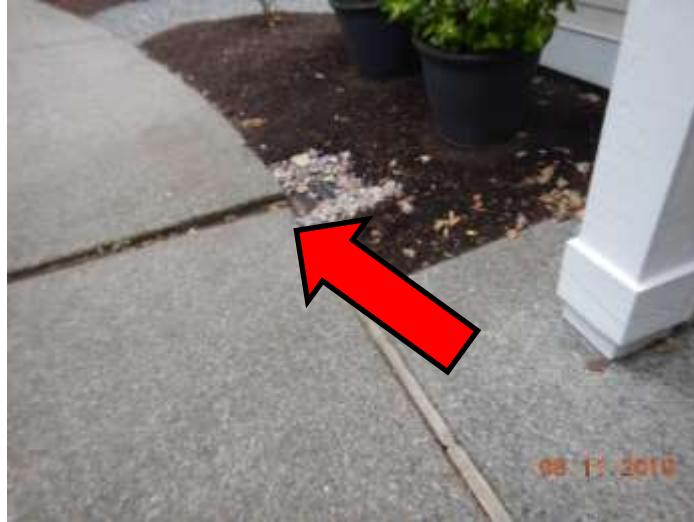
- Type: Concrete
- Condition: Satisfactory
- Trip Hazard: - There is substantial settlement of the front porch and walkway. A trip hazard exists due to the raised edges at the slabs

Trip hazard

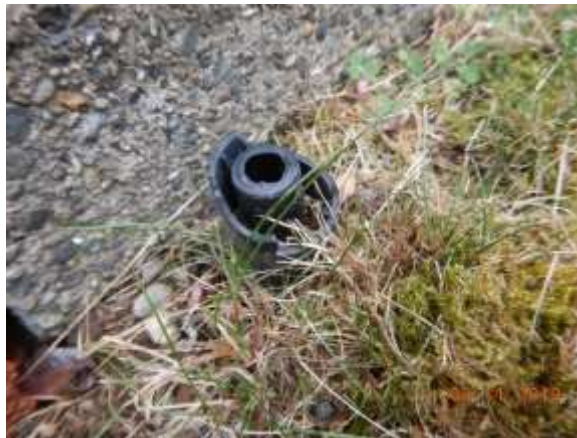
House Identification #: Visible
Overhead Power Lines: No
Retaining Walls: None that affect structure
Underground Oil Tank: No visible evidence
Irrigation System: - Seller should demonstrate that the irrigation system operates as designed and explain all winterization procedures as may be applicable. Some irrigation heads appear to be damaged

Damaged irrigation head

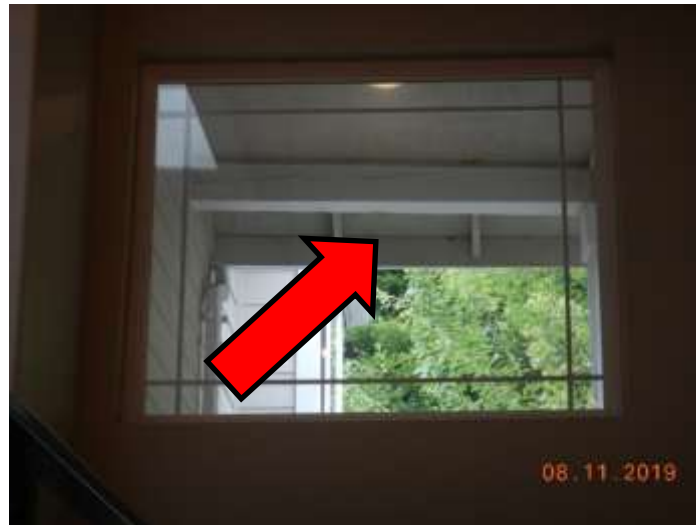
- Structural Movement: - There is evidence of settlement of the front porch. No adverse issues to the structure were identified as a result of this settlement. The settlement is likely related to the settlement at the adjacent slabs
- Exterior doors: Satisfactory
- Windows (ext. cladding): Satisfactory

Evidence of settlement (sloping beam)

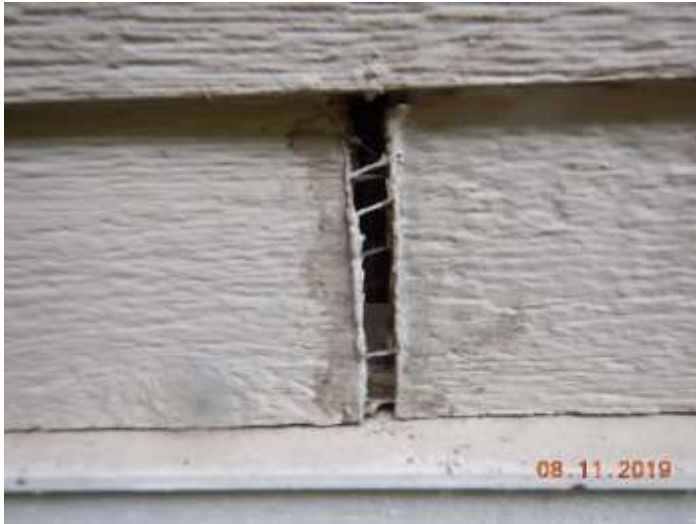
Gaps at the end joints should be caulked

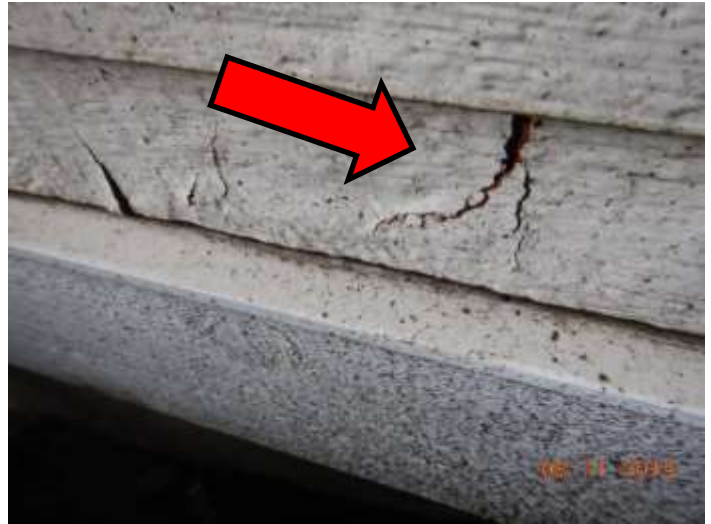
- Type: Composite
- Condition: Overall satisfactory
- There is evidence of siding failure where adjacent to the uncontrolled downspout located at the outer corner of the Living room sitting area
- Window/Door Flashing: Satisfactory
- Paint and caulking: - The end joints of the siding should be caulked as needed
- Exterior vents: Satisfactory

Failed siding at the Living room area

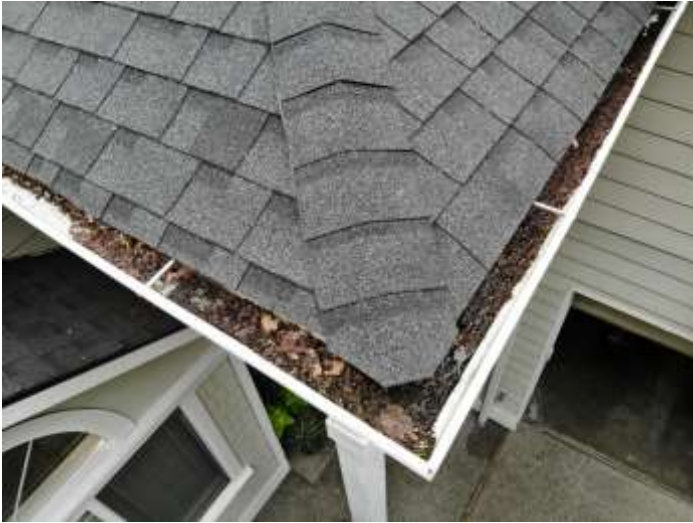
- Type: Continuous metal
- Condition:
- The gutters should be cleaned of debris
 - Once cleaned of debris, the slope of the gutter at the front porch should be verified. Settlement of this area may affect the slope of the gutters
 - Seller: explain the dent located at the gutter located at the driveway side of the garage. An old moisture stain is visible at the siding in this location

Debris in the gutter above the entryway

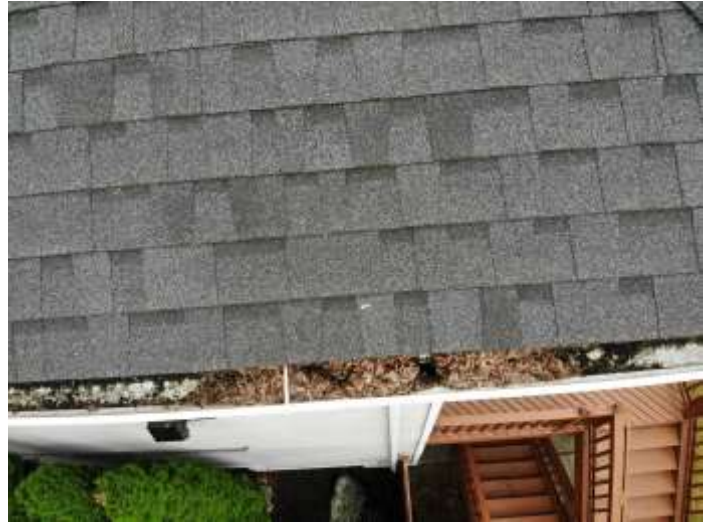
Debris at an upper rear gutter

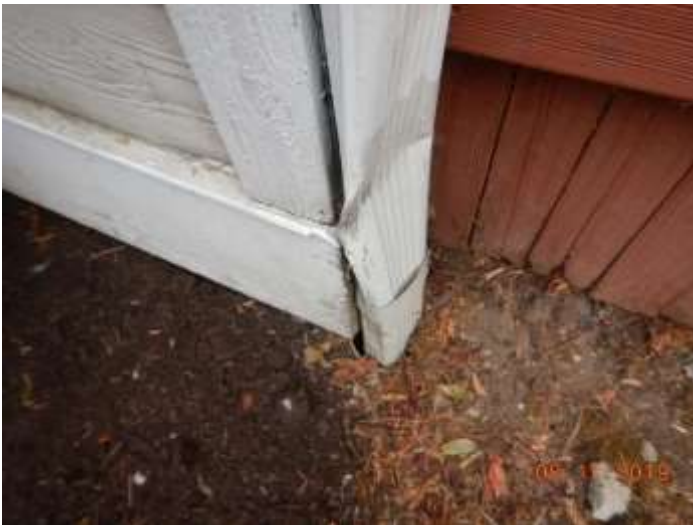
A downspout at the rear of the home is crushed, however appears to service its intended purpose

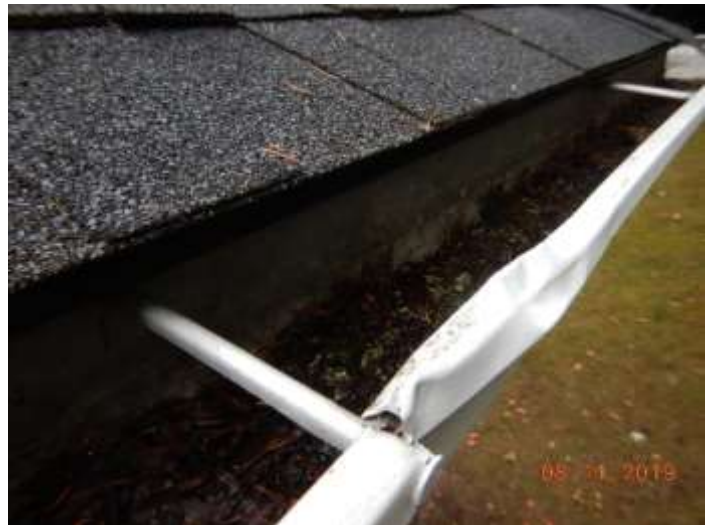
- Seller: explain the dent located at the gutter located at the driveway side of the garage. An old moisture stain is visible at the siding in this location

Dented gutter

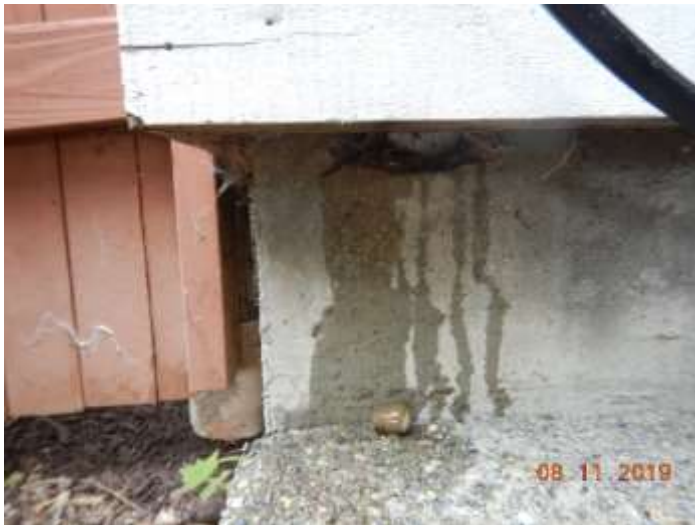
Gas Piping: - The rear hose bib appears to have an internal crack and substantially leaks into the adjacent wall when active. Recommend immediate review and repair by a licensed plumber (inspector turned off the water supply to the home as the sound of running water could be heard even with this valve set to the off position). See the related comments in the Basement bedroom section

Water running from the siding at the rear hose bib

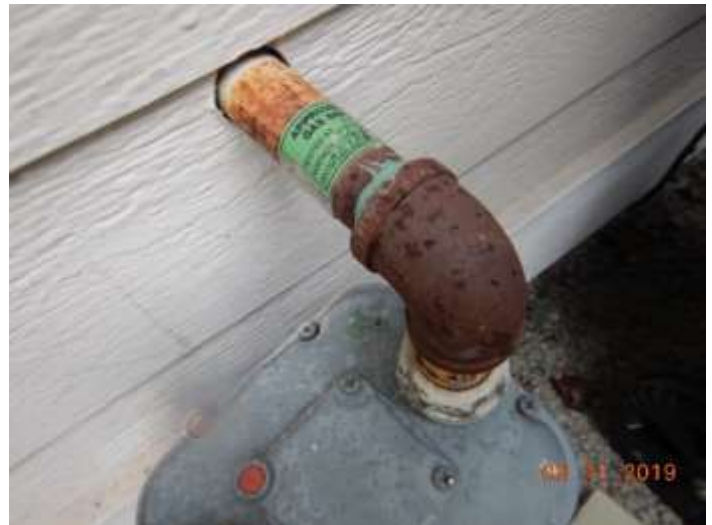
Rusting gas pipes

- All gas pipes should be coated with rust proof paint

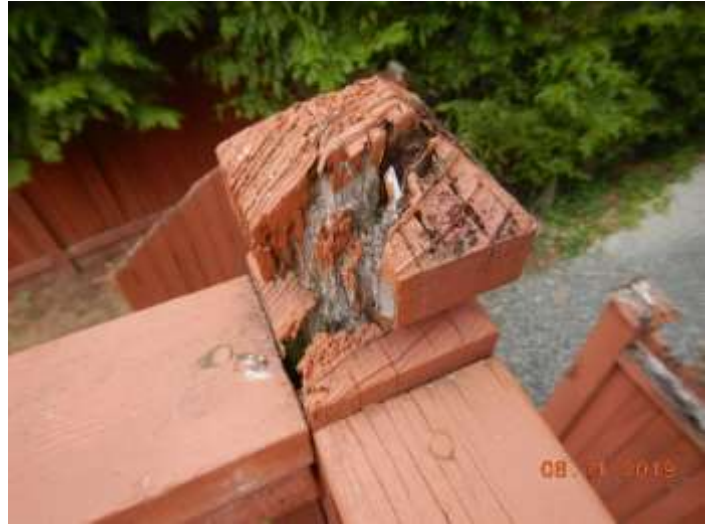
- There is evidence of wood rot at the top side of several barricade posts at the deck

Rotting barricade post (typical)

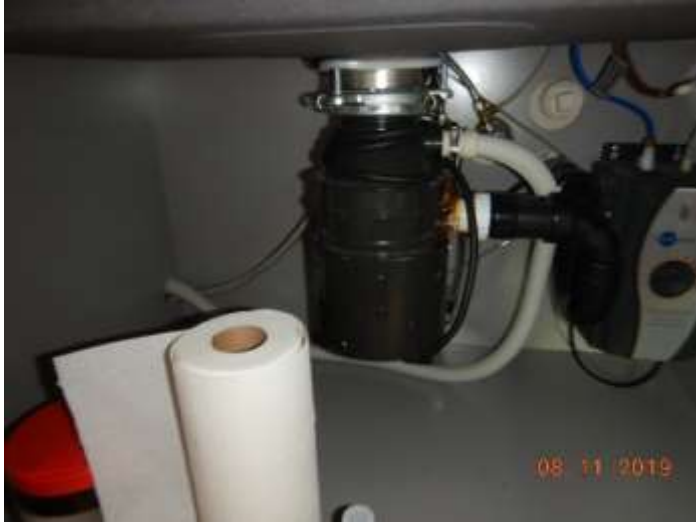
Dishwasher: Tested a full cycle. Not all functions and settings are tested
Dishwasher drainage: - The dishwasher drain should be secured to the underside of the countertop to prevent cross contamination of waste water with the dishwasher (high loop)
Cooktop: Tested all burners
Oven: Tested. Not all functions and settings are tested
Microwave (door): The door of the microwave was tested for operation
Ventilation: Tested
Refrigerator: - Seller: Is there a water supply to the refrigerator? If so, demonstrate this the supply and ice/water features of the refrigerator function as designed

Dishwasher drain

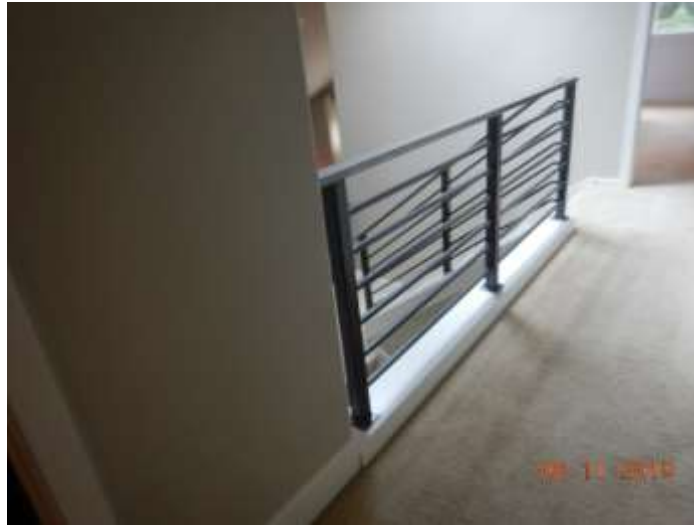
Barricades: - *Horizontal barricades are permitted by code, however can be a fall safety hazard as the style creates a climbing ladder*

Horizontal barricade

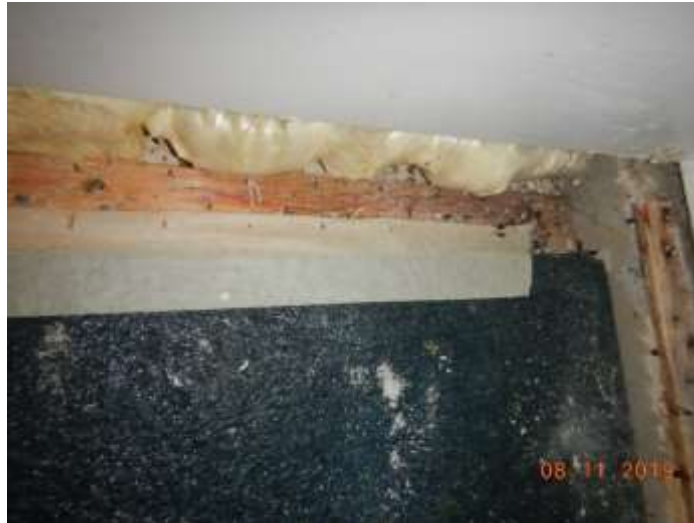
- Visibility: Room is occupied
- Structural Movement: - There is evidence of substantive settlement of the slab located in this space. Seller: explain the history of this settlement. Recommend further review and cost estimates to repair by a licensed contractor. Self leveling concrete should be used as slab jacking may result in damage to the primary waste line for the home
- Moisture Intrusion: No visible evidence
- Walls: Satisfactory
- Ceiling: Satisfactory
- Flooring: Satisfactory

Settlement of 2" +/-; expansion foam has been added. The carpeting was unsecured at the outer corner of the room

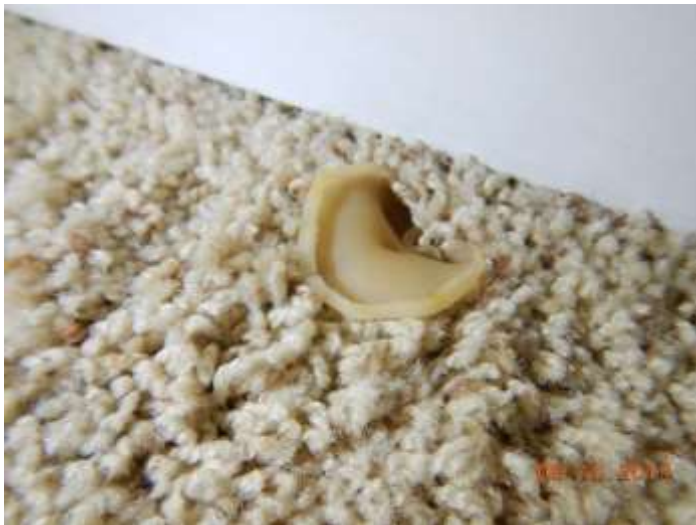
- Visibility: Room is vacant
- Structural Movement: No visible evidence of substantive structural movement
- Moisture Intrusion: - There is evidence of active moisture intrusion at the outer corner of the bedroom. The source of the moisture appears to be the damaged hose bib located at the outer wall at this area. All moisture damaged insulation, drywall, and carpeting pad should be removed and replaced
- Walls: Satisfactory
- Ceiling: Satisfactory
- Flooring: Satisfactory

Mushroom growing from the carpeting

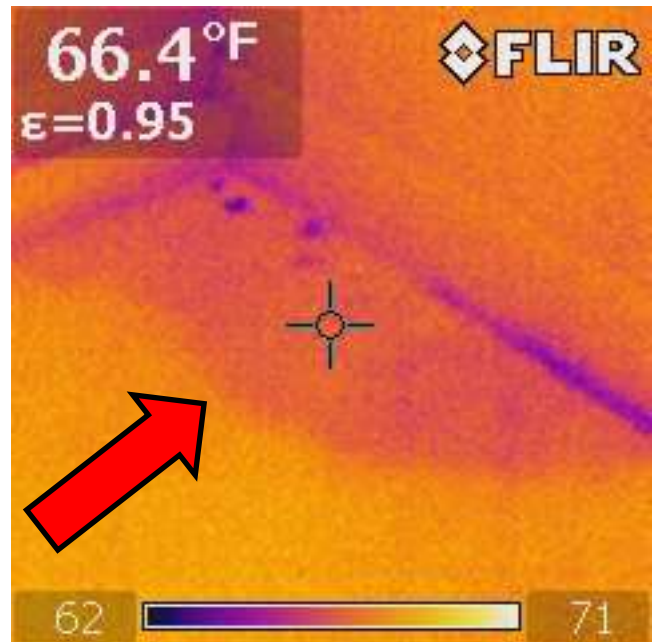
Moisture at the carpeting
(outer corner of the room)
