(425) 652-6515
www.Hergert.com
Kevin @ Hergert.com
Wa. Home Inspector 619
WSDA Inspector 79988
WSDA Control # 11168AQ-017

Property Description: (2) story single family home
Estimated property age: Built 1997 per listing
Occupancy Status: Occupied

Inspection Date: 10/09/2019
Inspection Time: 1:00 P.M. - 3:15 P.M. +-
Weather Conditions: Overcast, 55 deg f +-

Summary of Inspection

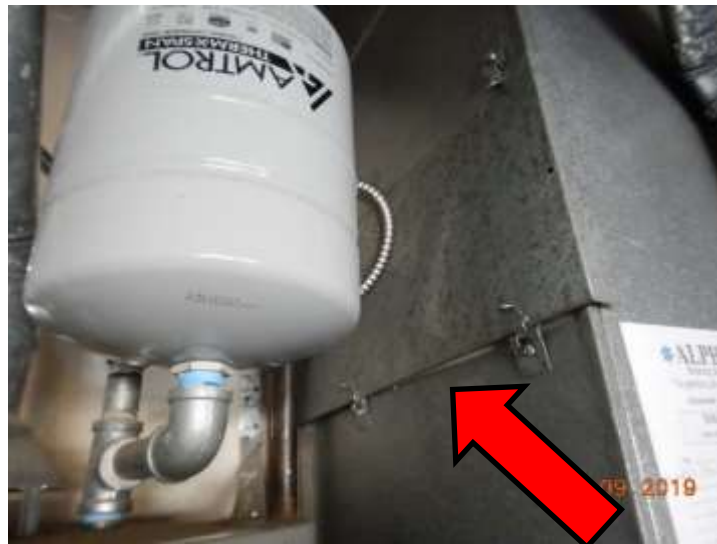
- Thermostat: Programmable @ floor 1
- Disconnect: Switch on furnace
- Combustion Air: Appears adequate
- Filter: Located above the furnace
 - The access to install a furnace filter appears to be obstructed by the water heater expansion tank

The furnace filter access appears to be partially blocked

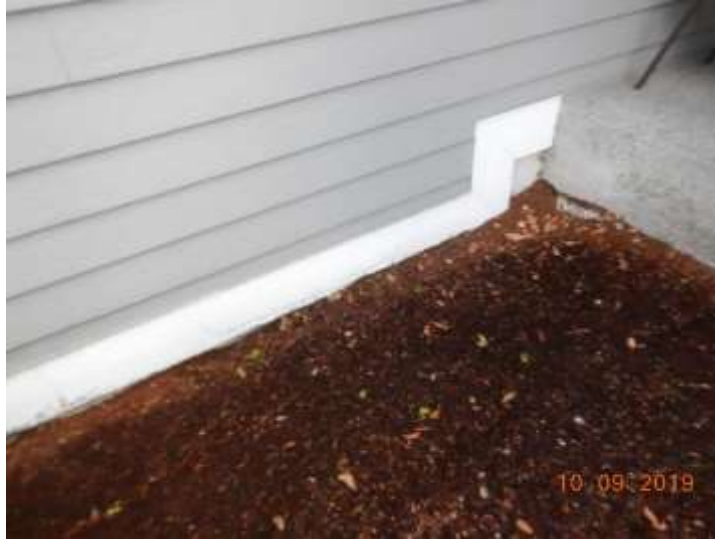
Grade at structure: Adequate grade away
Earth to wood contact: - Ground in contact with the siding (WDO conducive condition). Recommend 4-6" separation between the ground and siding
Vegetation contact: Negligible
Roof drain discharge: Underground discharge

Ground in contact with the siding
(WDO conducive condition)

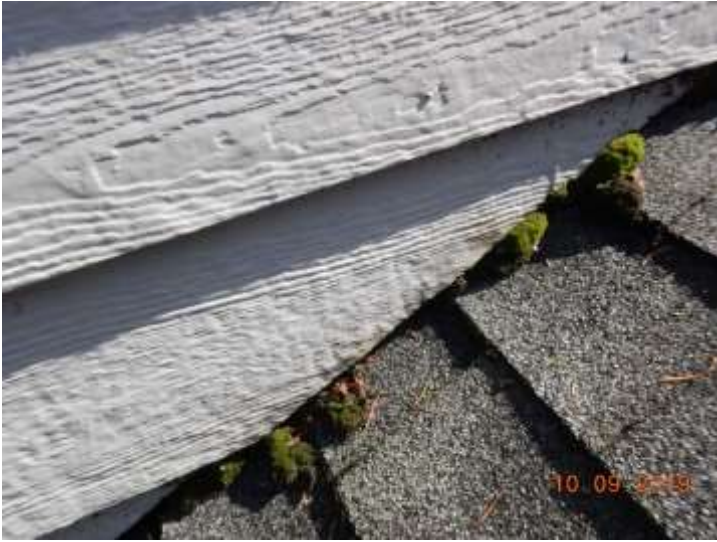
Condition: - The composition type siding is a known defect as the siding tends to retain moisture and begins to swell, crack and rot. There are varying degrees of failure visible at multiple locations of the siding. Many areas have moderate swelling and cracking at the base of the siding, however are still solid enough such that a metal probe cannot be pushed into the siding. There areas should be acceptable for several years with proper maintenance (keeping the lower edges of the siding painted). Areas that are heavily exposed to the weather and sun show more substantive deterioration. These areas are located primarily at the side walls at the Living room, dining room, and Family room. A probe can be pushed into the lower edge of many siding boards at these locations.

The lower edge of the siding at the rake wall is very brittle

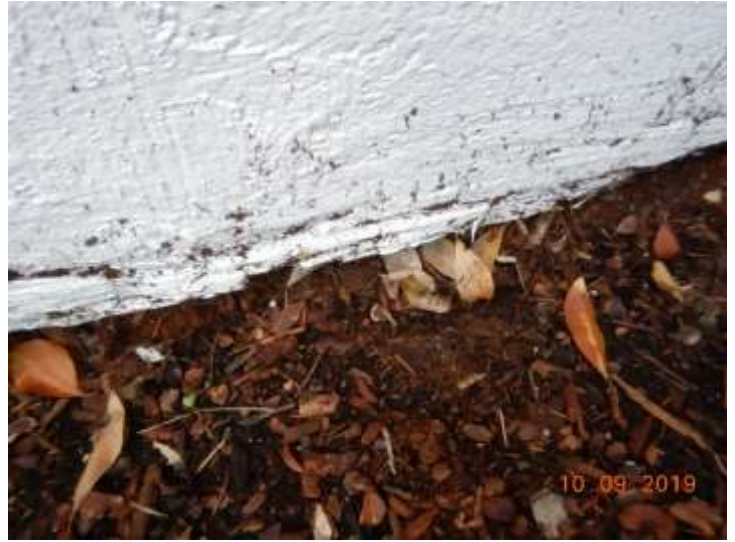
- There is evidence of wood rot at the band board located at the entryway side of the garage and at several foundation vents

Wood rot at the band board near the entryway

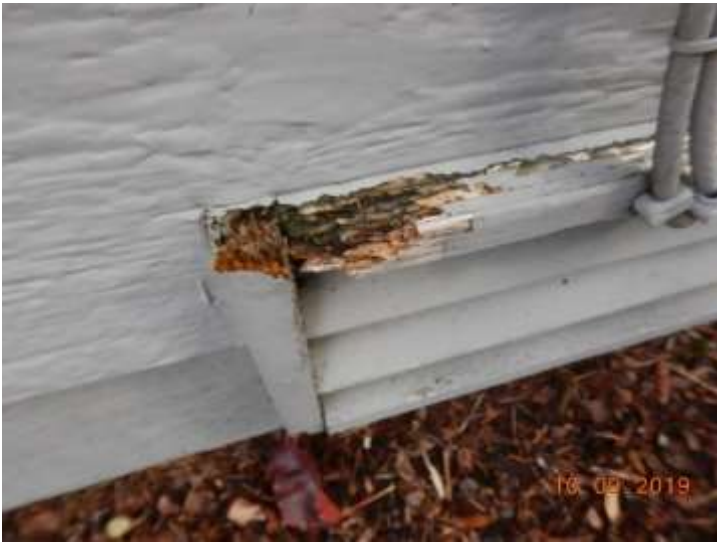
Deteriorated crawlspace vent

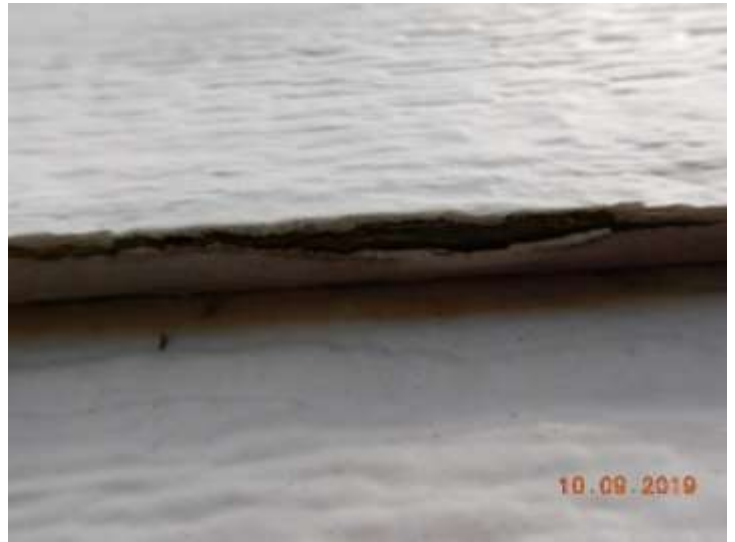
Failed lower edge of a siding board

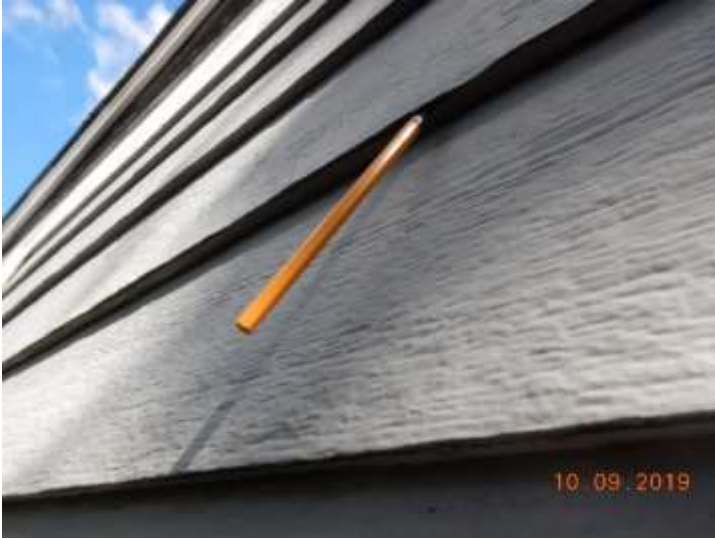
A probe can be easily pushed into the lower edge of the siding

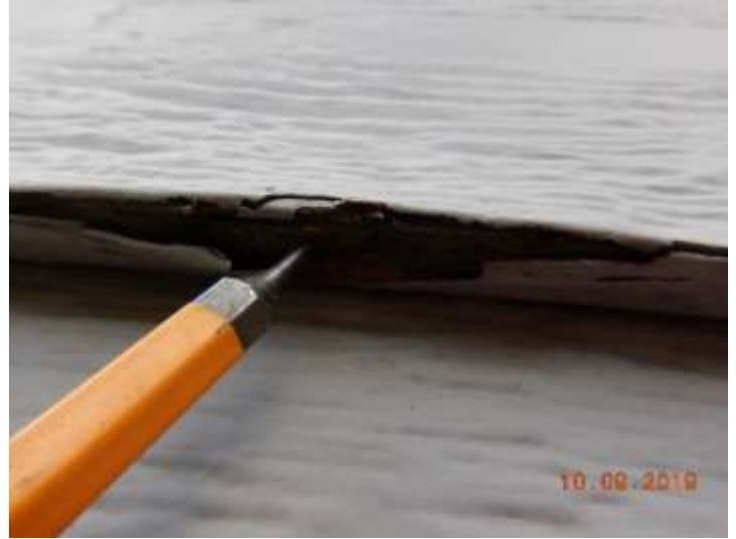
Probe pushed into the siding

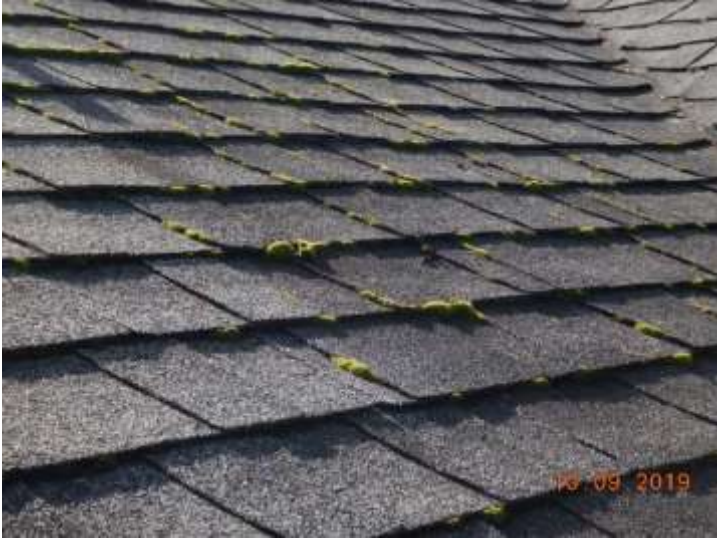
Minor moss on the roof

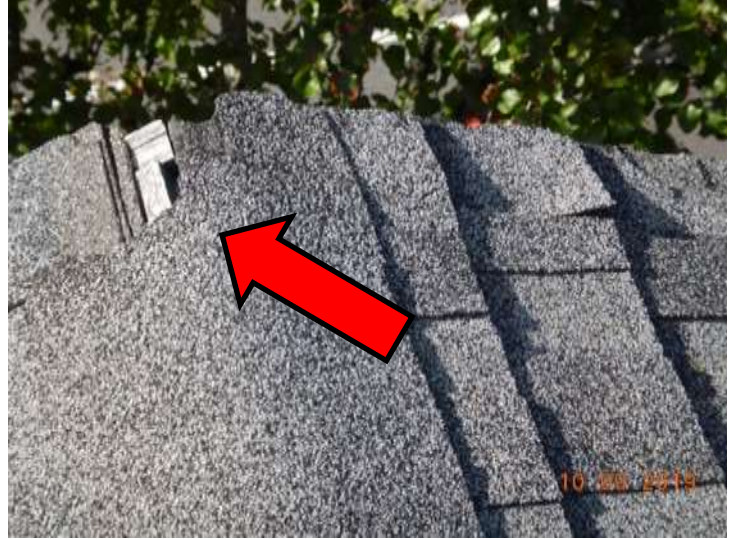
- All exposed nails at the roof should be re-sealed to prevent moisture intrusion
- There is minor wind related damage to the roof at the outer area above the Master bathroom

Wind related damage

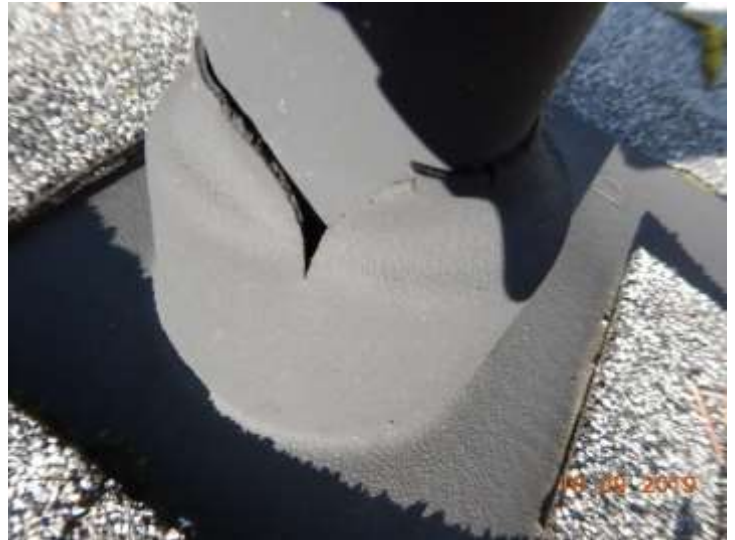
Cracked plumbing vent

- The plumbing vent boots (flashing) are cracked which could allow moisture intrusion during periods of rain. Recommend having these boots caulked or replaced

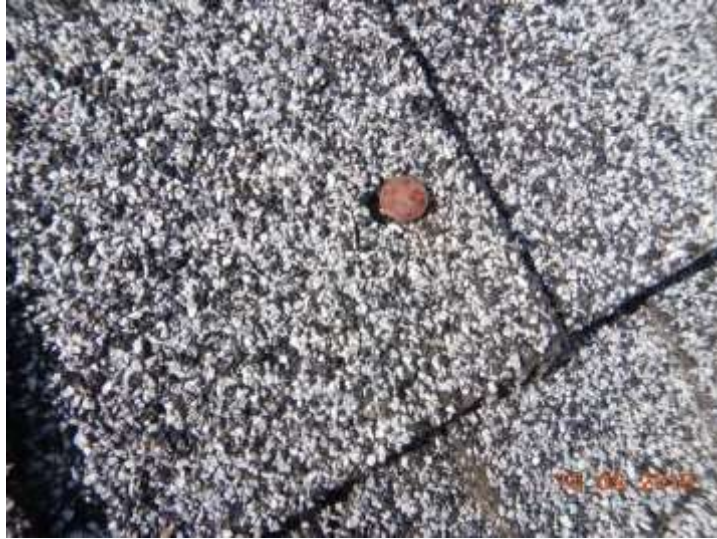
Exposed nail head

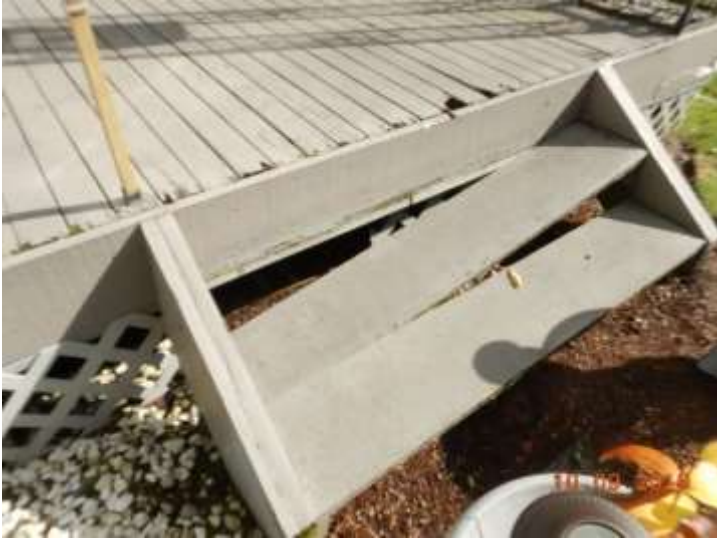
Structure: Pressure treated joists, beams, and posts
Decking: Cedar
Condition: - **There is substantial wood rot at the decking surface boards and stairs**
Connection to structure: The deck appears to be adequately secured to the home with lag bolts
Trip Hazard: None identified
Handrails: - **Recommend the installation of a graspable handrail from the deck as there are 4 or more risers**

Failed steps

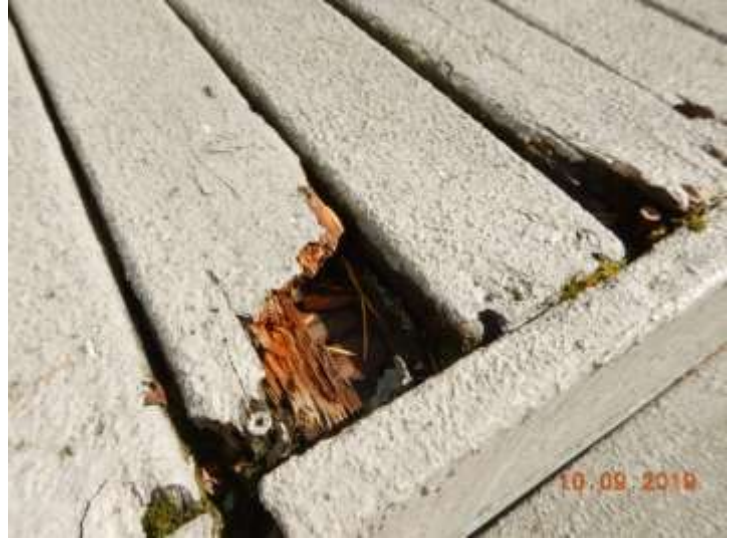
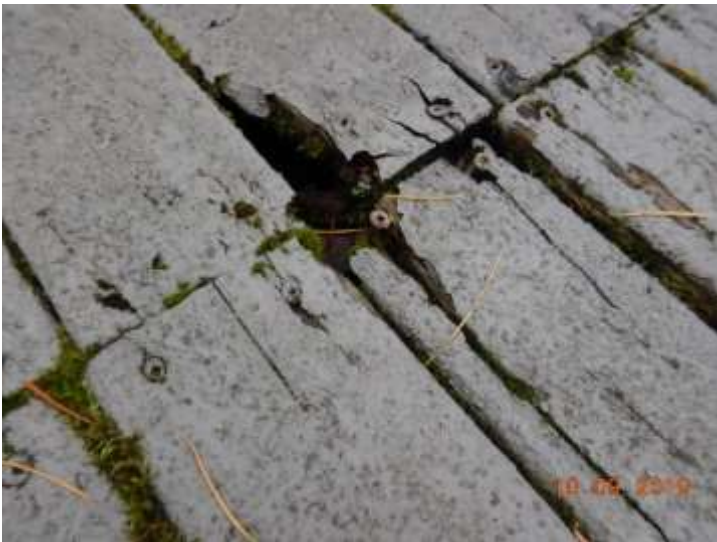
Wood rot at the decking

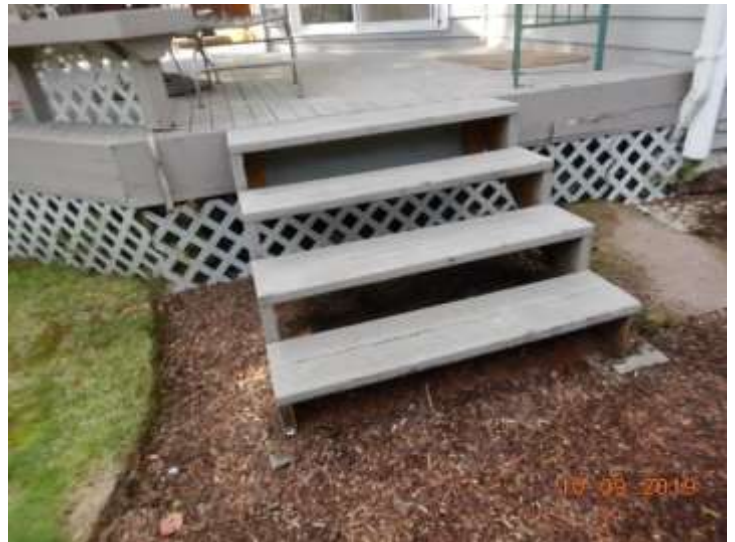
A graspable handrail should be installed where there are 4 or more risers

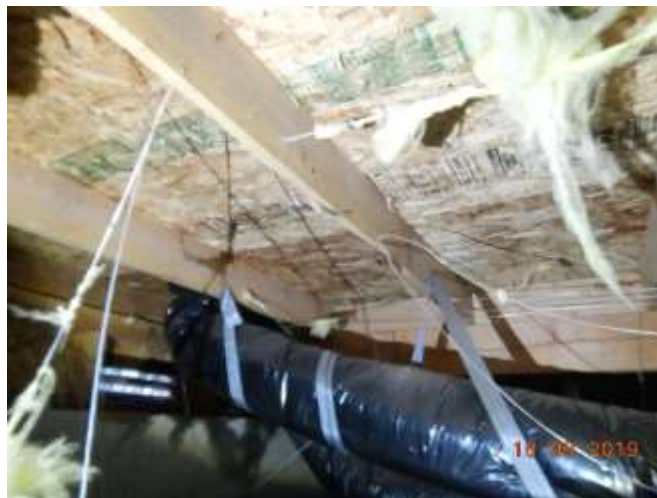
Under-floor: - A large section of insulation has been removed from the area below the Kitchen. This Seller: Explain why this insulation was removed. This area should be properly re-insulated
Domestic Water Pipes: Satisfactory
Heating Supply: Satisfactory

Missing under-floor insulation

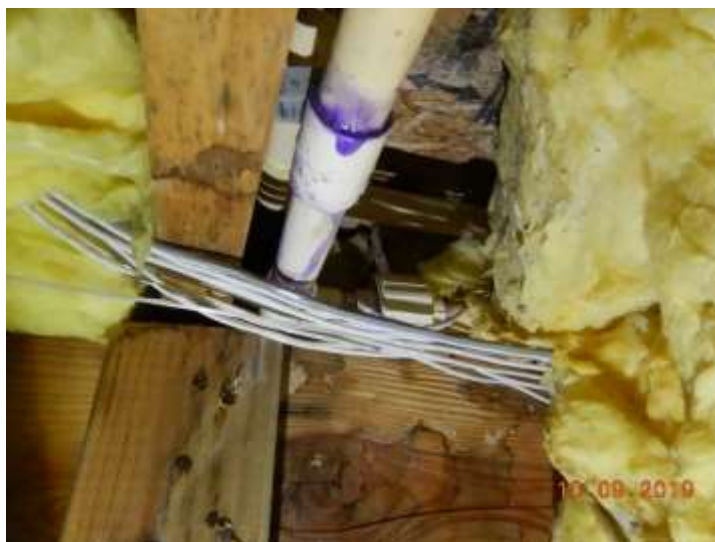
- The plumbing pipes within the home are CPVC. This type of pipe is not listed as a known defect; however the pipes can become brittle with age and fail, especially when impacted. <https://www.classaction.org/cpvc-pipe-lawsuits>. A prior repair or modification is visible in the crawlspace

Evidence of a prior repair or modification to the plumbing pipes. See the comment in the Plumbing section regarding CPVC piping

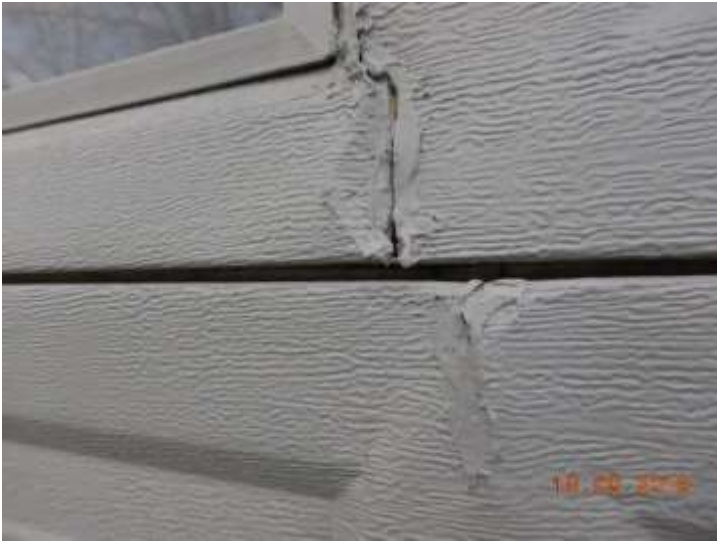
- Type: Metal roll up
Door condition: - The garage door weather-stripping is damaged and may result in pest intrusion into the garage
- There are metal fatigue cracks at the upper (2) garage door panels. The cracks are located in the vicinity of the arm attachment to the garage door opener
Springs and tracks: The springs and tracks appear to be in satisfactory condition
Garage door openers: Yes
Auto reverse of impact: - The garage door opener was not tested for auto reverse as there is a metal fatigue crack at the upper panel of the door
Photo cell reverse sensors: Tested for proper operation

Metal fatigue cracks

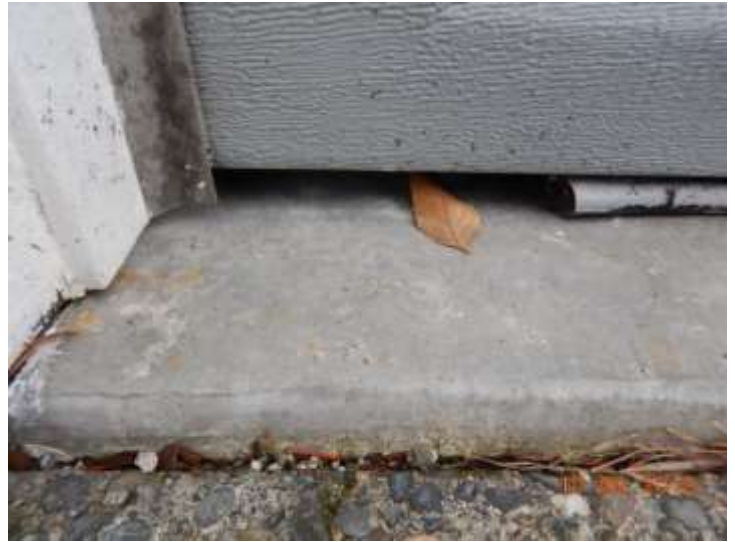
The gap at the weather-stripping may allow pest intrusion

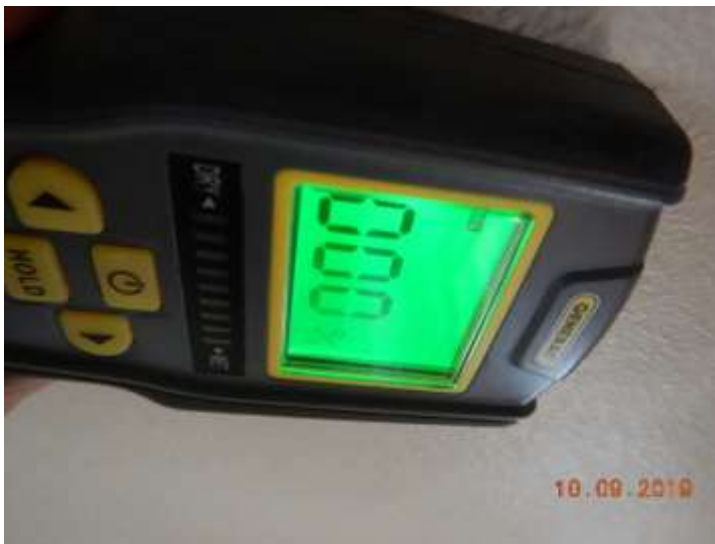
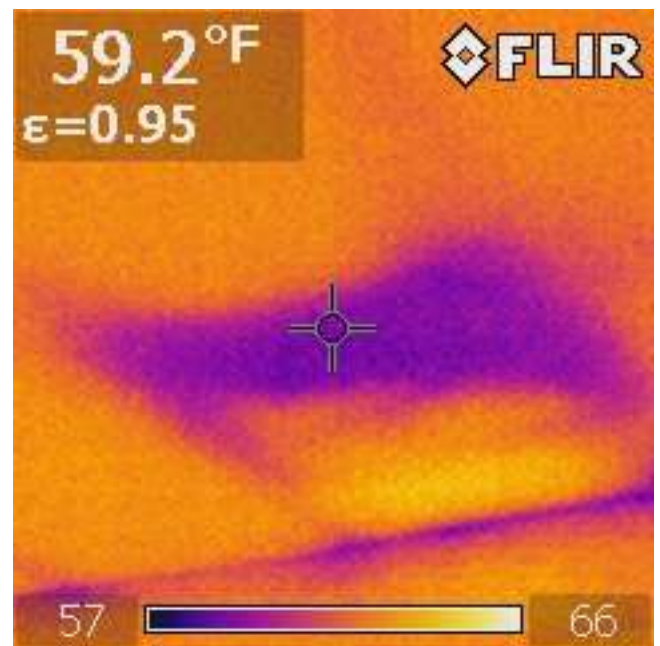
- Visibility: Rooms are occupied
Structural Movement: No visible evidence of substantive structural movement
Moisture Intrusion: No visible evidence
Walls: Satisfactory
Ceiling: - Seller: explain why the ceiling was re-painted at the Living room
- The above may be related to discoloration of the ceiling due to a possible area of missing insulation above (there is no access located for this attic)
Flooring: Satisfactory

There was no moisture indicated at the cold spot

Cold area at the ceiling of the Living room. This ceiling was recently repainted

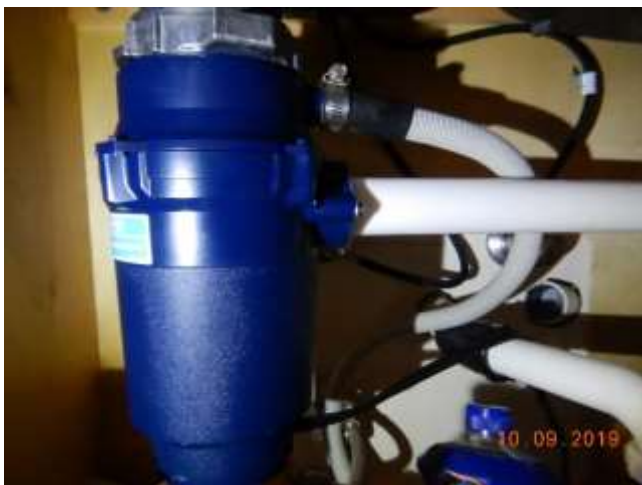
Dishwasher: Tested a full cycle. Not all functions and settings are tested
Dishwasher drainage: - The dishwasher drain should be secured to the underside of the countertop to prevent cross contamination of waste water with the dishwasher (high loop)
Cooktop: Tested all burners
Oven: Tested. Not all functions and settings are tested
Microwave (door): The door of the microwave was tested for operation
Ventilation: Tested
Refrigerator: The refrigerator appears to be operative. Not all functions and settings are tested
- The door handle of the refrigerator is loose

Dishwasher drain

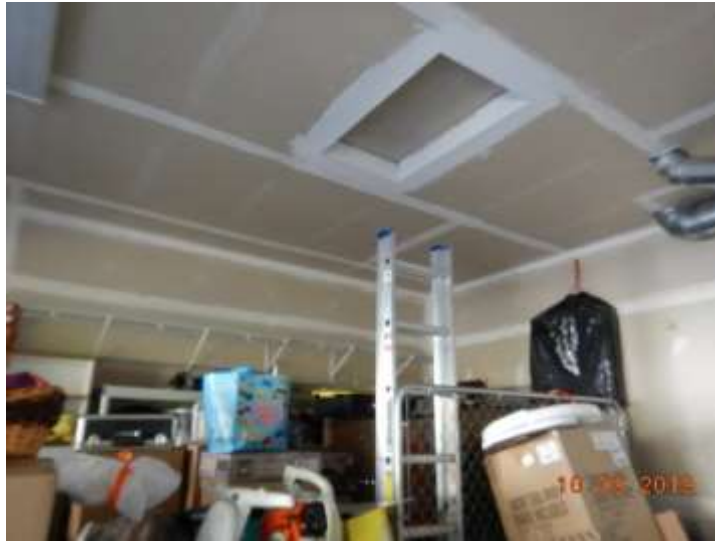
No access to the garage area attic
