Property Description: (2) story single family home
Property age/ size: Built 2001, 3,580 s.f. per listing
Occupancy Status: Vacant

Inspection Date: 02/16/2013
Inspection Time: 9:30 A.M. – 12:30 P.M. +-
Weather Conditions: Clear, 50 deg F +-

Hergert Inspection LLC

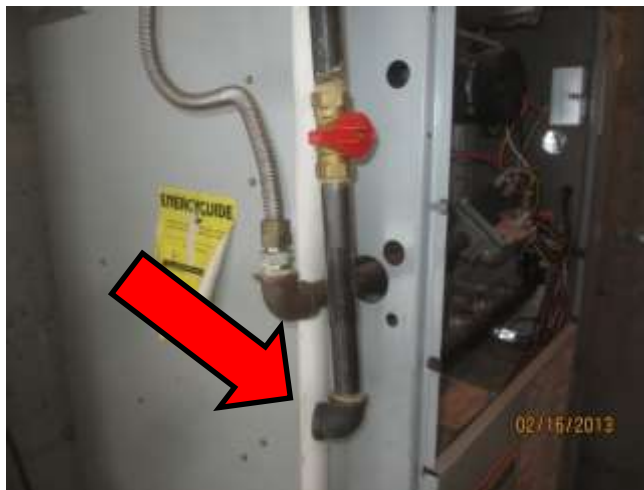
- Flue Secure: Inspected
Flue clearances: Per requirements where visible
- The open ended gas pipe should be capped when not connected to an appliance

Open ended gas pipe

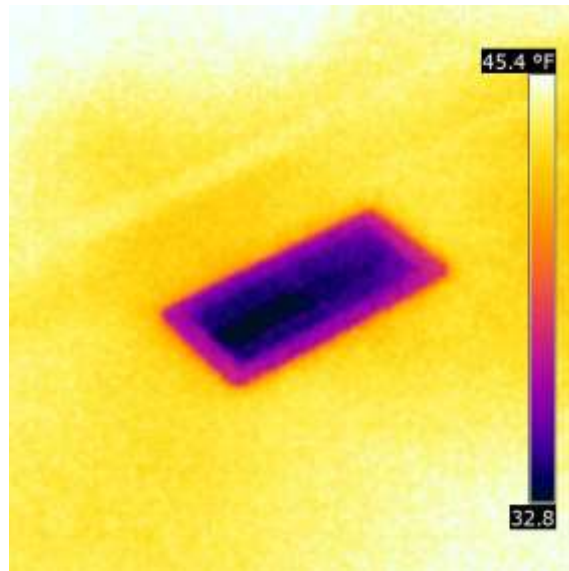
- Rating: 30-60 deg F
@ return air: - *The furnace is inoperative; not tested*
@ nearest register: - *The furnace is inoperative; not tested*
Heat Gain: - *The furnace is inoperative; not tested*

Temperature measured at heat register
The air conditioning is active even though the
thermostat is set on heating

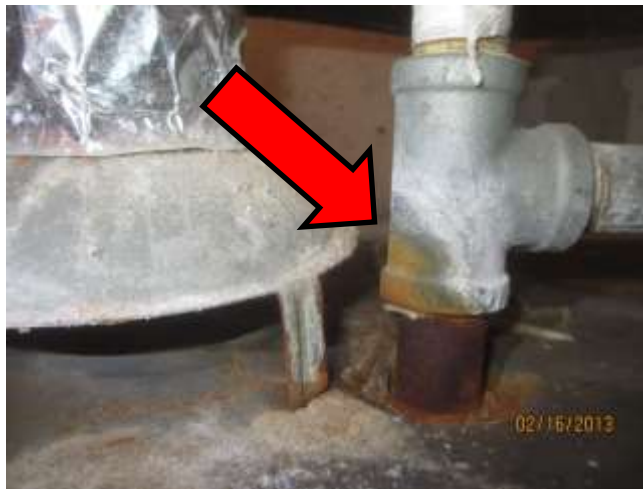
Flue secure: Inspected
Clearances: As required where visible
Draft Hood: - There is evidence of improper drafting of the water heater flue resulting in combustion gas spillage
Water connection: Inspected
Expansion Tank: Installed

Evidence of combustion gas spillage

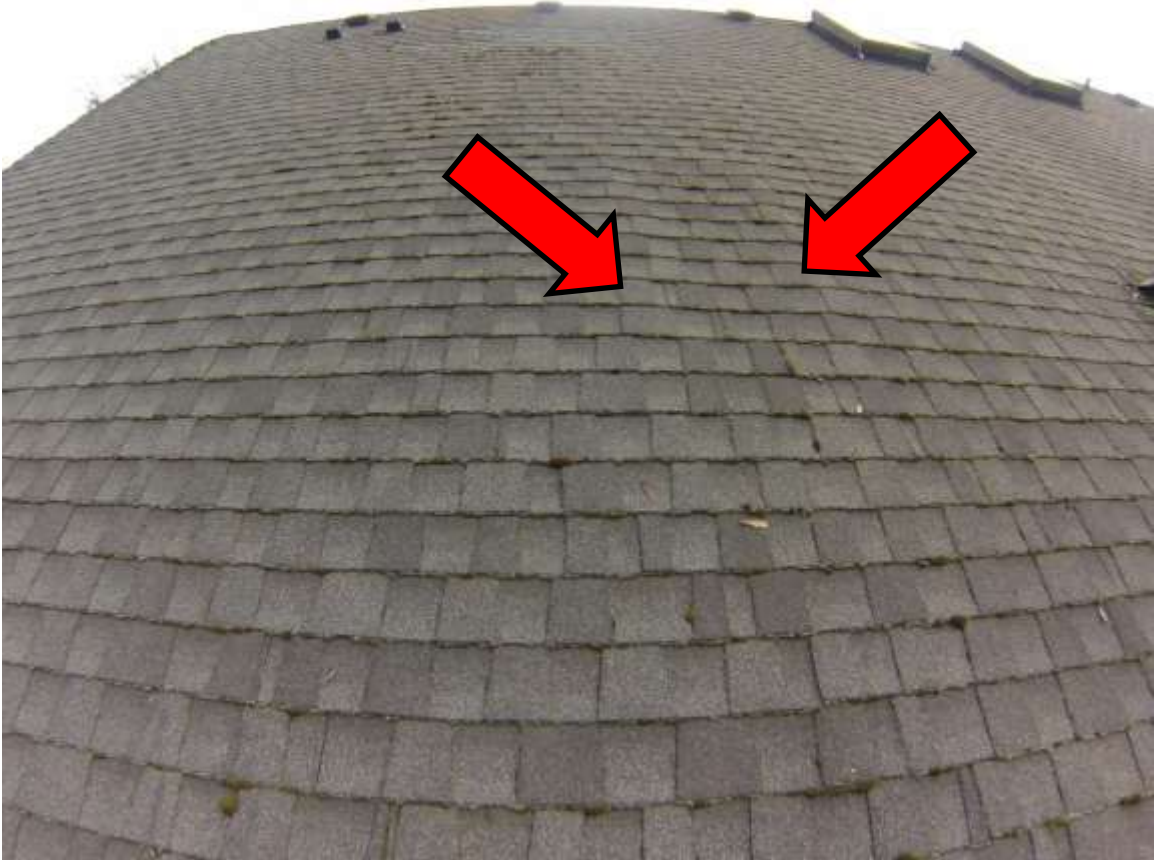
Visible sag in the roof sheathing above the Master bedroom

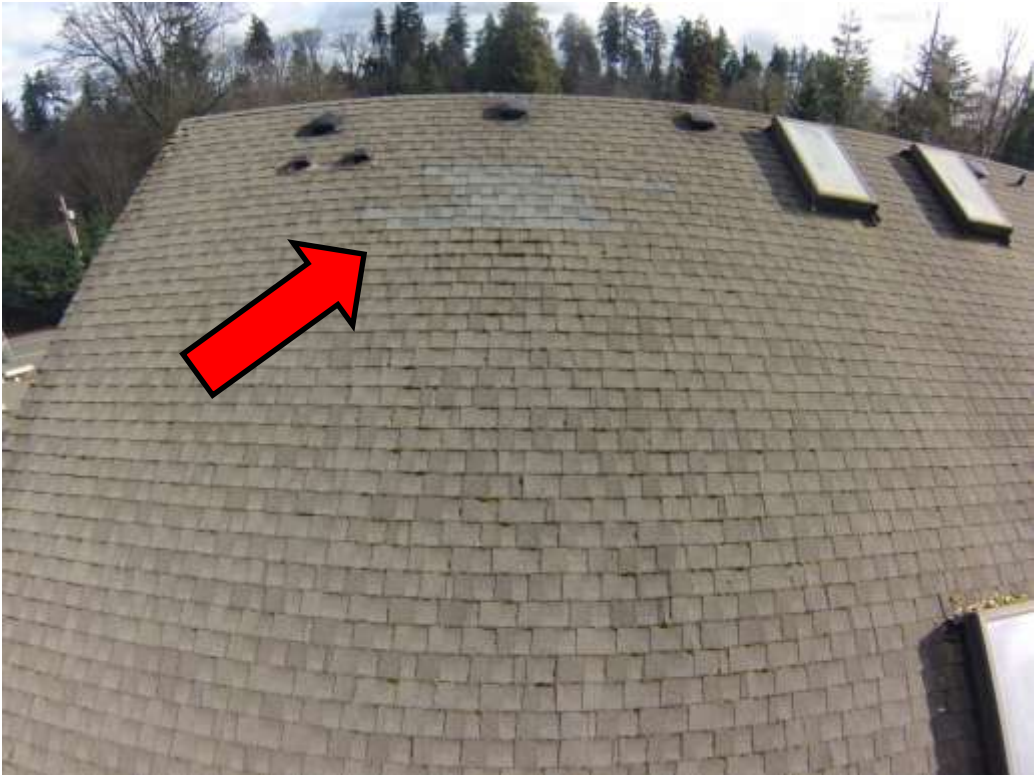
Rear roof repair at the Master bedroom area

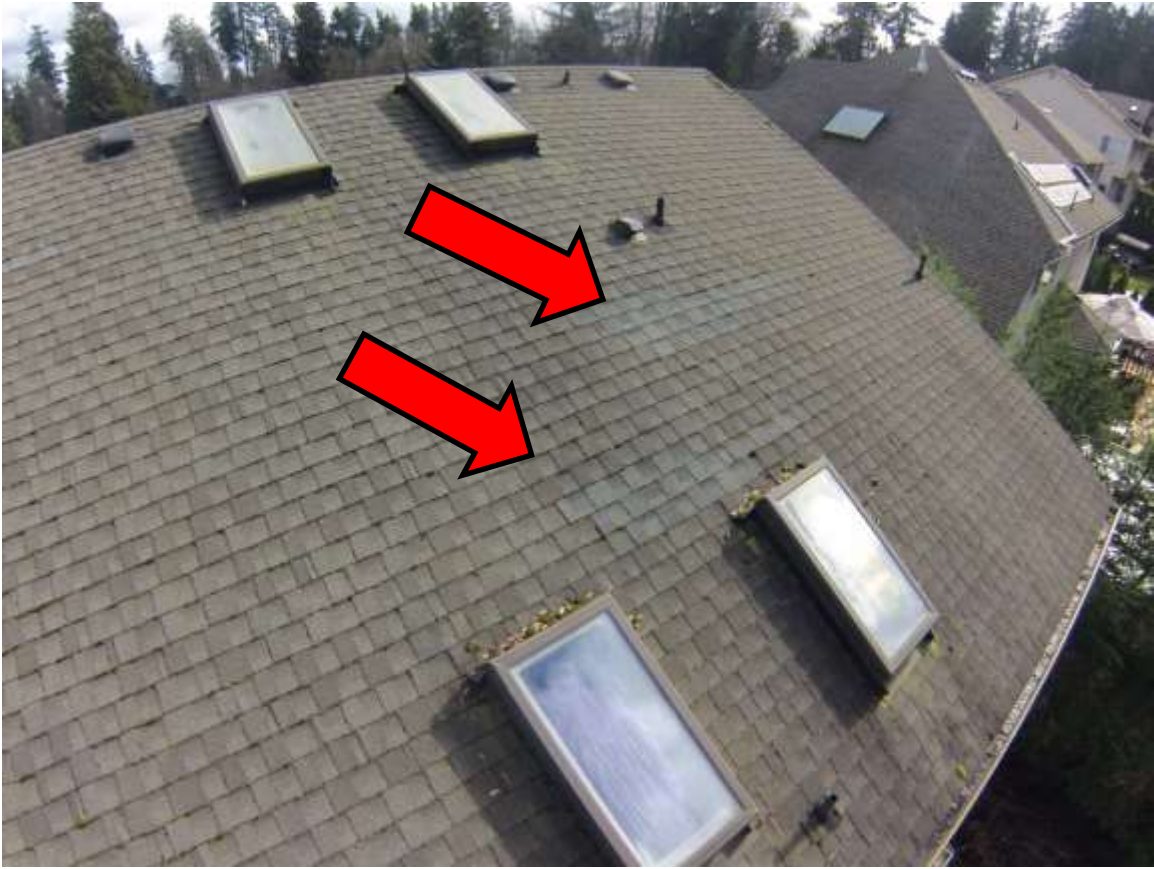
Roof repairs above the Master bathroom area

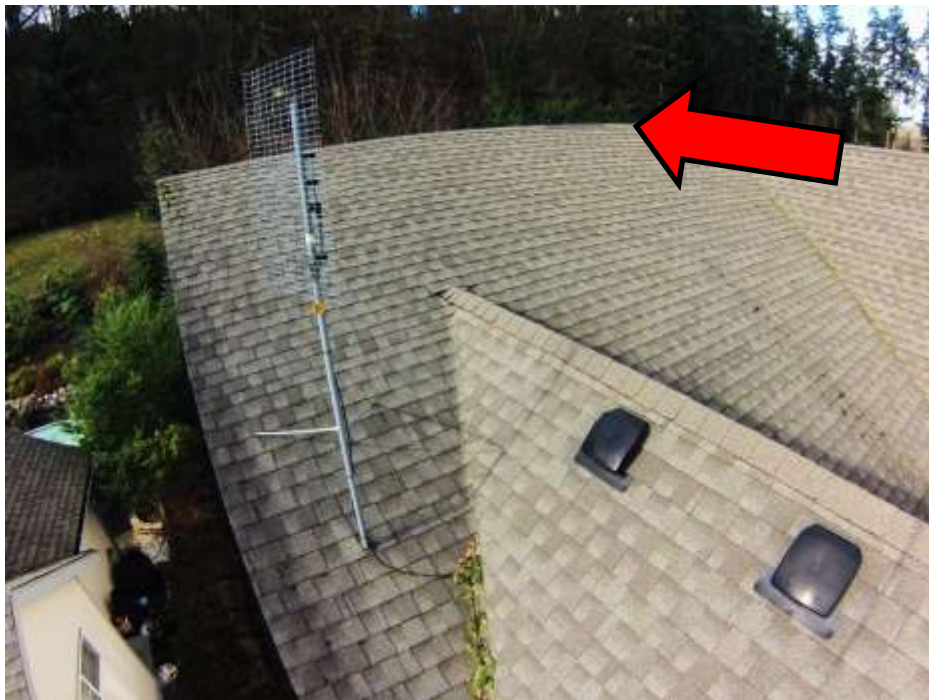
Ridge repairs

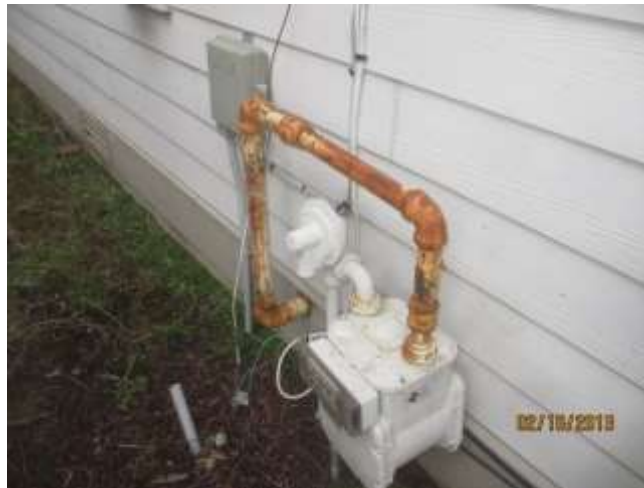
Hose Bibs: Satisfactory
Gas Piping: - The exterior gas pipes should be coated with rust proof paint

Rusting gas pipes

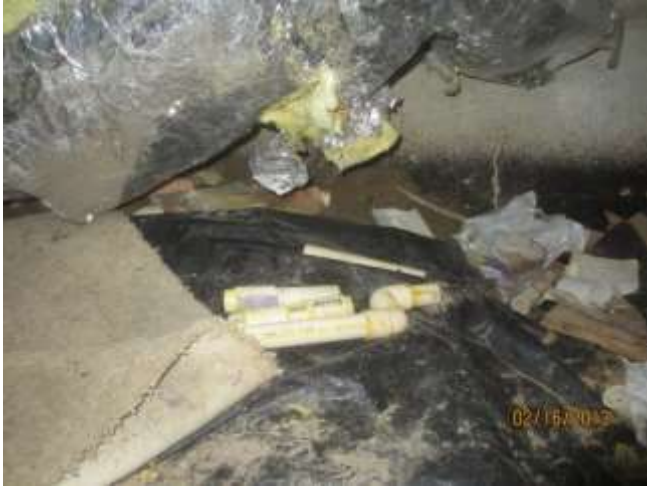
CPVC pipe repair remnants

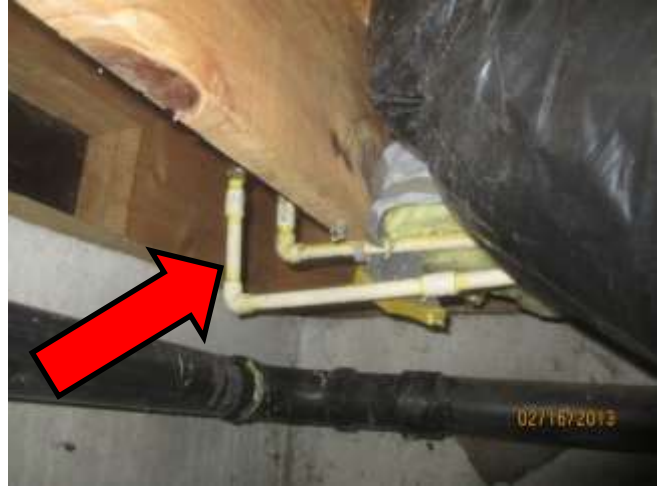
Waste lines: Satisfactory
Domestic water lines: Satisfactory
- **There is active plumbing leakage at the main bathroom and Kitchen areas**
Valves/ Other: None visible

Leakage at the Kitchen sink area

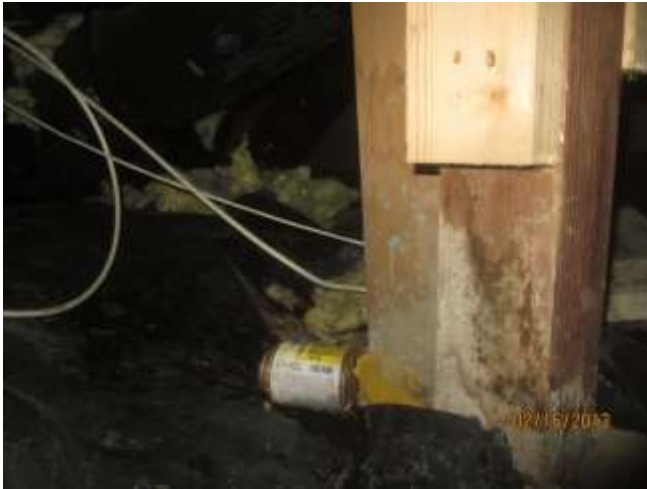
Moisture stains below the main bathroom

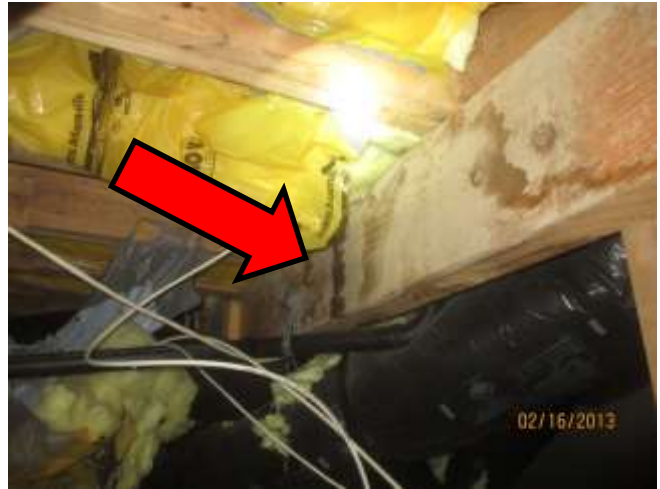
Active leakage below the floor 1 main bathroom

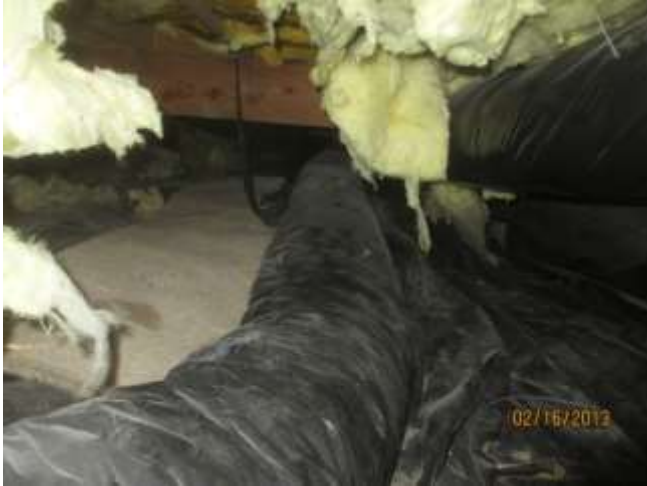
Duct Work: - There are heating ducts in the crawlspace that are disconnected. Most of these ducts are moisture saturated from plumbing leaks. The ducts should be replaced
Ventilation Ducts: No visible defects
Gas Piping: No visible defects
Dryer vent: No visible defects

Moisture saturated heating duct

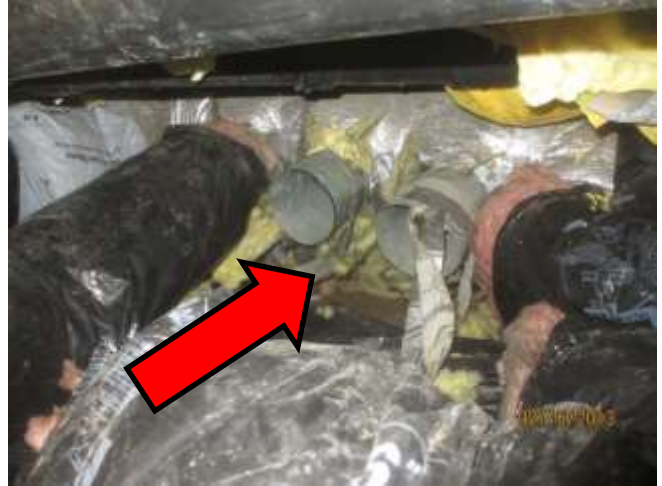
Disconnected heating ducts

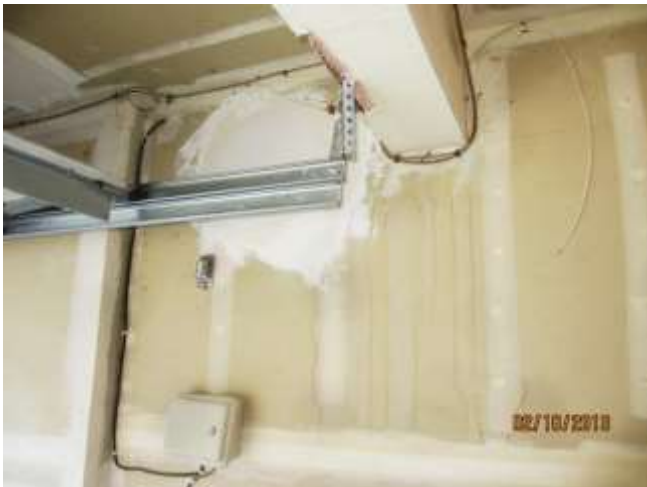
Moisture stains at the South wall and beam

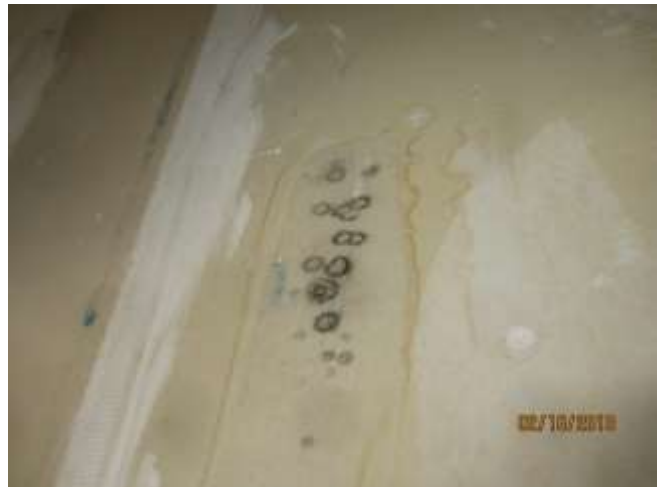
Moisture stains and mold at the South wall

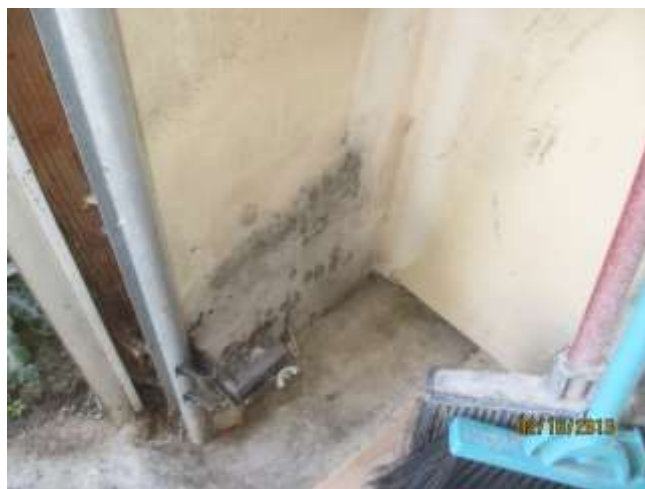
Mold at the East garage area

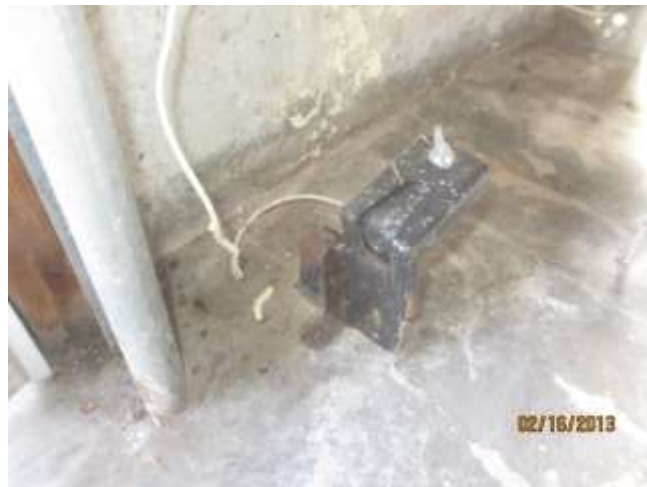
- Type : Metal roll up
Door condition: The doors are in satisfactory condition
Springs and tracks: The springs and tracks appear to be in satisfactory condition
Garage door openers: Yes, the North door only
Auto reverse of impact: Unable to test as the photocell reverse in inoperative
Photo cell reverse sensors: - The garage door sensors at the North garage door are not properly aligned

Loose photocell sensor

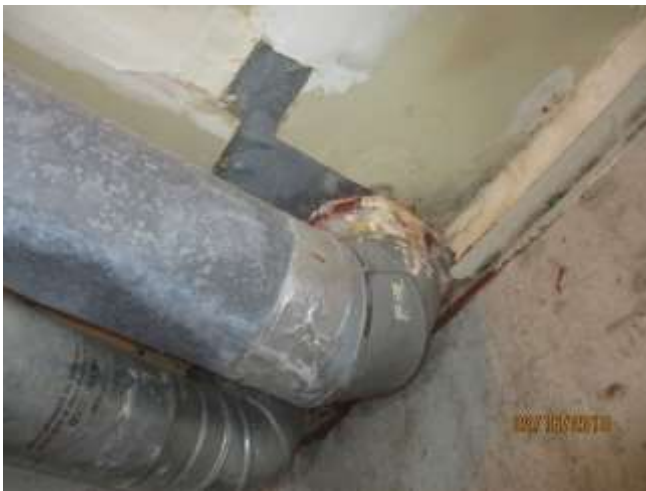
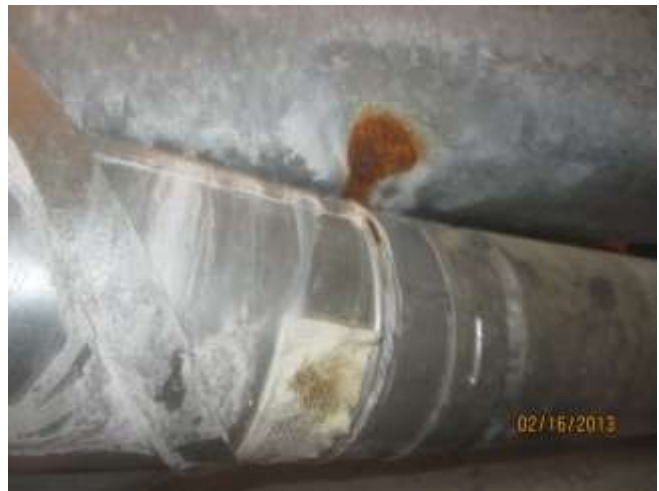
- There is evidence of moisture and rusting at the furnace flue and fresh air intake. The rust may be related to moisture intrusion and/or a lack of venting-leakage from the flue

Rusting at the fresh air intake

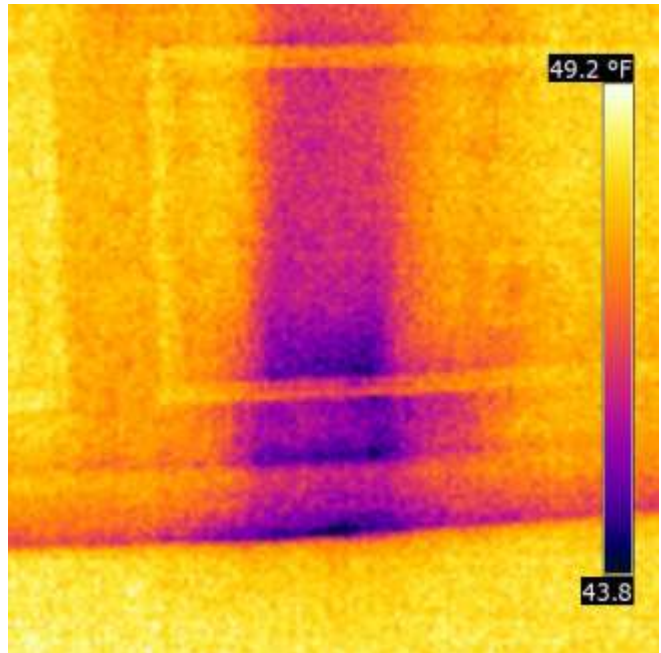
Cold spot on the Dining room wall which is either the result of moisture intrusion or missing insulation

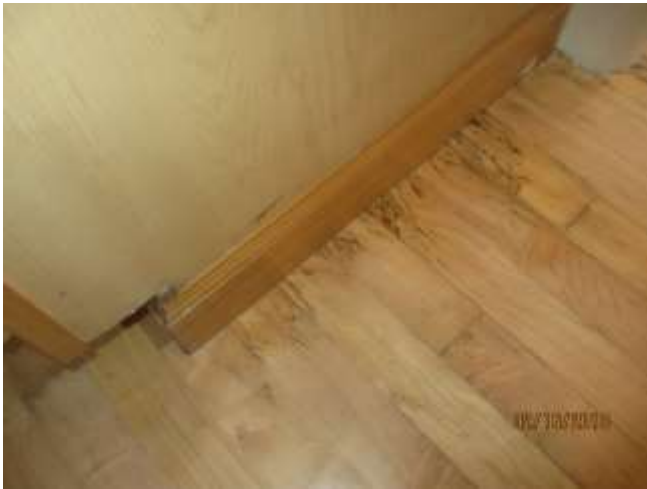
Moisture damaged hardwood floors

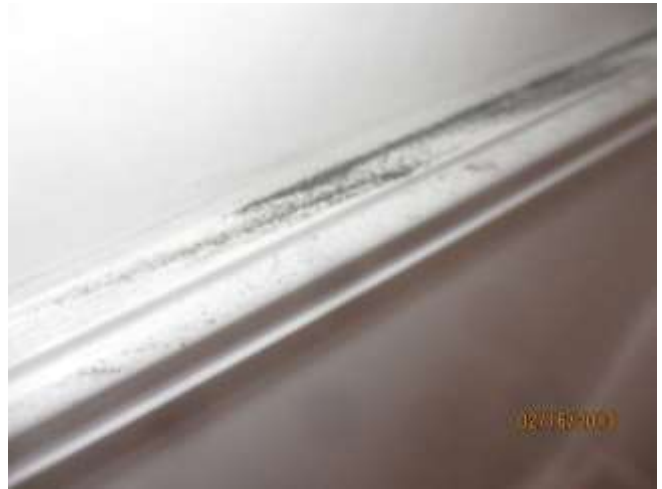
Evidence of microbial growth (mold)

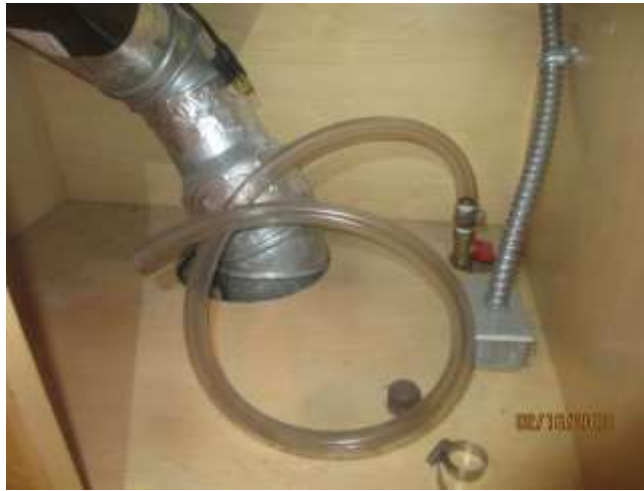
Uncapped gas line. The gas line extension is not proper

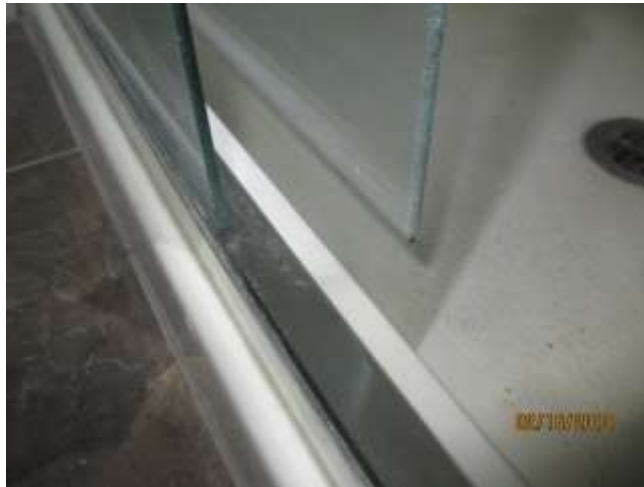
Missing shower door guides

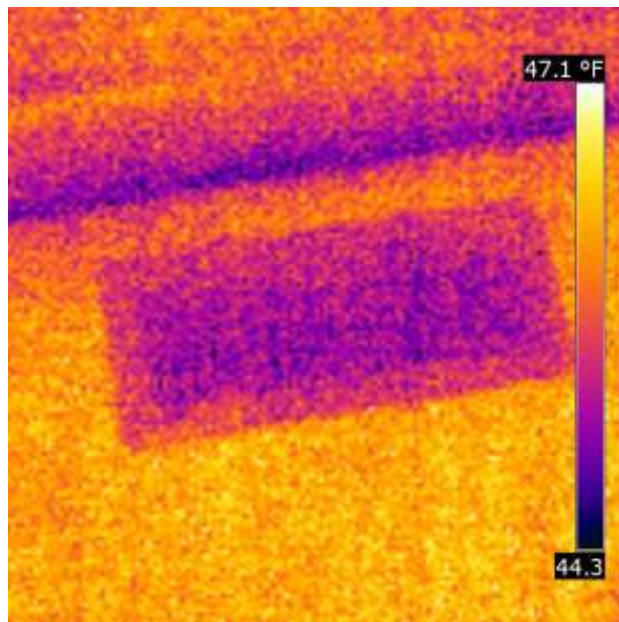
Source: Forced air register
Air Flow/ Heat Gain: - *There is no airflow to the bedrooms. See the comment in the crawlspace section*

No airflow to the bedrooms

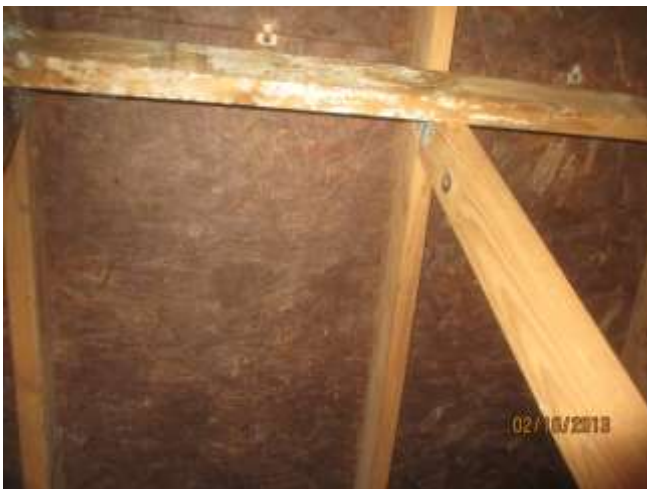
Evidence of microbial growth

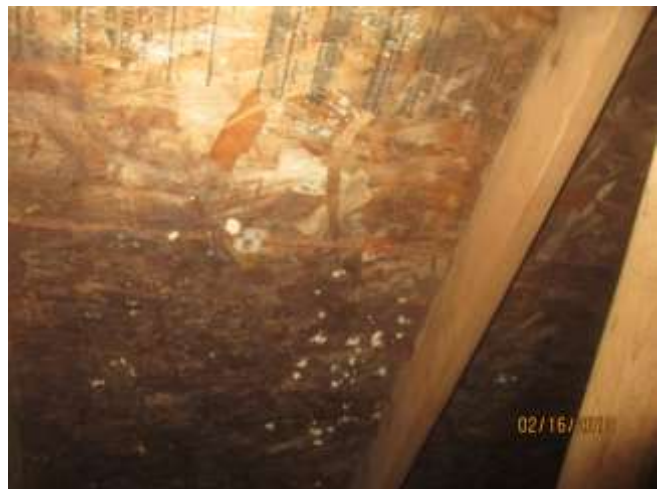
Evidence of microbial growth

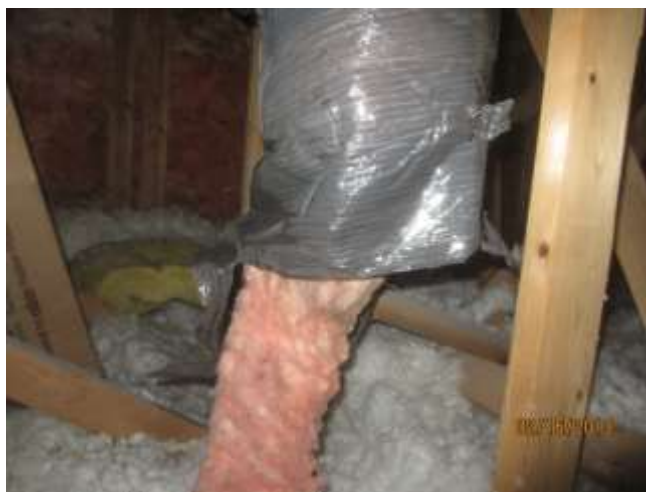
Disconnected bathroom ventilation duct

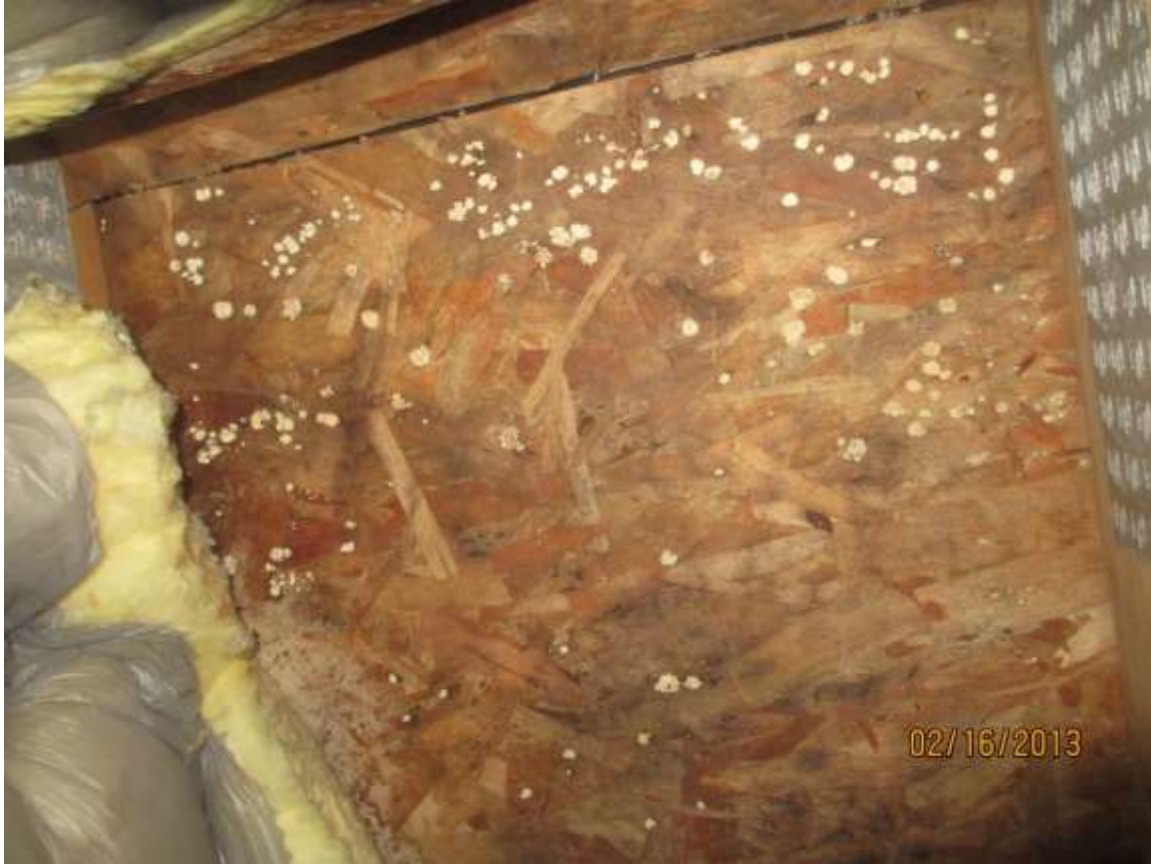
Evidence of microbial growth
