Property Description: (2) story single family home
Estimated property age: Built 2001 per listing
Occupancy Status: Occupied

Inspection Date: 10/23/2019
Inspection Time: 1:45 P.M. - 3:30 P.M. +-
Weather Conditions: Overcast, 55 deg f +-

Hergert Inspection LLC

Summary of Inspection

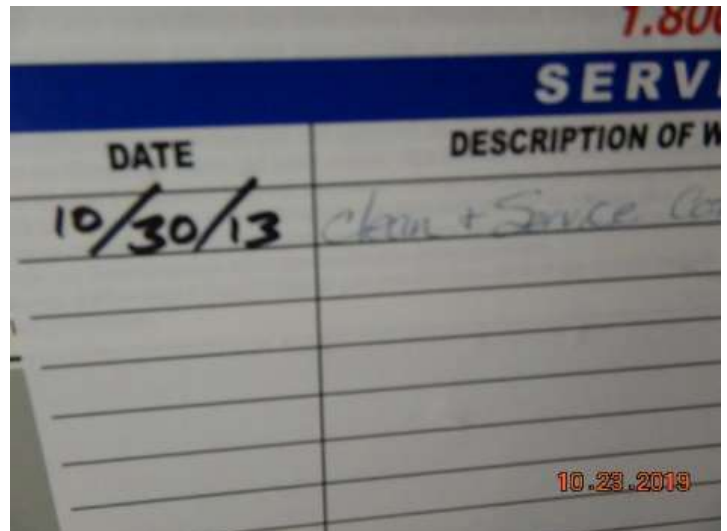
- The age of the furnace is 19 years. The remaining anticipated useful life expectancy is 6 years
- Recommend furnace to be cleaned, serviced, and shown to be in good working order by a qualified furnace technician. The last service date for the furnace was in 2013 per the tag on the furnace

Service tag

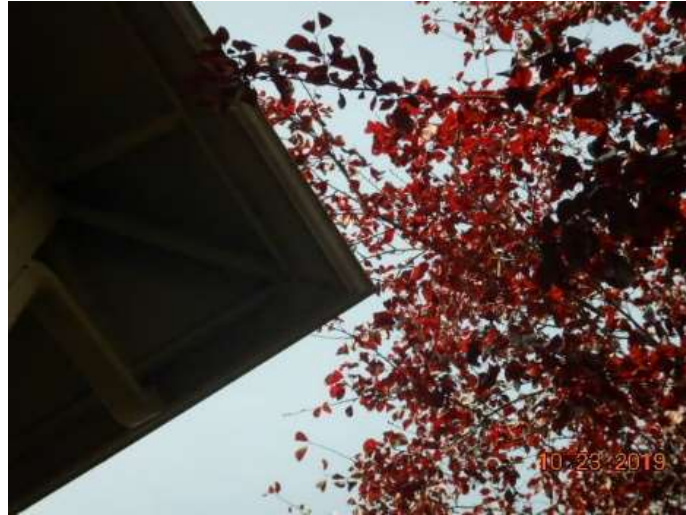
Grade at structure: Adequate grade away
Earth to wood contact: Clearance as required
Vegetation contact: - Vegetation in contact with structure (WDO conducive condition)
Roof drain discharge: Underground discharge

Vegetation in contact with the structure
(WDO conducive condition)

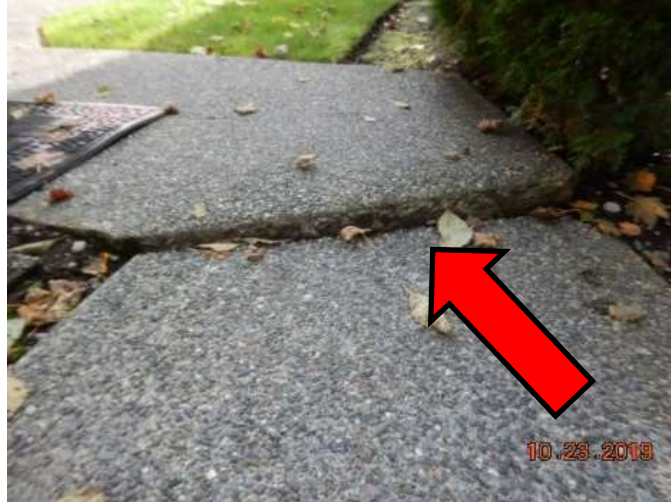
Type: Concrete
Condition: Satisfactory
Trip Hazard: - There is substantial settlement of the side yard walkway. A trip hazard exists due to the raised edges at the walkway

Trip hazard

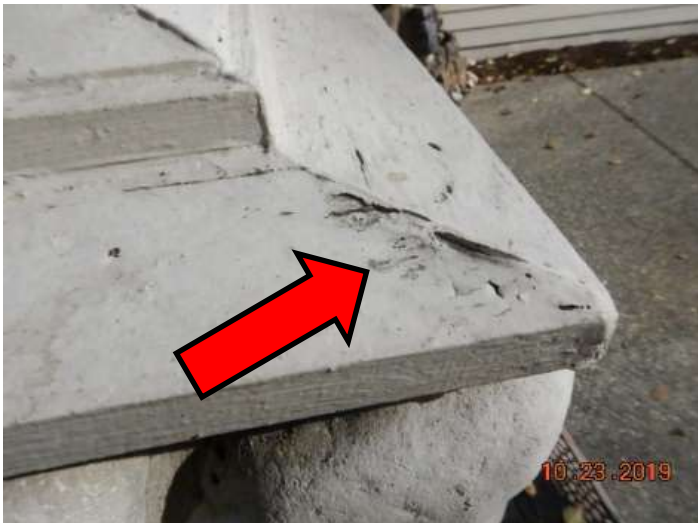
- There is evidence of wood rot at the base of the garage door wrap boards
- The top of the entryway columns should be re-caulked and painted to prevent deterioration
- The top of the fascia board tails should be covered with metal flashing or roofing to prevent wood rot at the fascia board tails

Failed caulking

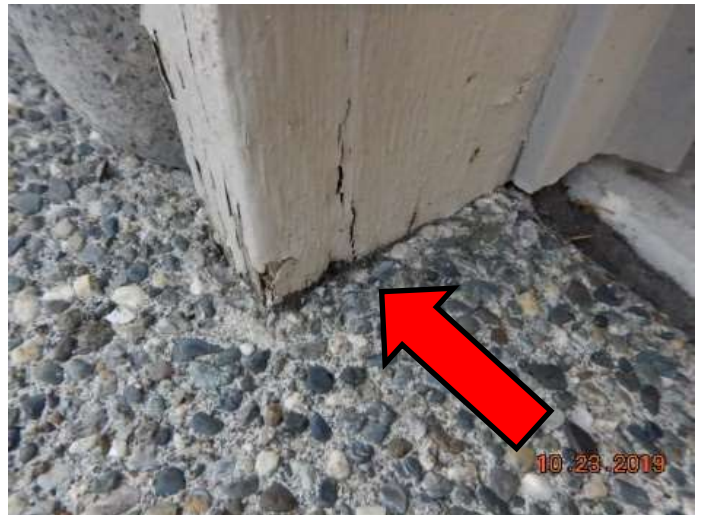
Type: Cedar
Condition: Overall satisfactory
- There is evidence of wood rot at the base of the garage door wrap boards
Window/Door Flashing: Satisfactory
Paint and caulking: Satisfactory
- The top of the entryway columns should be re-caulked and painted to prevent deterioration
Exterior vents: Satisfactory

Wood rot at the garage wrap

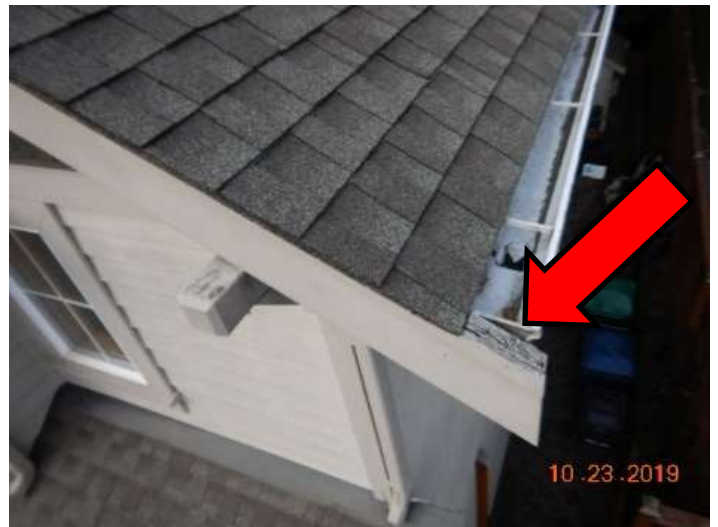
Exposed fascia board tail (typical)

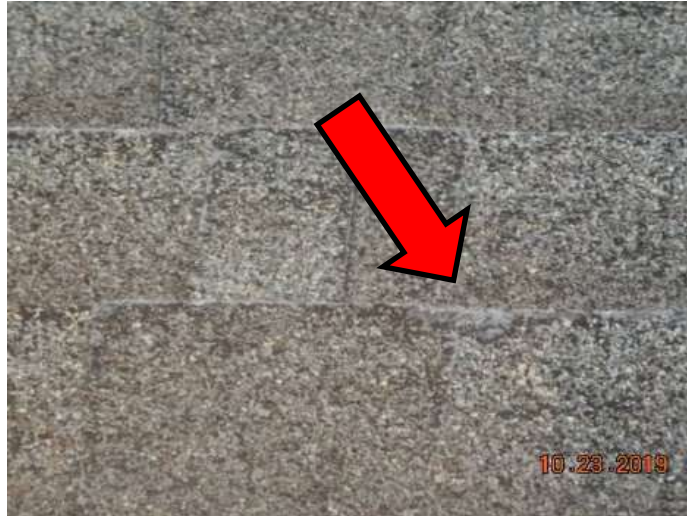
Estimated Pitch: 4:12
Material: Composition
Layers: 1+
How Inspected: From eave at (2) locations, the street, rear yard, and a pole mounted camera
Condition: Overall satisfactory
- The top of the fascia board tails should be covered with metal flashing or roofing to prevent wood rot at the fascia board tails
Overall satisfactory; the condition of the roof is consistent with its age. Roofs will typically last 25-30 years
Ventilation: Eave and roof hat vents

Age related wear to the lower edge of the shingles

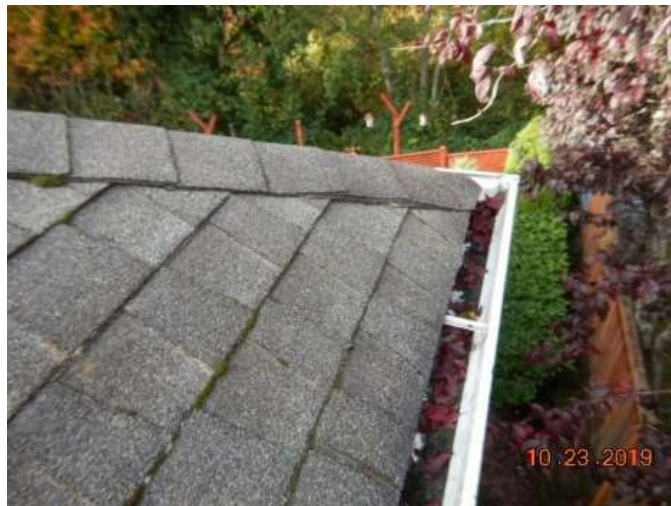
Minor debris in the gutters

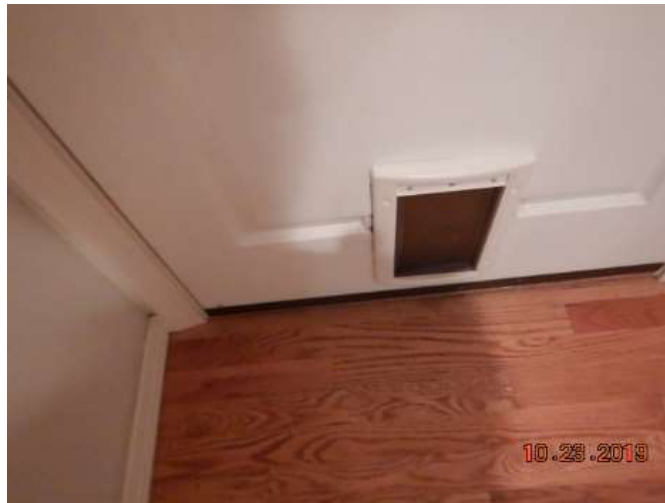
- The pet door cut into the garage to house door is a breach in the 1 hour fire separation from the garage to the living spaces

Sources of ignition: All 18" or more above the slab where required
Safety bollard: Located in front of the mechanical equipment as required
Fire separation: - The pet door cut into the garage to house door is a breach in the 1 hour fire separation from the garage to the living spaces

Pet door cut into the garage-house door

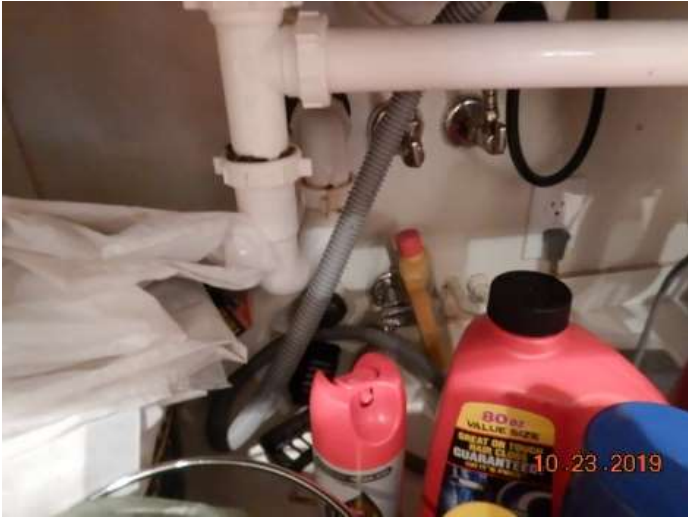
Dishwasher: Tested a full cycle. Not all functions and settings are tested
- The counter-balance spring at the dishwasher door appears to be non-functioning
Dishwasher drainage: - The dishwasher drain should be secured to the underside of the countertop to prevent cross contamination of waste water with the dishwasher (high loop)
Cooktop: Tested all burners
Oven: Tested. Not all functions and settings are tested
- The display at the oven does not fully illuminate as designed
Microwave (door): The door of the microwave was tested for operation
Ventilation: Tested
Refrigerator: The refrigerator appears to be operative. Not all functions and settings are tested

Dishwasher drain

- The counter-balance spring at the dishwasher door appears to be non-functioning
- The dishwasher drain should be secured to the underside of the countertop to prevent cross contamination of waste water with the dishwasher (high loop)
- The display at the oven does not fully illuminate as designed

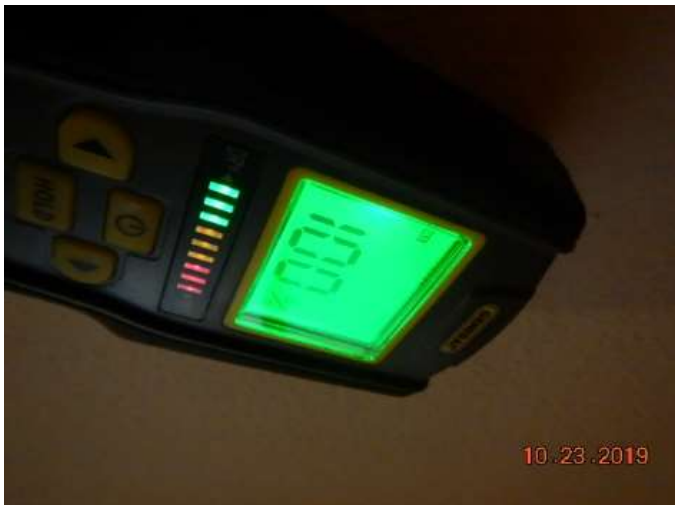
- Visibility: Room is occupied
- Structural Movement: No visible evidence of substantive structural movement
- Moisture Intrusion: - There is evidence of an active leak at the ceiling area of this room. The source of the leak appears to be related to the Master bathroom tub and/or shower above
- Walls: Satisfactory
- Ceiling: Satisfactory
- Flooring: Satisfactory

High moisture reading

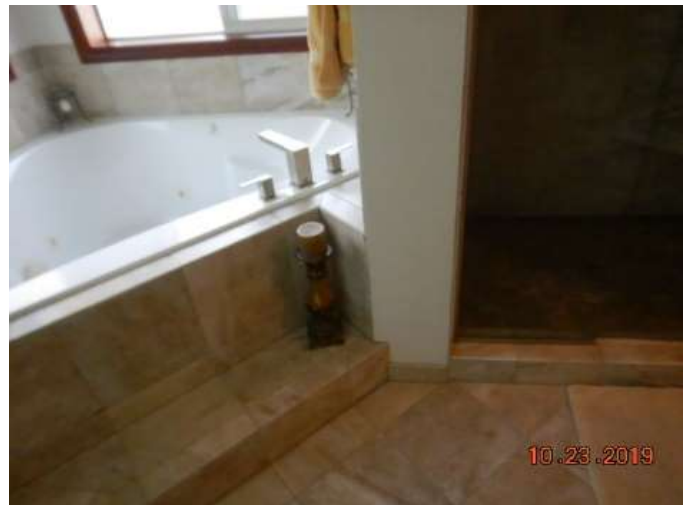
- There is evidence of an active leak at the ceiling area of this room. The source of the leak appears to be related to the Master bathroom tub and/or shower above

The leak appears to originate at the tub/shower valve area

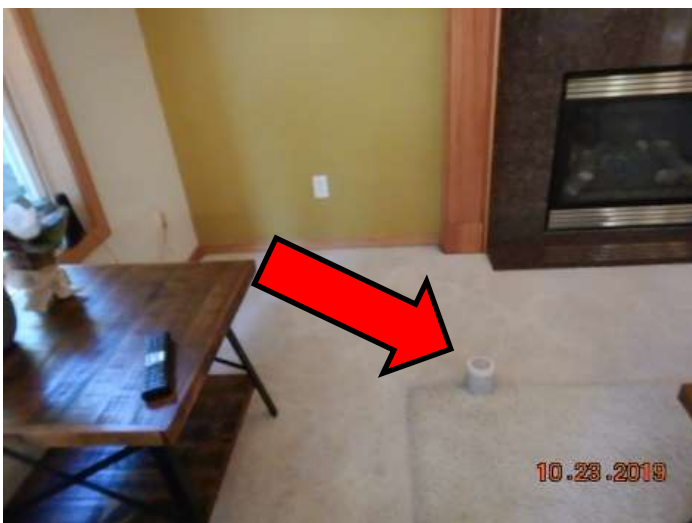
Approximate location of the leak (above)
in relation to the fireplace

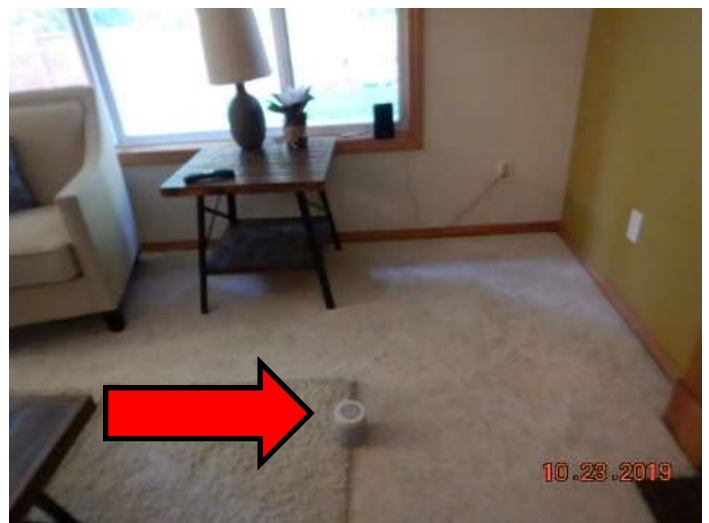
Approximate location of the leak (above)
in relation to the window

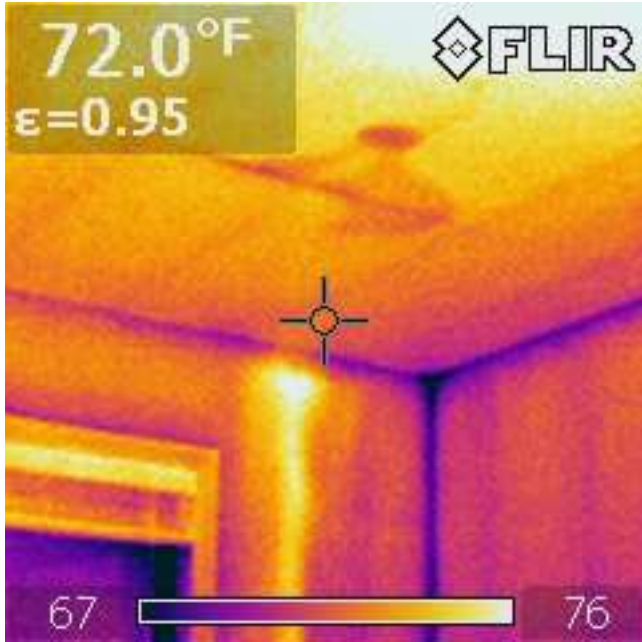
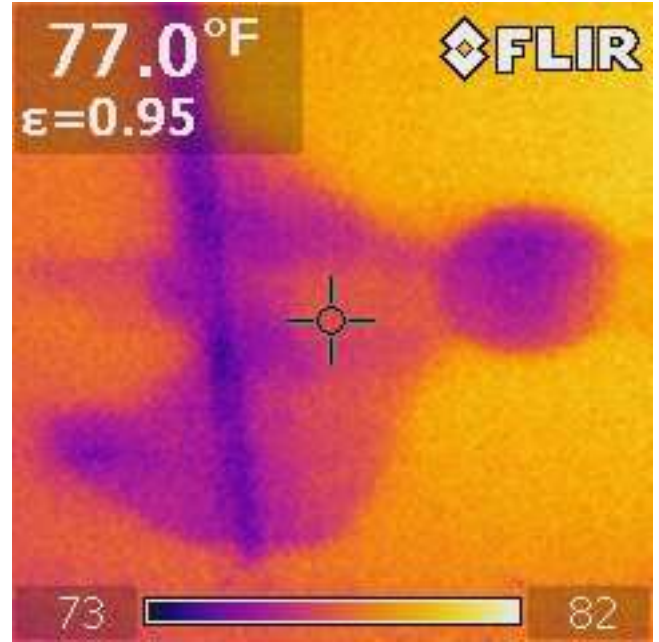
Evidence of leakage
