(425) 652-6515  
www.Hergert.com  
Kevin @ Hergert.com  
Wa. Home Inspector 619  
WSDA Inspector 79988  
WSDA Control # 10760AQ-090

Property Description: (2) story single family home  
Estimated property age: Built 2017 per listing  
Occupancy Status: Staged

Inspection Date: 11/29/2017  
Inspection Time: 9:00 A.M. - 11:30 A.M. +/-  
Weather Conditions: Overcast, 55 deg f +/-

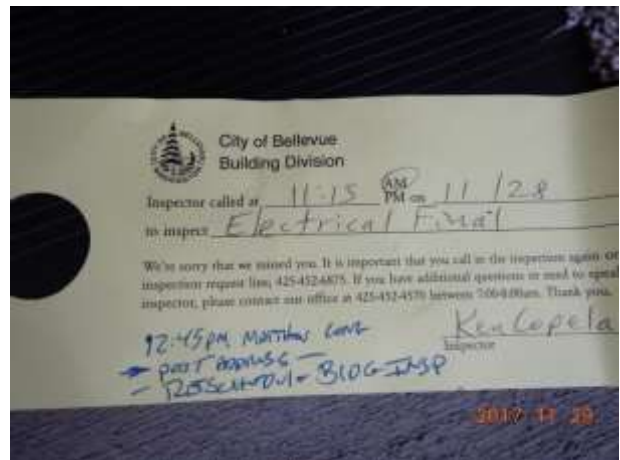
The electrical system has not received final approval

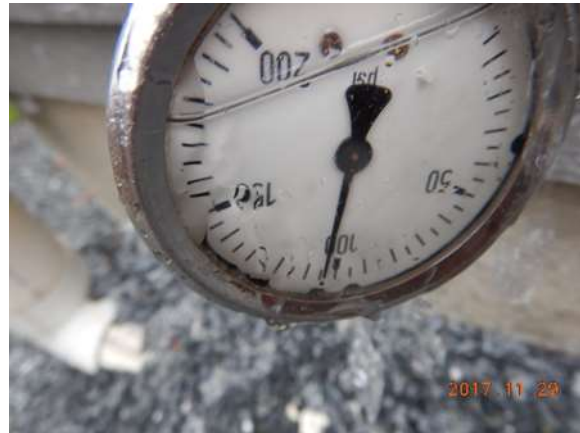
- The domestic water pressure substantially exceeds the maximum pressure of 80 PSI. The excess pressure may result in premature pipe or plumbing fixture failure. Recommend installation of a pressure reducing valve (this type of valve was not located)
- The fire suppression system is not active

Water pressure is excessive (> 80 PSI)

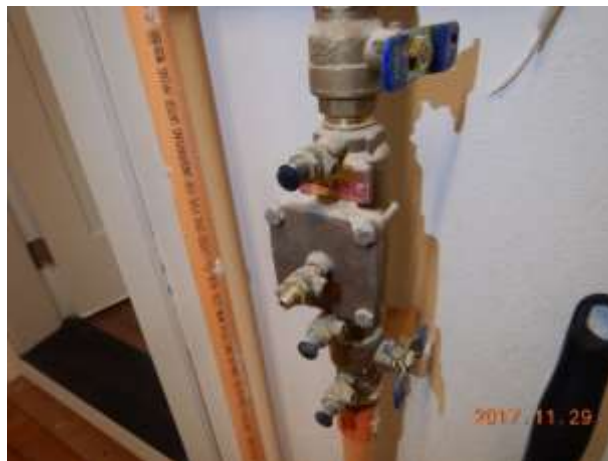
- The fire suppression system is not active

The fire suppression valves are in the off position

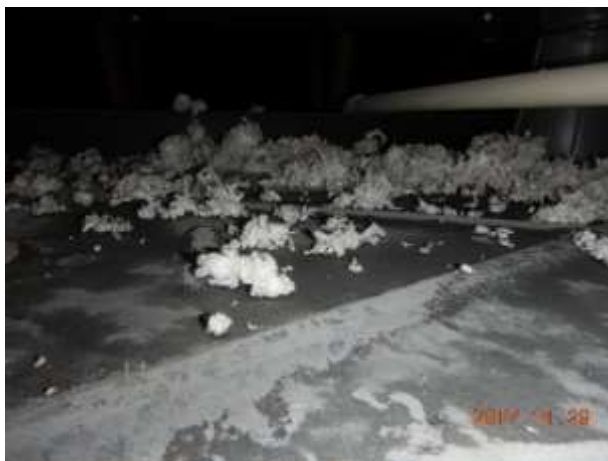
Debris in the drip pan

Est. Useful Life new: 25 years  
Est. age of furnace: 1 year + based on the serial number  
Servicing: The furnace is under (2) years old, therefore servicing is not typically needed  
- *The inspection of the heat exchanger involves dismantling of the components of the furnace and is beyond the scope of a Home Inspection*  
- *All debris should be removed from the drip pan located below the furnace as the debris could clog the drain line*

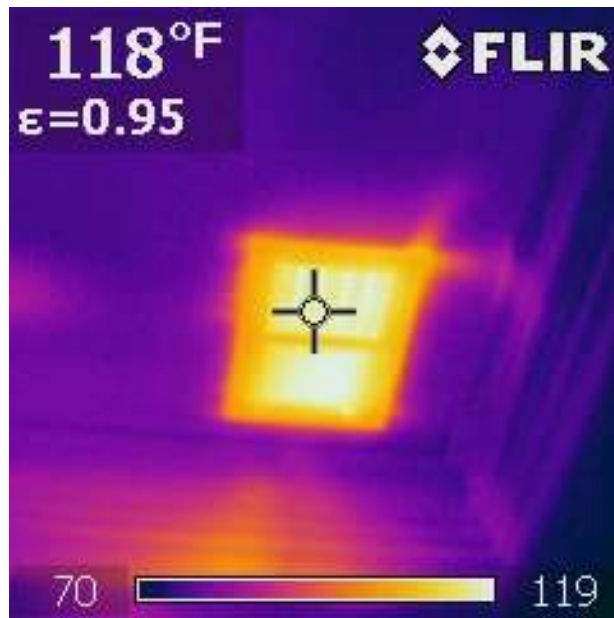
Rating: Not specified  
- There is a substantial imbalance in the heating supply from floor 1 to 2. The heating system ducts need to be balance to provide an equal distribution of the airflow

Heat produced at floor 1

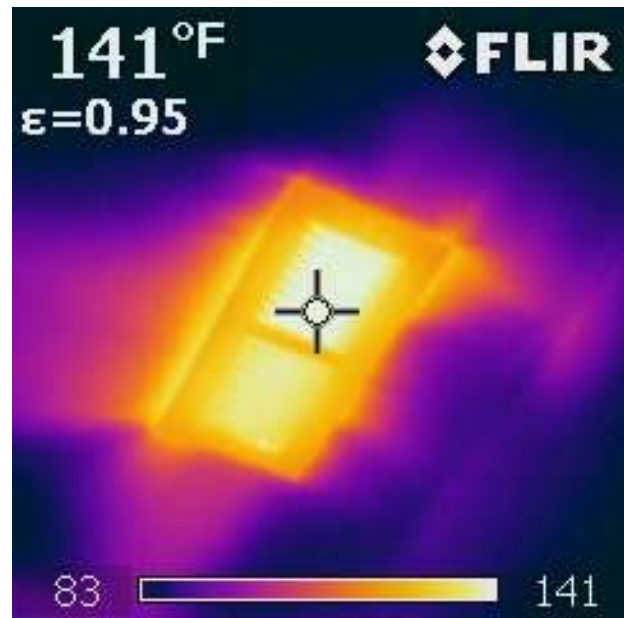
Heat produced at floor 2

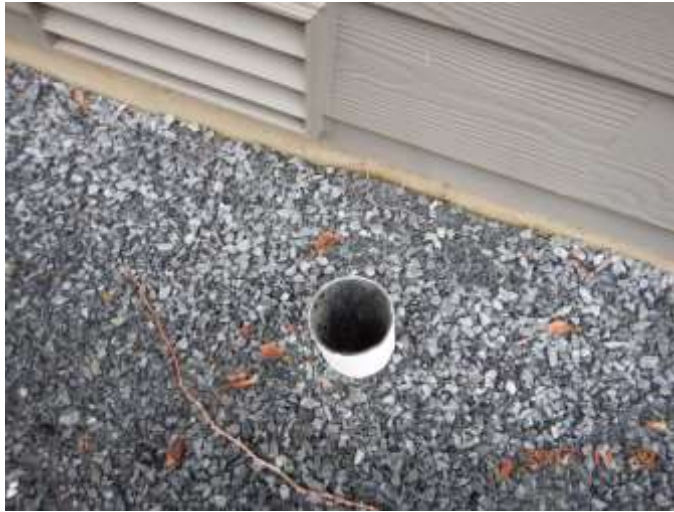
Open drain pipe

Grade at structure: Adequate grade away  
Earth to wood contact: Clearance as required  
Vegetation contact: Negligible  
Roof drain discharge: Underground discharge  
- The open drain pipe located at the North side yard should be cut to grade and capped

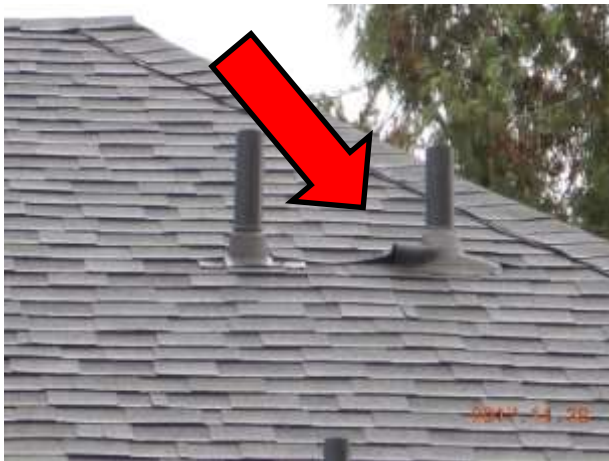
- A flashing (boot) at a plumbing vent located above the S.W. side of the home is bent upwards which could result in moisture intrusion. This vent may be positioned the wrong direction
- The weather-proof cover is not installed at a roof fall protection anchor located at the East facing roof area
- The gutters do not appear to be properly sloped as there is substantive standing water in the gutters
- The material used for the stair nosing is not consistent. Both cedar and white wood have been used

Raised side of a plumbing vent

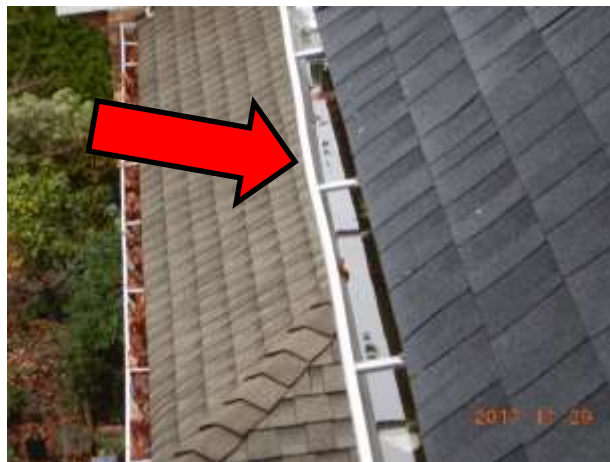
Condition: - The gutters do not appear to be properly sloped as there is substantive standing water in the gutters

Standing water in the gutters

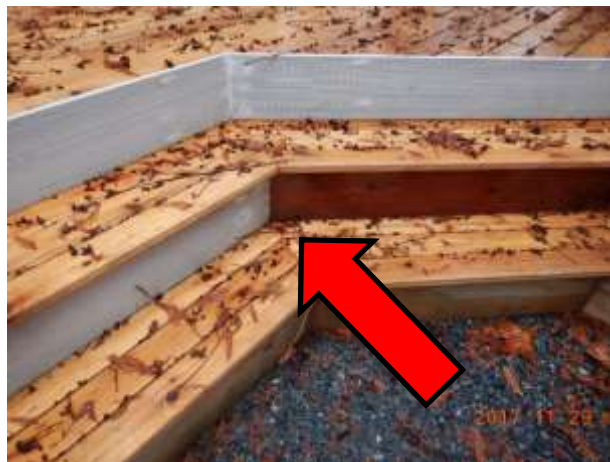
Condition: - The material used for the stair nosing is not consistent. Both cedar and white wood have been used

Inconsistent use of materials

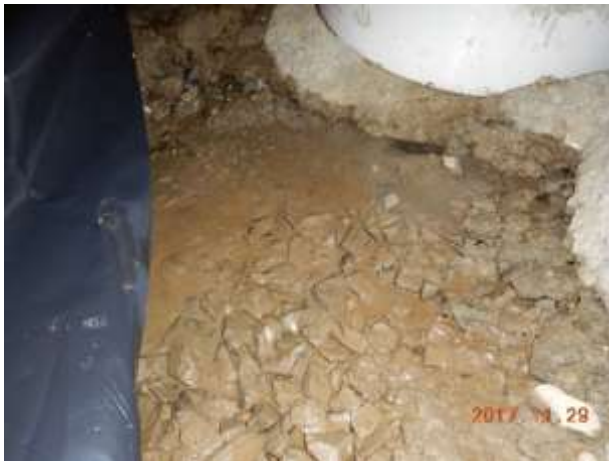
Ventilation: Appears adequate  
Vapor Barrier: - The vapor barrier is not installed at several small areas of the crawlspace  
Moisture Intrusion: - There is evidence of active moisture intrusion at the crawlspace  
Sump Pump: None visible

Active moisture intrusion

Conductive conditions: - The moisture intrusion and missing vapor barrier noted above are WDO conducive conditions  
Visible Evidence: No visible evidence

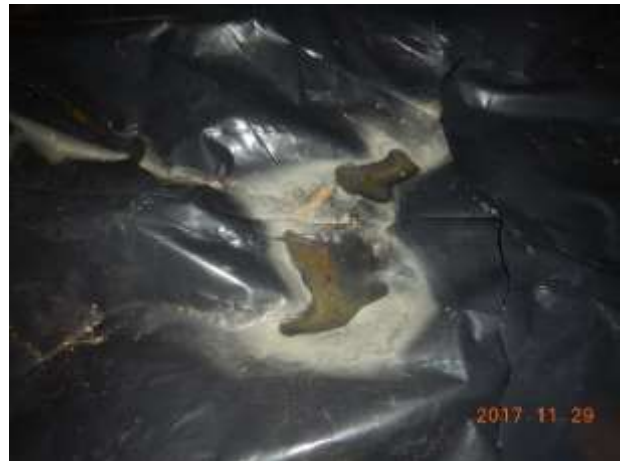
Puddles of water on top of the vapor barrier

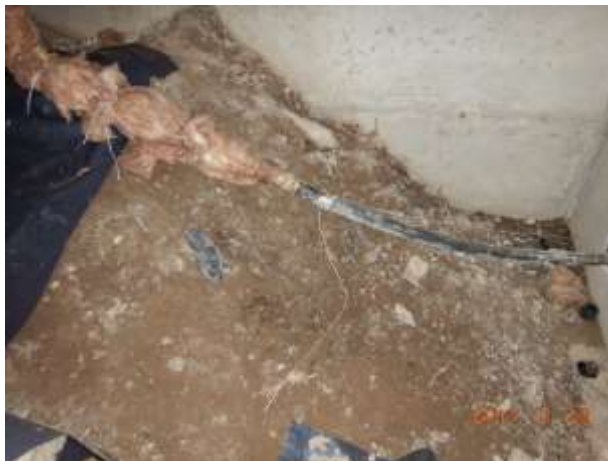
Missing vapor barrier

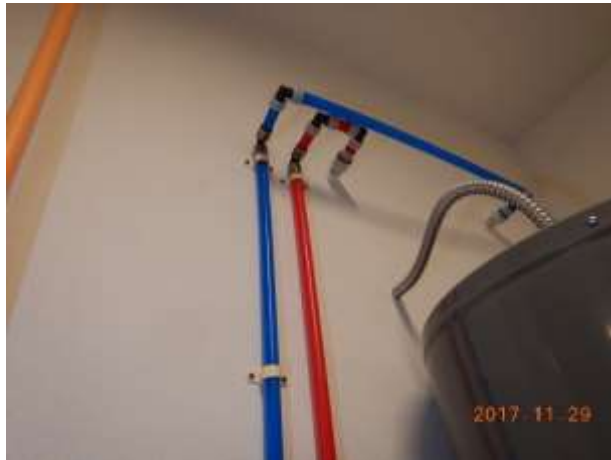
Missing pipe insulation

Domestic waste lines: There is no evidence of leakage at the plumbing waste lines located within the garage  
Domestic water lines: There is no evidence of leakage at the domestic water lines located in the garage  
- All domestic water pipes within the garage should be insulated

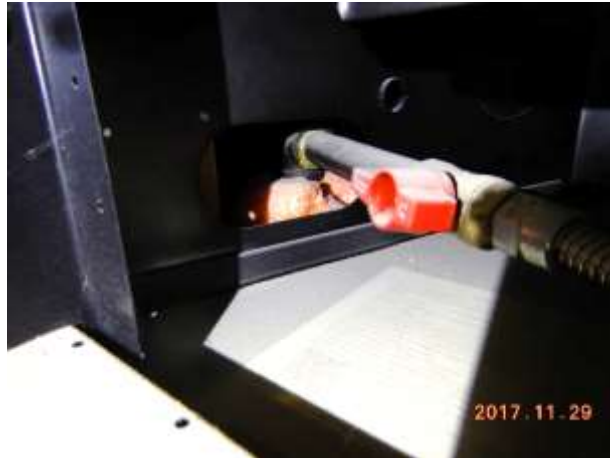
The gap surrounding the gas piping should be sealed to prevent air intrusion

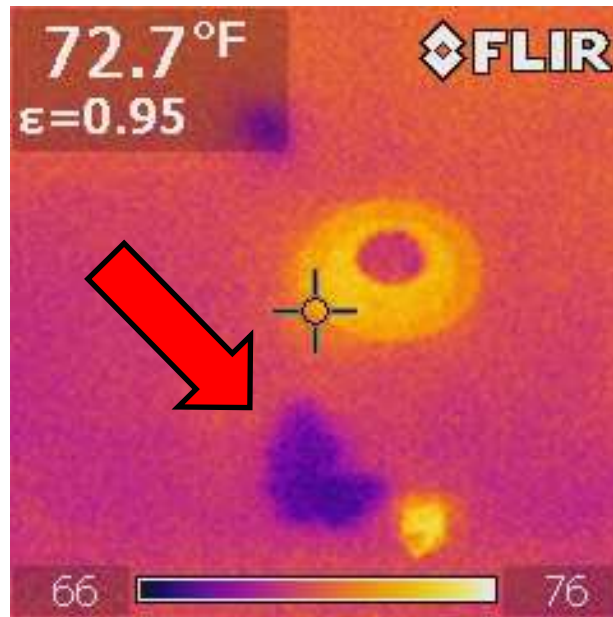
- Visibility: Rooms are occupied
- Structural Movement: No visible evidence of substantive structural movement
- Moisture Intrusion: - There is evidence of an active leak from the ceiling area of the Nook. This moisture is **LIKELY** related to the shower door issue as noted in the Master Bedroom section
- Walls: Satisfactory
- Ceiling: Satisfactory
- Flooring: Satisfactory
- Cabinets: Satisfactory
- Scribe molding should be installed at the side of the cabinets and cabinet panels where adjacent to the walls
- The second drawer down at the island needs adjustment as it rubs on the adjacent drawer
- Countertops: Satisfactory

Evidence of moisture

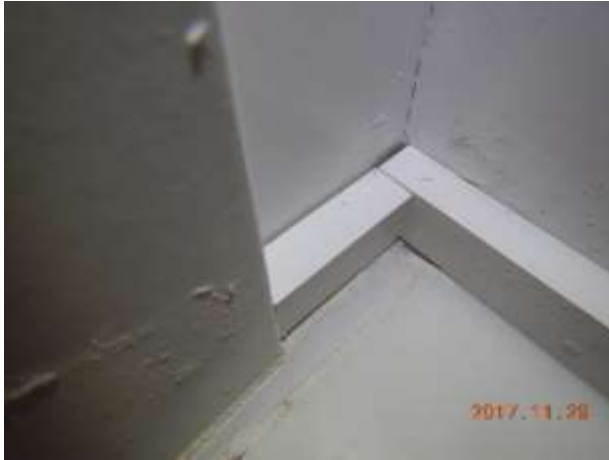
The material used for base shoe is not a ¼ round as used throughout the industry. Corners are blunt cut and not caulked

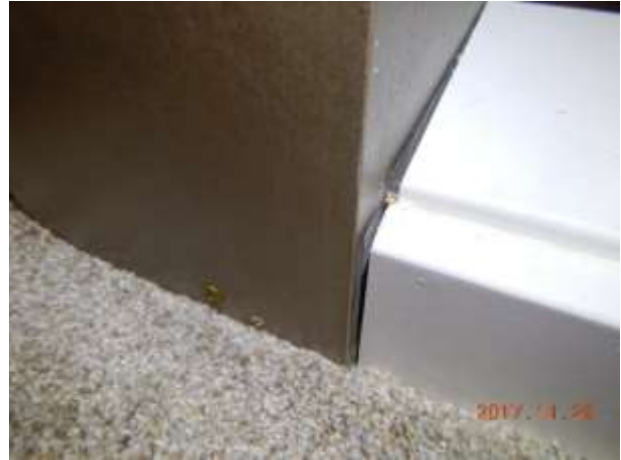
Large gaps adjacent to the stairwell barricade post

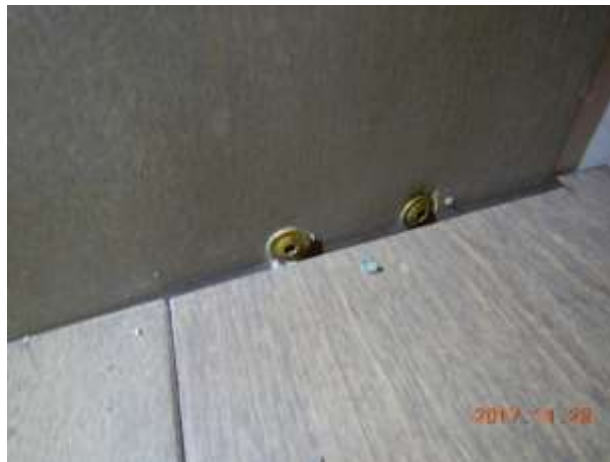
Screws visible at the stairwell barricade post. It may be possible that the builder was planning to add base shoe to this area

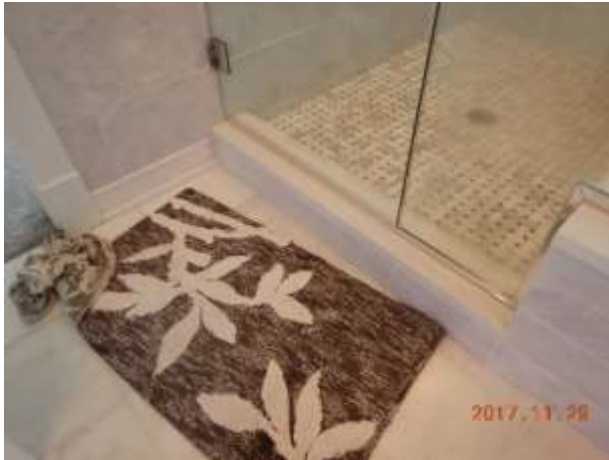
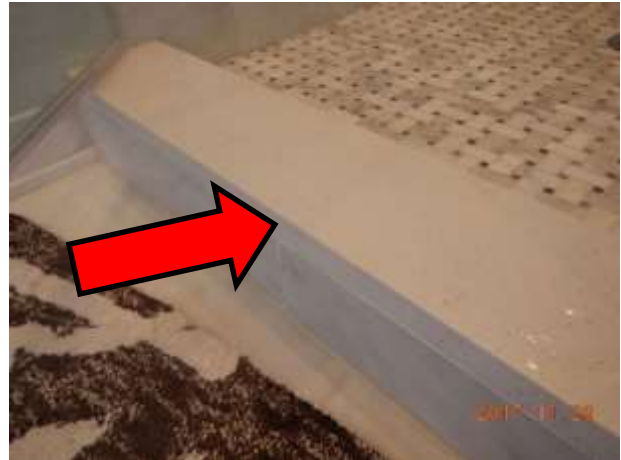
See image to right

The curb slopes towards the room

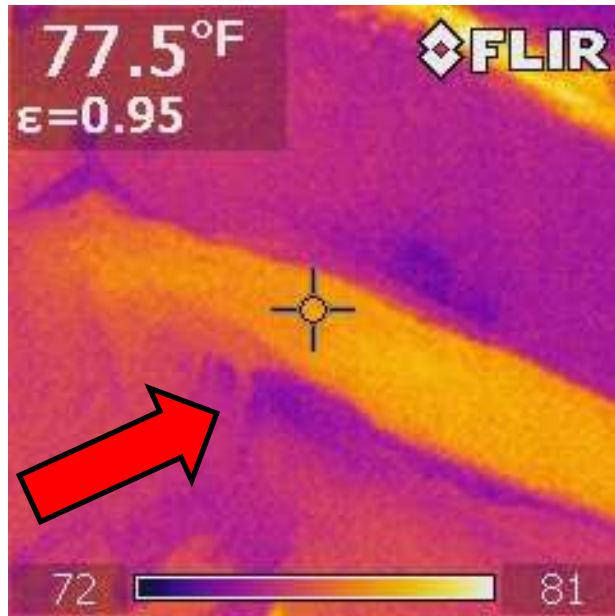
Water flow from out the shower

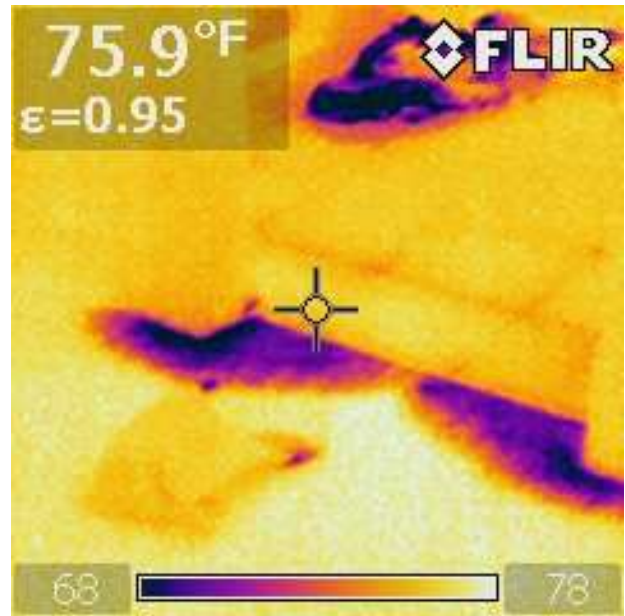
Water on the adjacent carpeting

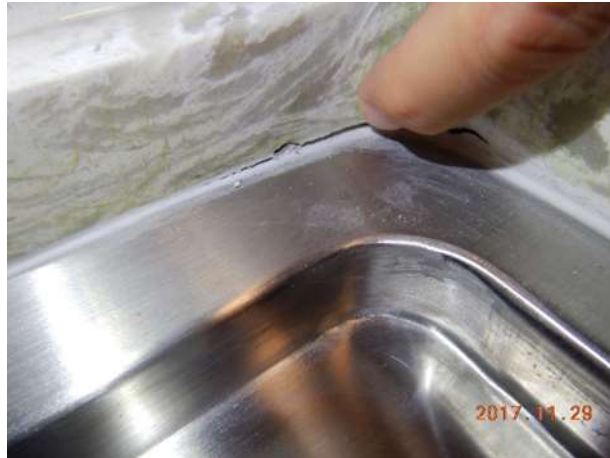
Large gaps at the corners of the sink

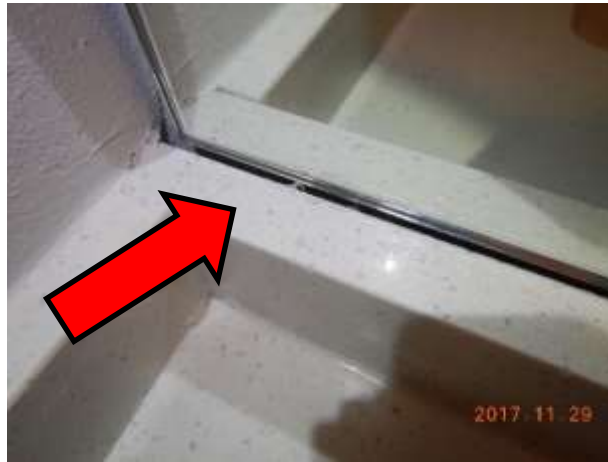
Large gaps at the backslash/mirror

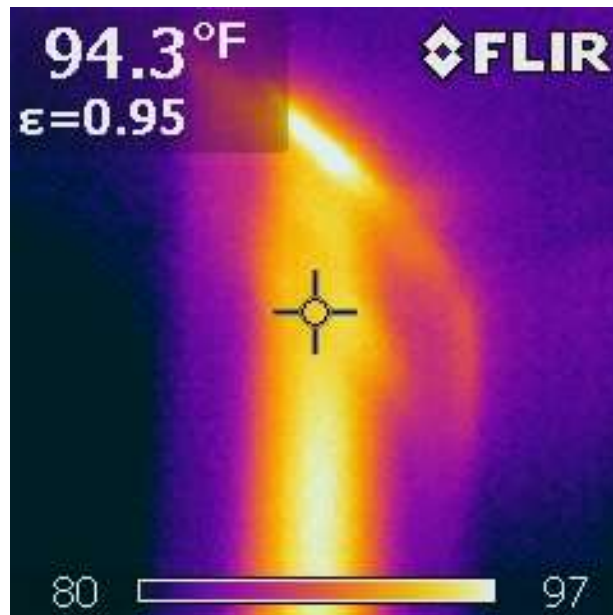
Visibility: Room is vacant  
Structural Movement: - There are ceiling-wall cracks at the closet and entryway to the bedroom  
Moisture Intrusion: No visible evidence  
Walls: Satisfactory  
Ceiling: Satisfactory  
Flooring: Satisfactory  
Cabinets: Satisfactory  
Countertops: Satisfactory  
Mirrors: Satisfactory

The ceiling cracks appear to be related to the heat stacks located within the walls

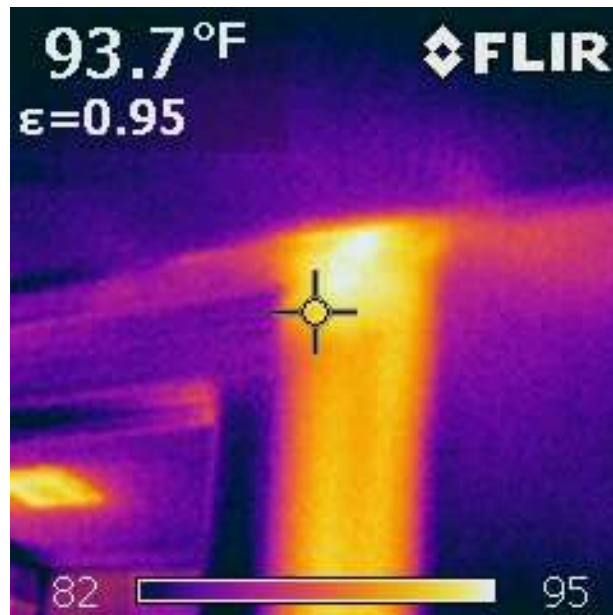
Visibility: Room is vacant  
Structural Movement: - There are cracks at the ceiling adjacent to the bathroom door  
Moisture Intrusion: No visible evidence  
Walls: Satisfactory  
Ceiling: Satisfactory  
Flooring: Satisfactory  
Cabinets: Satisfactory  
Countertops: Satisfactory  
Mirrors: Satisfactory

The ceiling cracks appear to be related to the heat stacks located within the walls

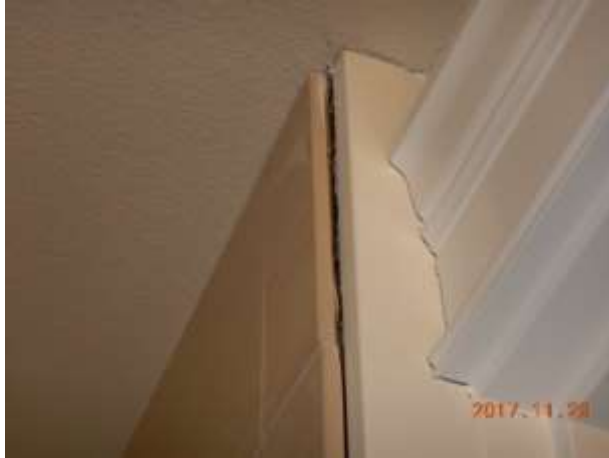
Gaps at the shower wall tiles

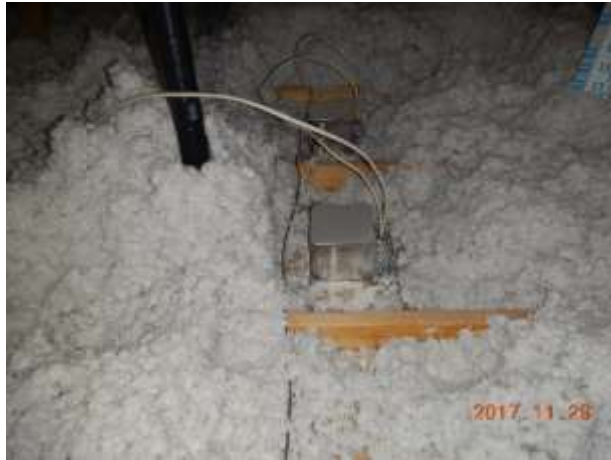
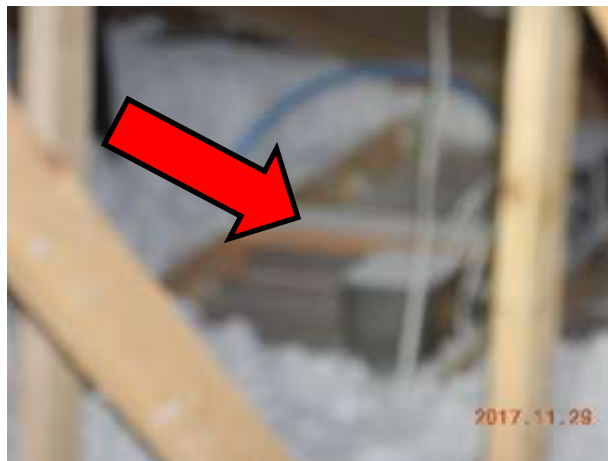
Type: Blown in  
Condition: - There are numerous areas of missing or compressed insulation  
- The fire suppression system pipes are not insulated in the vicinity of the S.E. bedroom. This lack of insulation could result in freezing/broken pipes

Missing insulation

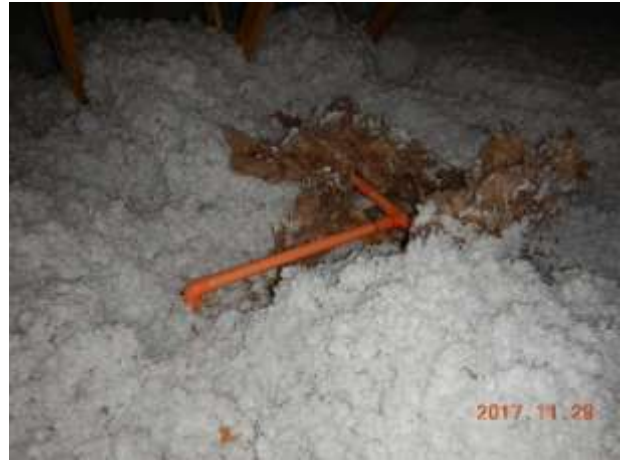
Exposed fire suppression system pipes
