Property Description: (2) story single family home  
Estimated property age: Built 2019 per listing  
Occupancy Status: Under construction

Inspection Date: 09/10/2019  
Inspection Time: 10:45 A.M. - 1:30 P.M. +-  
Weather Conditions: Overcast, 65 deg f +-

Hergert Inspection LLC

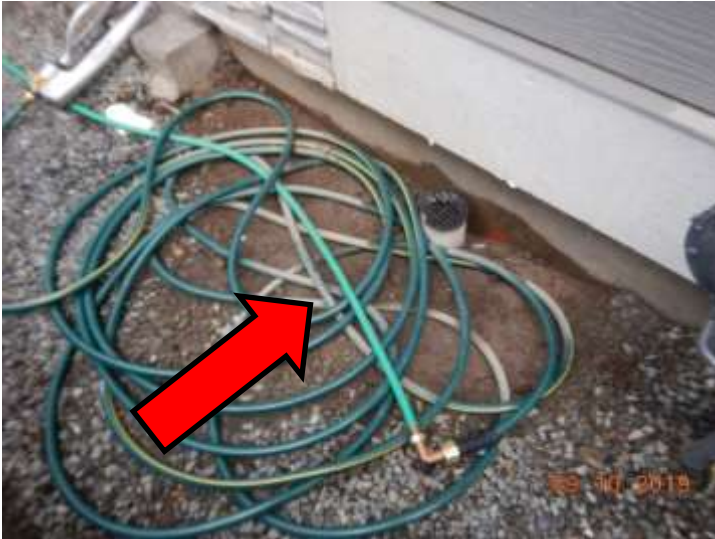
Grade at structure: - The grade at the South side of the garage should be adjusted so the water flows into the storm drain pipe (near the electric meter)  
- There is a possible location at the South side yard just East of the rear of the home that is not properly graded for proper drainage. Recommend continue to monitor and correct as needed

Reverse grade (ground slopes towards the house)  
(WDO conducive condition)

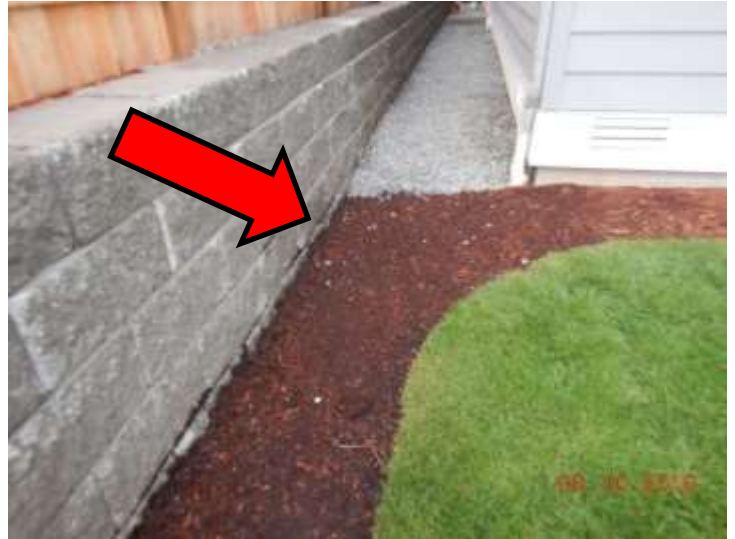
Possible area of standing water

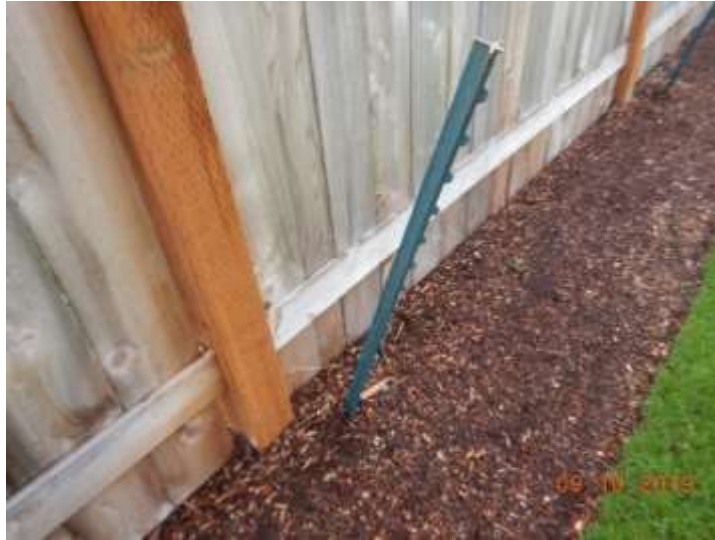
Metal posts at the rear yard

Other: - The metal fence posts should be removed from the East area of the rear yard

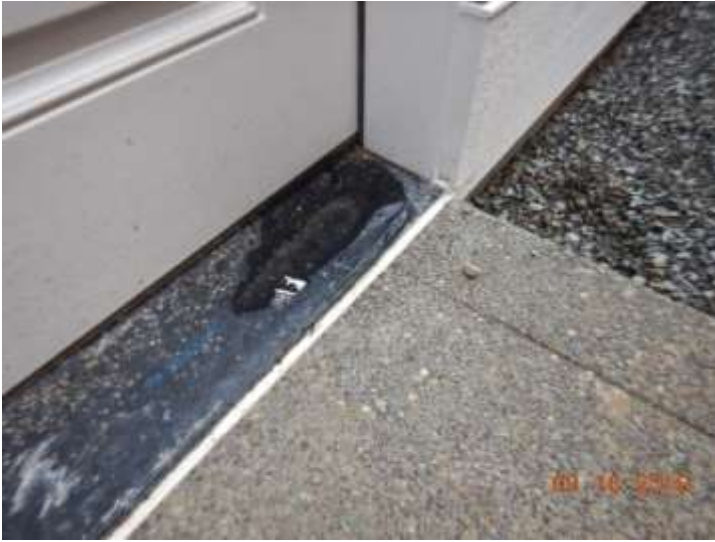
Threshold cover

- Structural Movement: No visible evidence of substantive movement
- Exterior doors: Satisfactory  
- The door threshold covers should be removed where installed and the threshold surfaces touched up where needed
- Windows (ext. cladding): Satisfactory

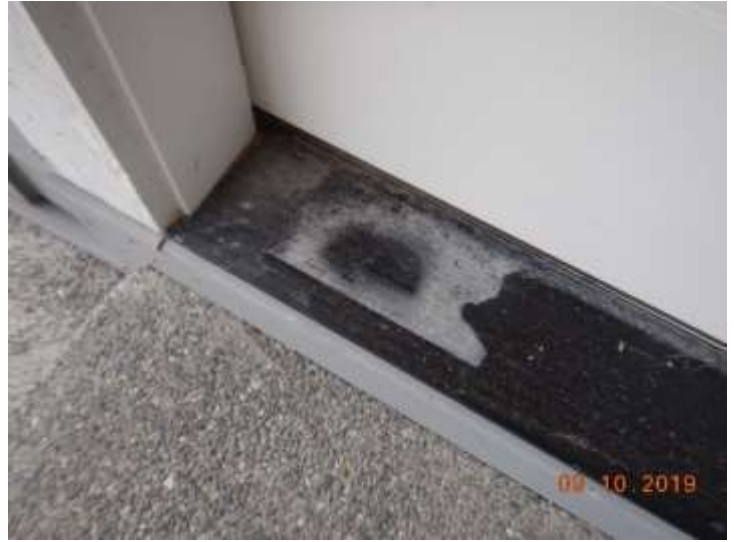
Threshold needing touch up

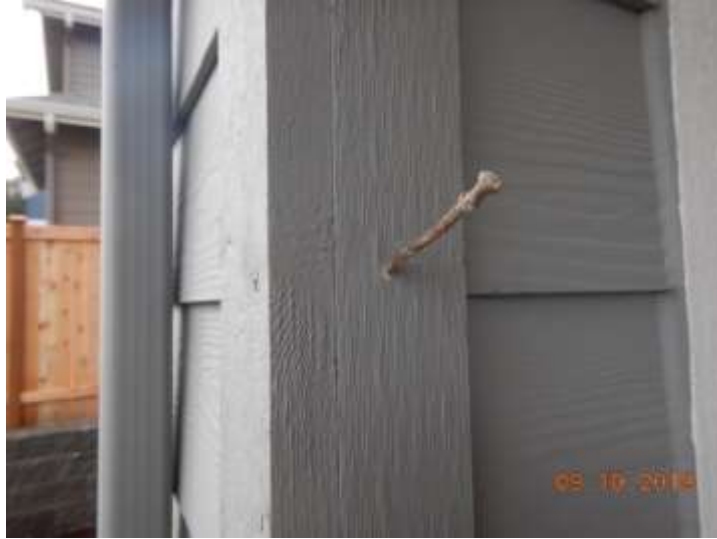
Nail protruding (typical)

- Type: Fiber cement board
- Condition: Overall satisfactory  
- All nails protruding from the siding should be removed and the siding/paint touched up as needed
- Window/Door Flashing: Satisfactory
- Paint and caulking: Satisfactory
- Exterior vents: Satisfactory

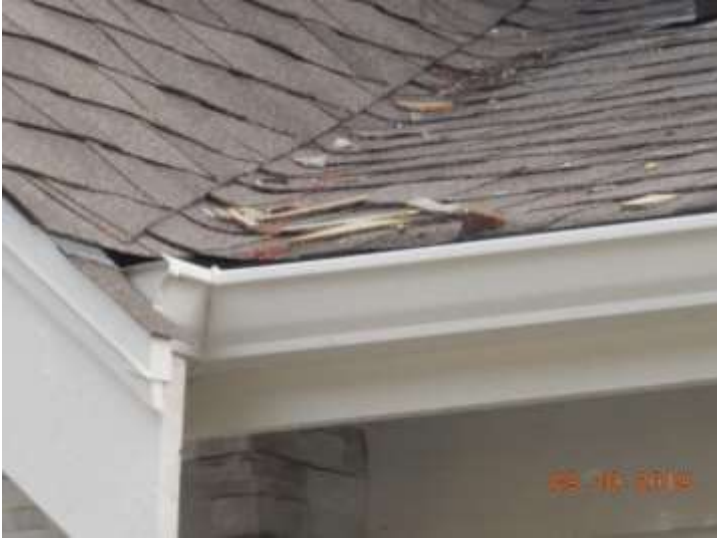
Debris on the lower roof

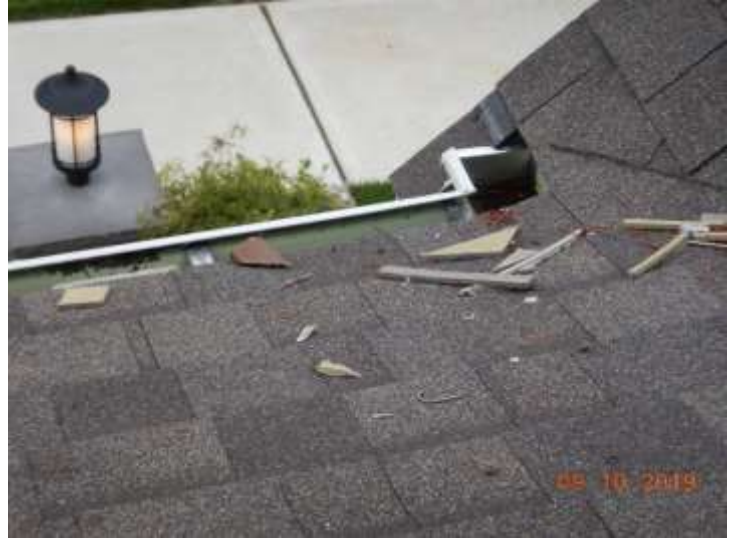
Debris on the lower roof and gutters

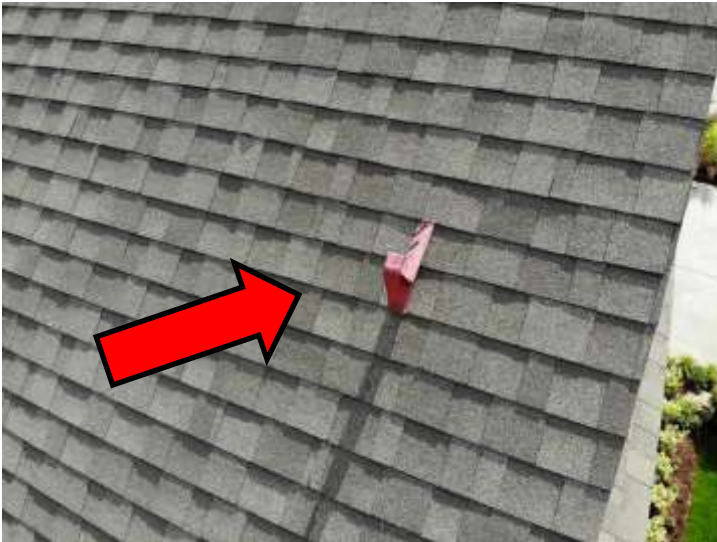
Metal anchor left on the roof

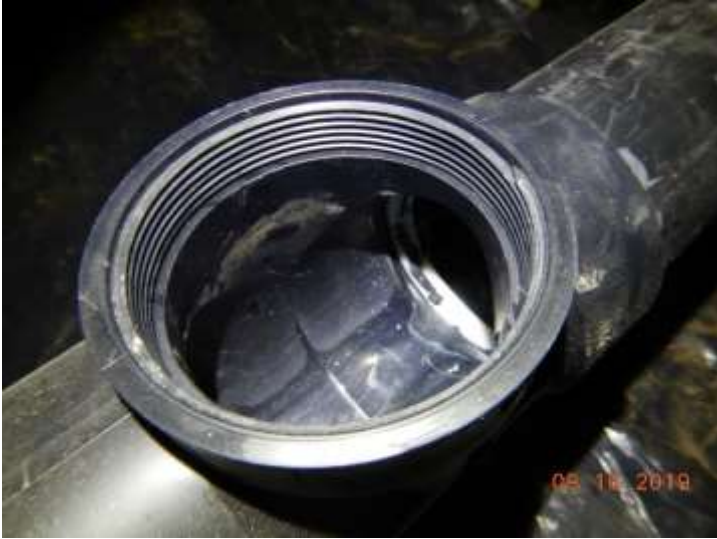
Waste lines: - A cap is missing at the main plumbing waste line  
Domestic water lines: Satisfactory  
Valves/ Other: None located

Missing cap

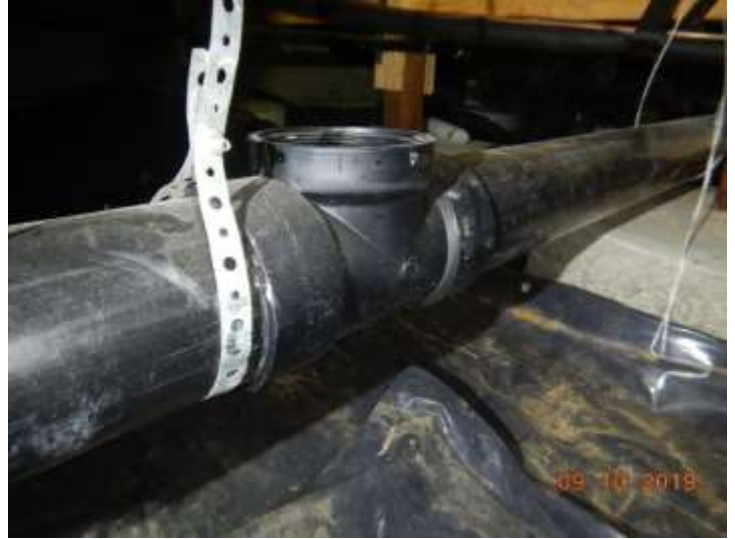
Waste line with missing cap

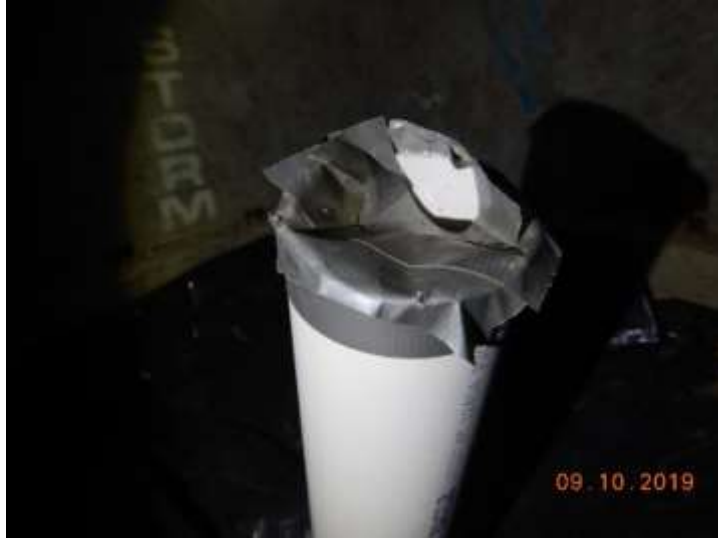
The crawlspace drain pipe should be tightly screened to prevent rodent intrusion

Visible Evidence: No visible evidence  
- Recommend installing a screen at the foundation drainage pipe to prevent rodent entry at this location into the crawlspace  
*Tip: Rodents are a common problem in crawlspaces. Recommend a proactive approach by setting rodent traps*

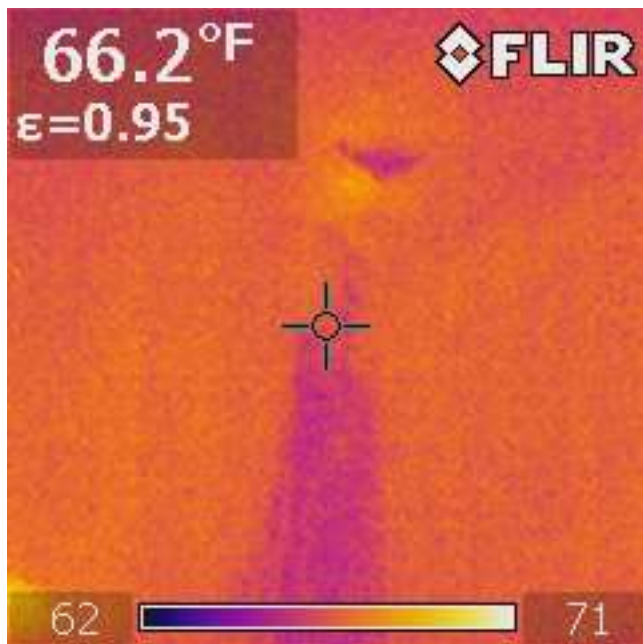
- Visibility: Rooms are vacant
- Structural Movement: No visible evidence of substantive structural movement
- Moisture Intrusion: - There is evidence of an active leak from the ceiling area of the Kitchen. The leak appears to be related to the drain lines of the tub in the Master bathroom
- Walls: Satisfactory
- Ceiling: Satisfactory
- Flooring: Satisfactory
- Cabinets: - The face plate of the lower left drawer to the left of the range is damaged as it was mis-drilled  
- A cabinet pull is missing at the butler's pantry  
- The cabinet trims should be filled where applicable
- Countertops: Satisfactory

Moisture intrusion at the ceiling

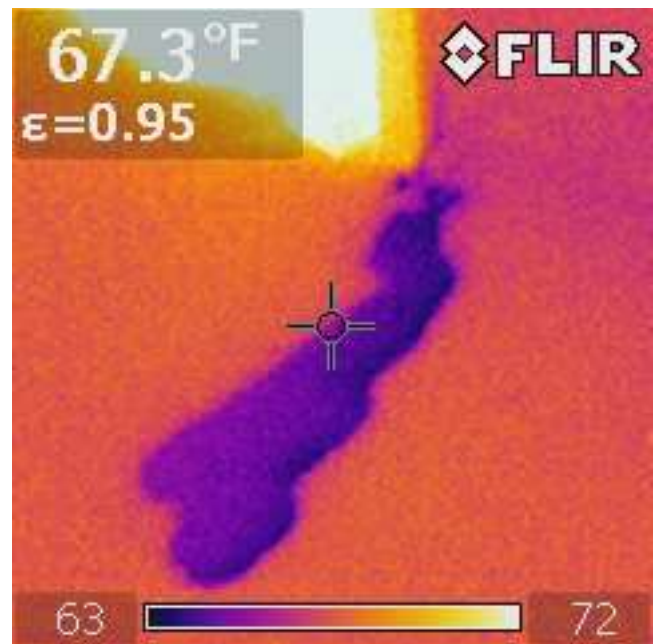
Water on the floor from the ceiling leakage

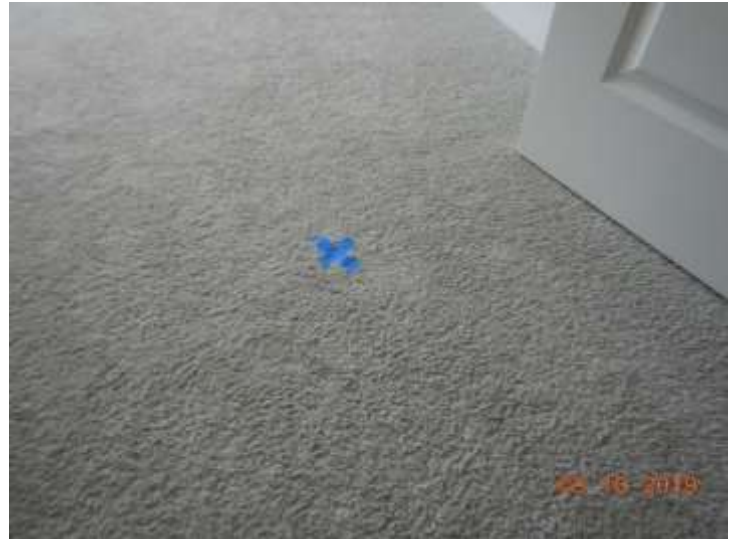
Depression at the flooring/pad

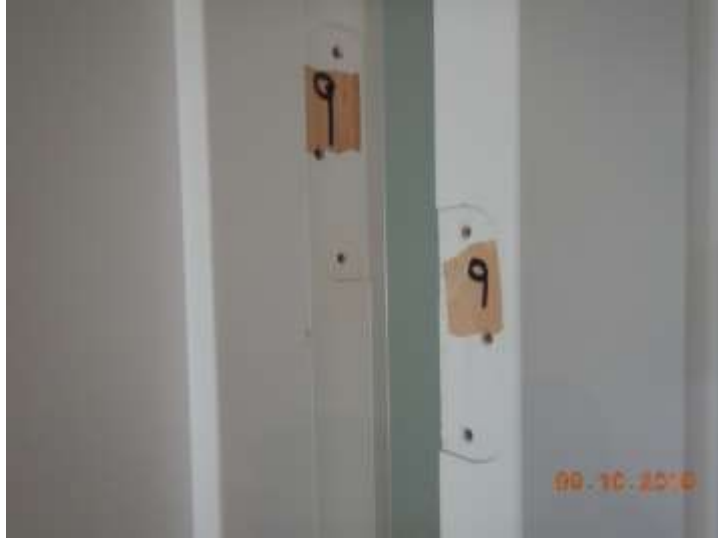
Operation/latching: Tested for proper operation and latching  
Door condition: - A hinge is missing at the stationary section of the Bonus room door. The hinge locations do not line up  
Millwork condition: Satisfactory

Hinge locations do not line up
