(425) 652-6515
www.Hergert.com
Kevin @ Hergert.com
Wa. Home Inspector 619
WSDA Inspector 79988
WSDA Control # 11168Q-014

Property Description: Upper level condominium
Estimated property age: Built 1995 per info on web
Occupancy Status: Vacant

Inspection Date: 10/12/2019
Inspection Time: 2:00 P.M. - 3:30 P.M. +-
Weather Conditions: Overcast, 60 deg f +-

Hergert Inspection LLC

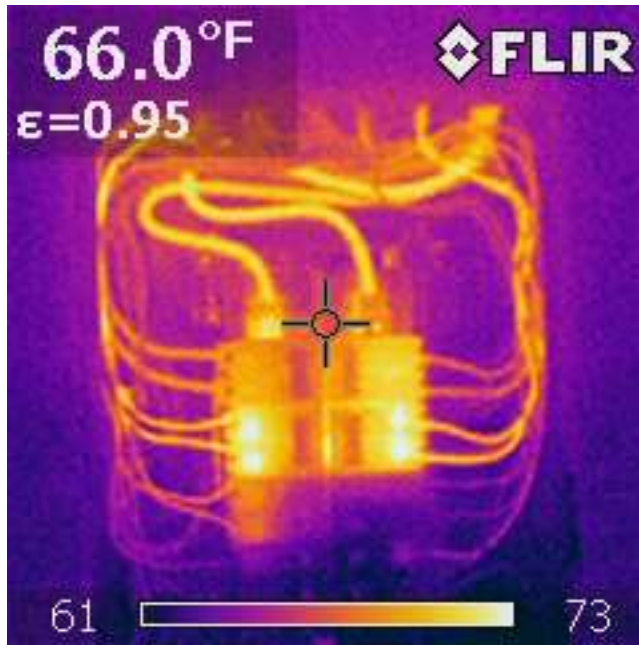
No evidence of overheating

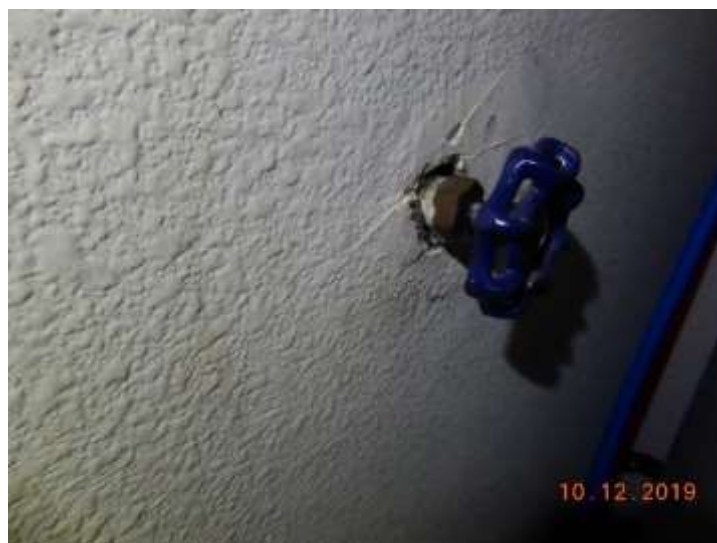
- The water distribution pipes within the home are polybutylene. The system is a manifold system with individual supply shut off valves at the manifold. This type of piping is a known defect

- Source Wa post; “There is yet another, very different, type of polybutylene installation, found in houses built from 1989 to 1996. It's called a manifold system. In such a system, there's a central station for all the beginning points of every plumbing endpoint. In other words, wherever water is used in the house, its plumbing lines start at the central distribution center. Rather than the rigid pipe used in other installations, the manifold system uses flexible piping. The central station is usually found near the water heater and mounted on a wall. From there, a flexible line runs all the way through the house to the supply point, such as a bathroom vanity. These systems often used polybutylene, though that ended with the suspension of all polybutylene use. Manifold systems can be used with other types of plastic piping. Because manifold systems use flexible pipes, there are almost no joints along the way -- and the joints are where polybutylene commonly leaks. The junctions of the piping also are visible at either the supply end or the manifold and can be monitored for problems. This is a major improvement over the old system, but beware: Joints have been found in this system where lines cannot bend “

Domestic water distribution pipes

- Leak detection systems: <https://www.statefarm.com/simple-insights/residence/water-leak-detection>

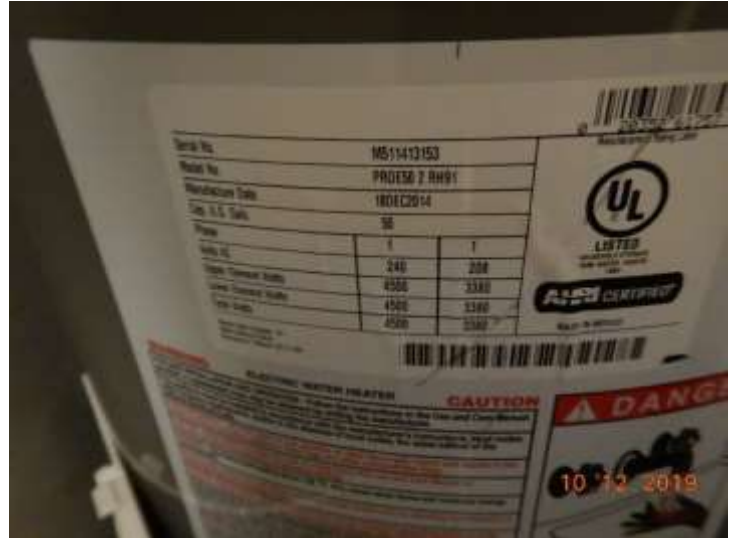
Data plate

Est. Useful Life new: 12 years
Serial number/year: 2014
Est. age of heater: 5 years based on the serial number
Est. remaining life: *- The age of the water heater is 5 years. The remaining anticipated useful life expectancy is 7 years*

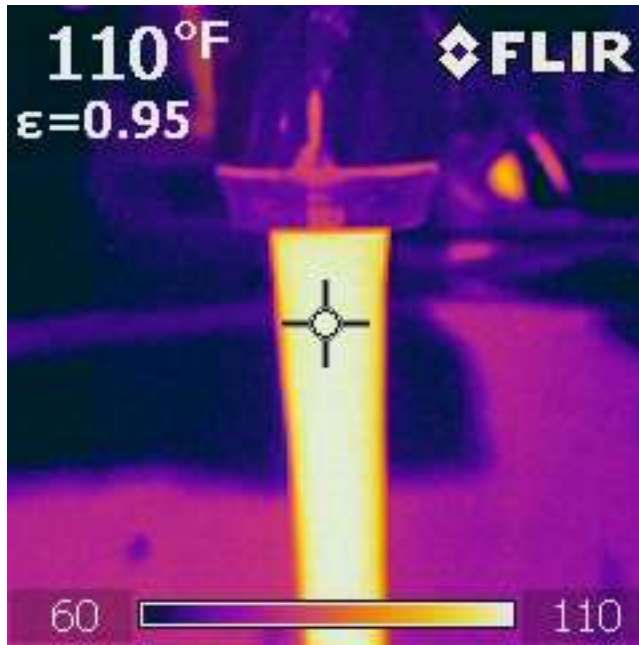
TPR valve: As per required
Earthquake Straps: Installed
Safe water temperature: 120 deg F per industry standards
Measured temperature: 110 deg F

Hot water temperature

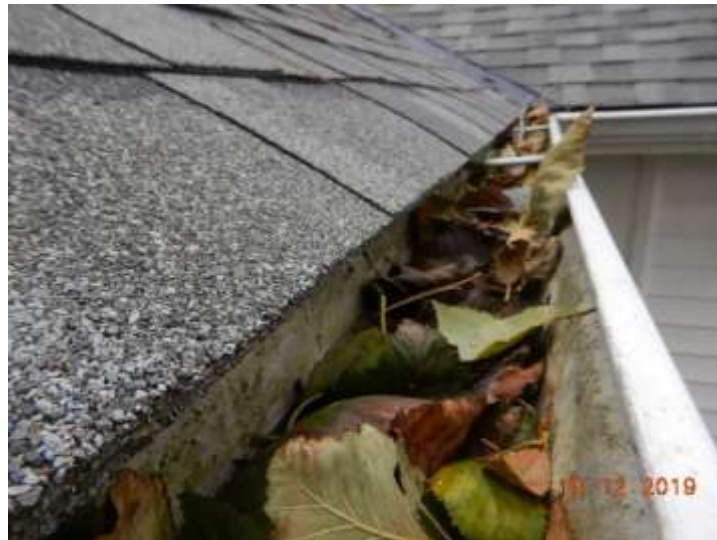
Debris in the gutters

Condition: - The gutters should be cleaned of debris. The HOA should be advised of this condition

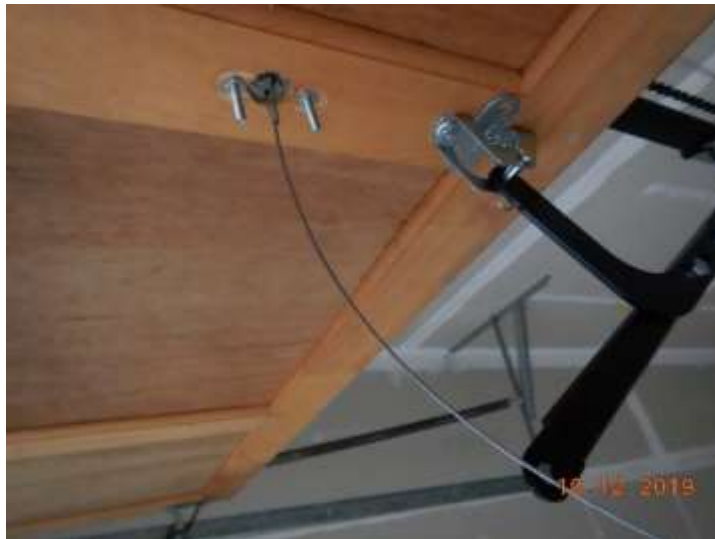
Cable attached to the emergency access key port

Type: Wood roll up
Door condition: The doors are in satisfactory condition
Springs and tracks: The springs and tracks appear to be in satisfactory condition
Garage door openers: Yes
- The emergency access key should be provided for the garage door opener so that the door can be opened in the event of a power failure or failure of the garage door opener. The key is needed to pull the mechanism that releases the garage door from the opener
Auto reverse of impact: Reversed when reasonable force was applied
Photo cell reverse sensors: Tested for proper operation

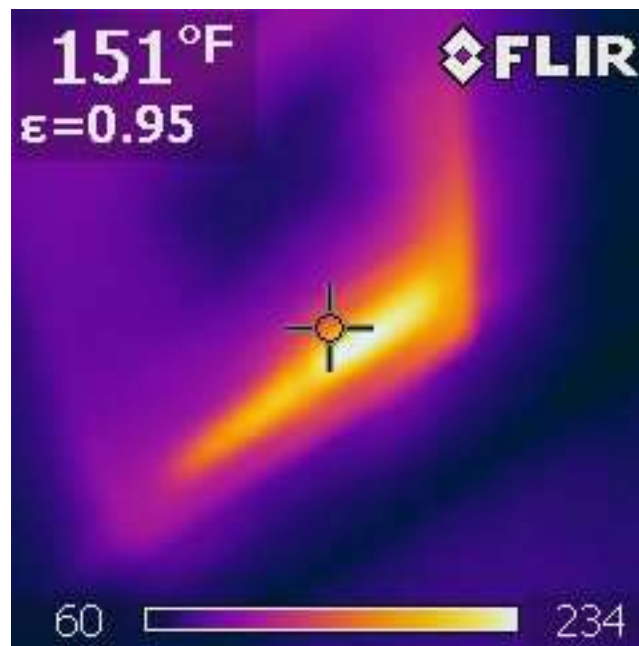
Maintain proper clearances to combustibles

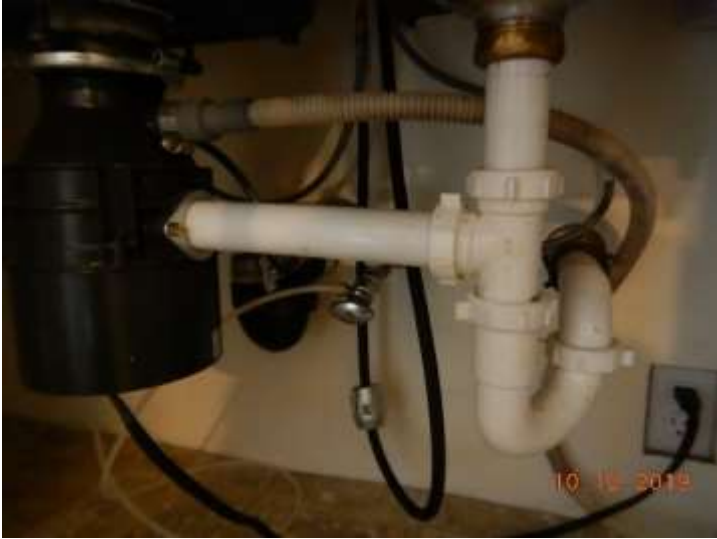
Dishwasher drain

Dishwasher: Tested a full cycle. Not all functions and settings are tested
Dishwasher drainage: - The dishwasher drain should be secured to the underside of the countertop to prevent cross contamination of waste water with the dishwasher (high loop)
Free Standing Range: - Tip over restraints are not installed at the range. A bracket is typically installed to secure a rear leg of the range to prevent rotation if excessive downward pressure is applied to the door
Cooktop: Tested all burners
Oven: Tested. Not all functions and settings are tested
Microwave (door): The door of the microwave was tested for operation
Ventilation: Tested
Refrigerator: The refrigerator appears to be operative. Not all functions and settings are tested

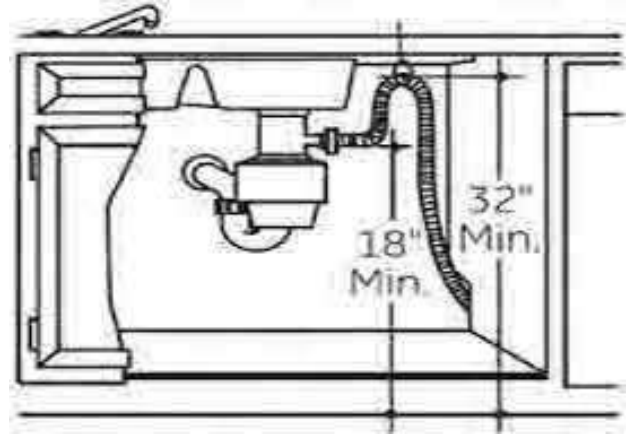
Proper dishwasher high loop

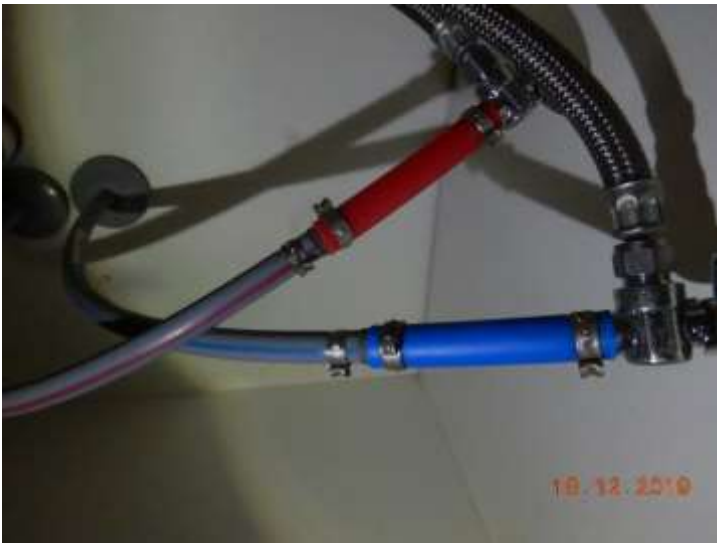
Pex pipe was spliced onto the piping to the sinks

- Seller: Explain why PEX pipe was spliced onto the ends of the polybutylene supply pipes for the sink. This also pertains to the Main bathroom

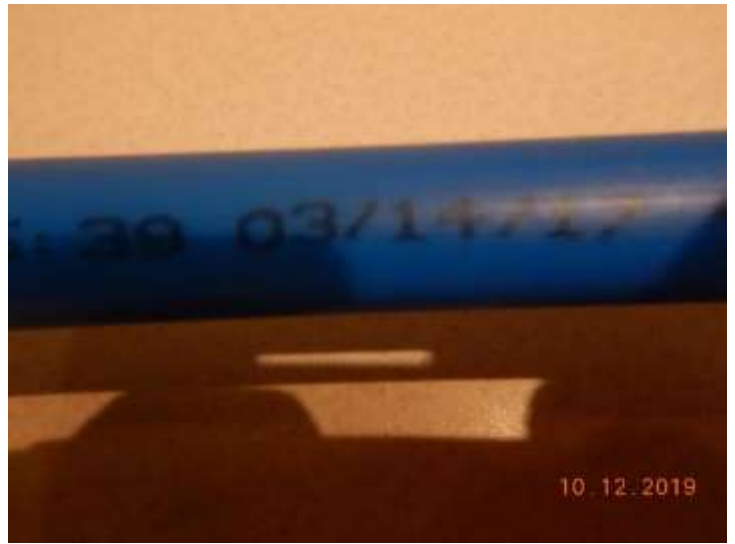
The pex pipe is dated 3/2017

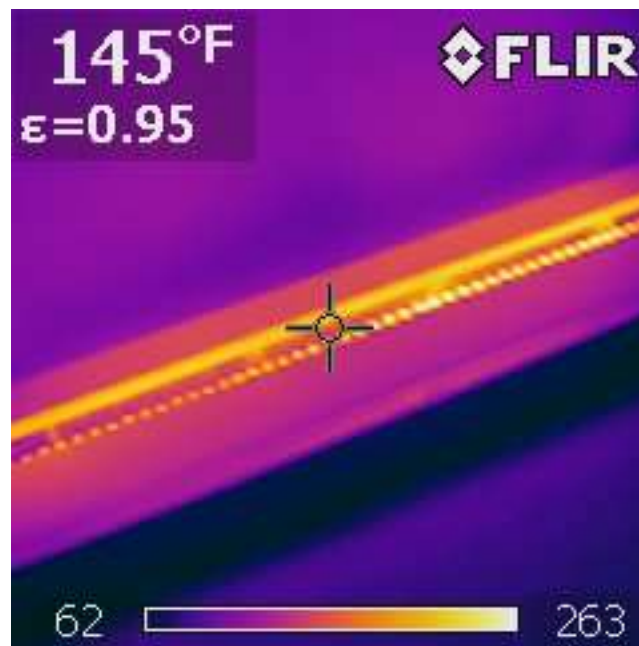
Maintain proper clearances to combustibles

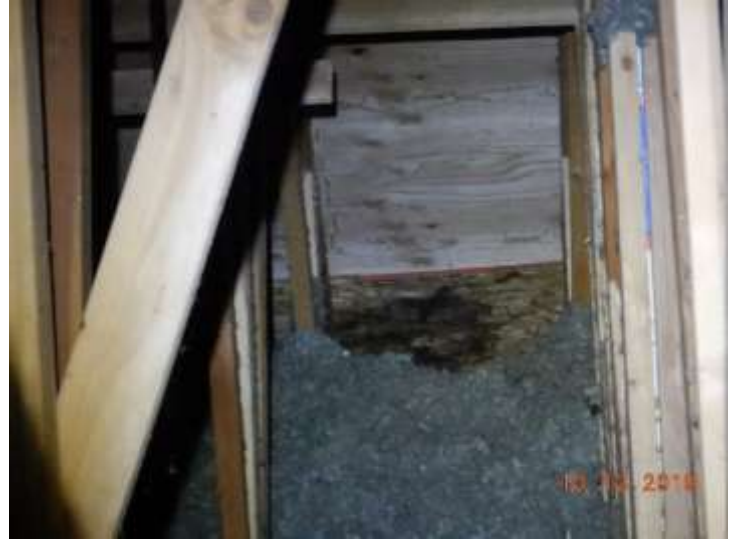
Evidence of prior roof sheathing repair at the Living room area. The roof appears to be “newer”
