Property Description: Townhouse style condominium
Estimated property age: Built 1998 per listing
Occupancy Status: Vacant

Inspection Date: 10/16/2019
Inspection Time: 3:00 P.M. – 5:00 P.M. +-
Weather Conditions: Overcast, 55 deg f +-

Hergert Inspection LLC

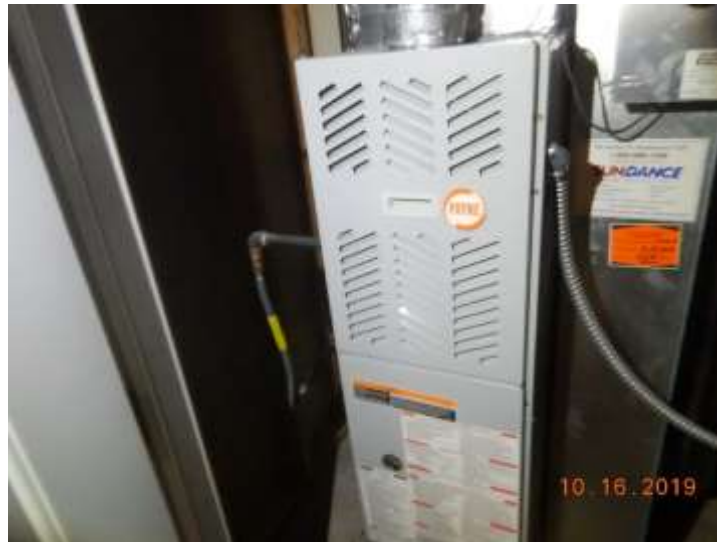
Furnace

- *The age of the furnace is 19 years. The remaining anticipated useful life expectancy is 6 years*
- Recommend furnace to be cleaned, serviced, and shown to be in good working order by a qualified furnace technician. There is no tag on the furnace which indicates any prior servicing of the furnace

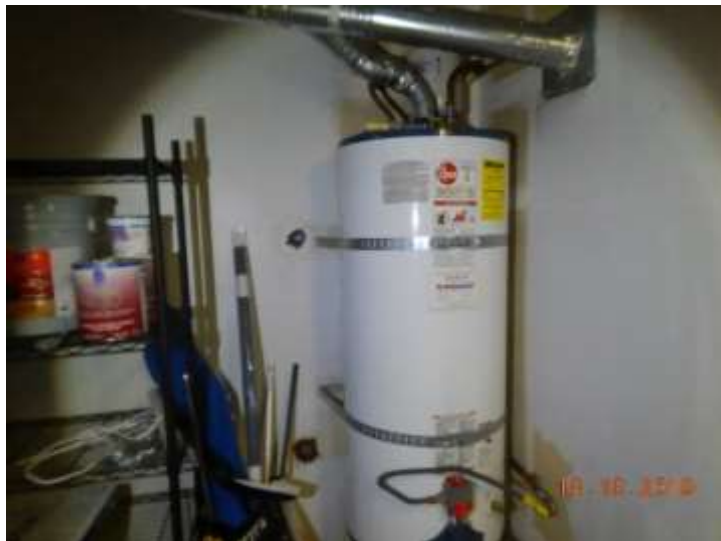
Water Heater

Est. Useful Life new: 12 years
Serial number/year: Rhng 0600131813. Ansi 1998
Est. age of heater: 19 years based on the serial number
Est. remaining life: - The water heater is fully functional with no visible evidence of rusting, however is past the end of its anticipated useful life expectancy by 7 years

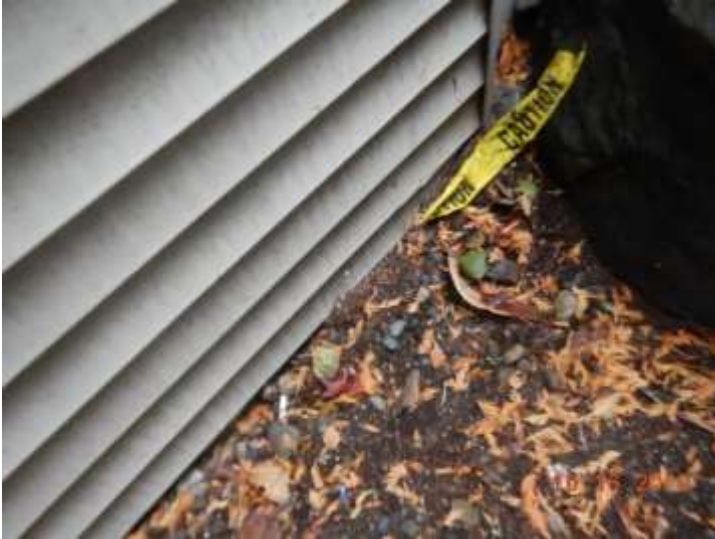
- Grade at structure: Adequate grade away
- Earth to wood contact: - Ground in contact with the siding (WDO conducive condition). Recommend 4-6" separation between the ground and siding. The HOA should be advised of this condition
- Vegetation contact: - Vegetation in contact with structure (WDO conducive condition). The HOA should be advised of this condition
- Roof drain discharge: Underground discharge

Ground in contact with the siding
(WDO conducive condition)

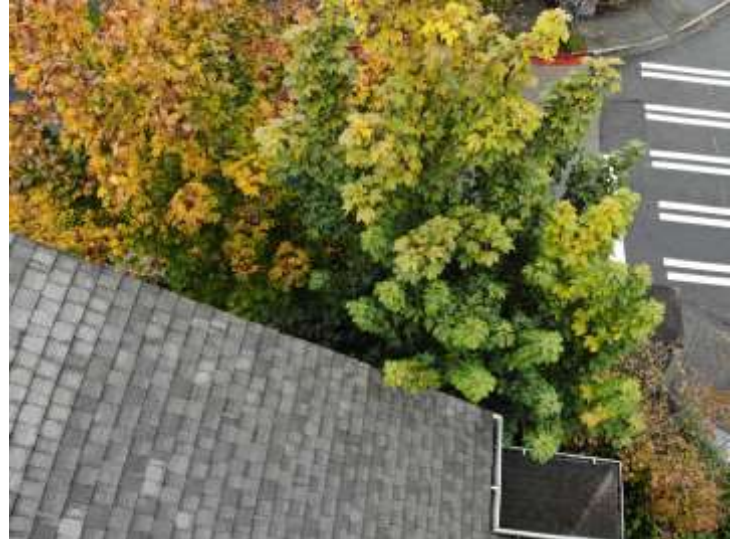
- Ground in contact with the siding (WDO conducive condition). Recommend 4-6” separation between the ground and siding. The HOA should be advised of this condition
- Vegetation in contact with structure (WDO conducive condition). The HOA should be advised of this condition

Vegetation in contact with the structure
(WDO conducive condition)

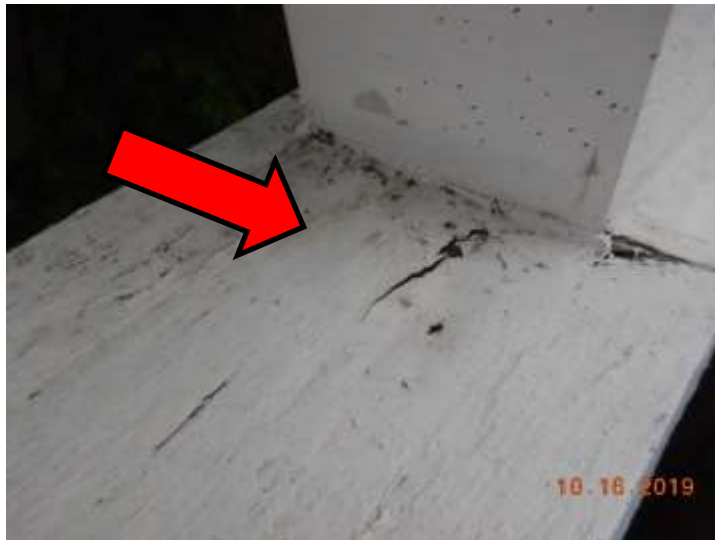
Type: Vinyl
Condition: Overall satisfactory
- There is evidence of wood rot at the cap located at the deck barricade. The HOA should be advised of this condition
Window/Door Flashing: Satisfactory
Paint and caulking: Satisfactory
Exterior vents: Satisfactory

Evidence of wood rot

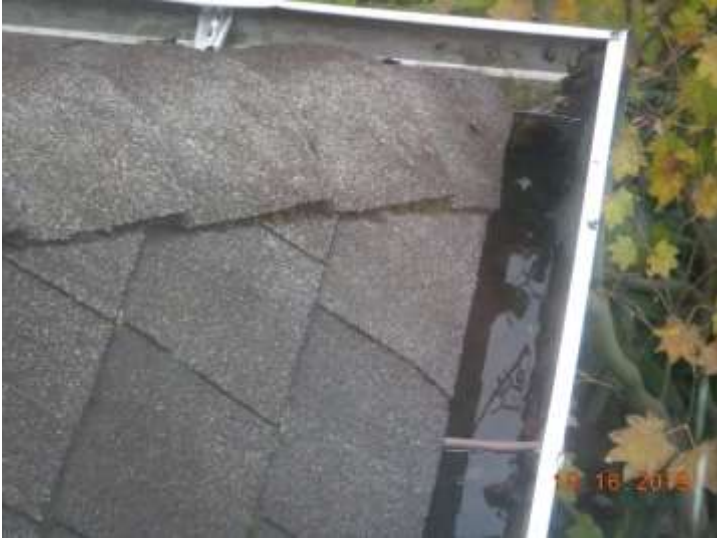
Condition: - The gutters should be cleaned of debris. The HOA should be advised of this condition
- There is evidence of gutter spillage and/or a clogged underground drainage pipe located at the right side of the entryway. Recommend continue to monitor. The HOA should be advised of this condition as needed

Water and debris inside a gutter

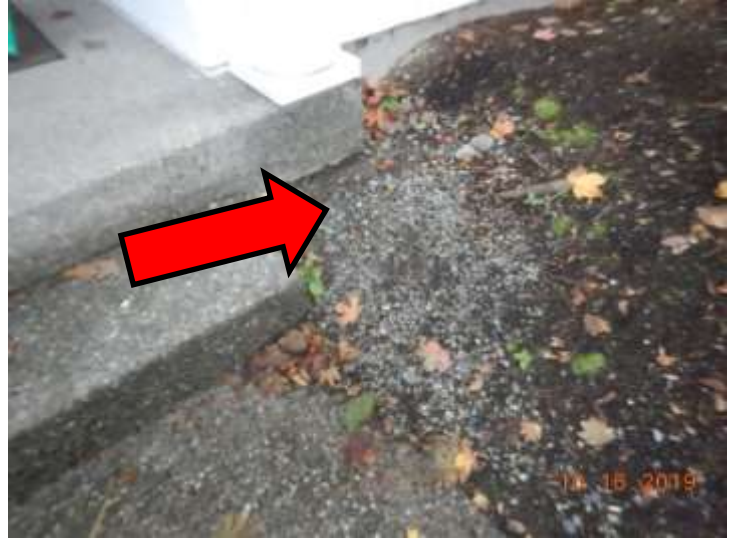
Evidence of possible gutter spillage and/or clogged drain

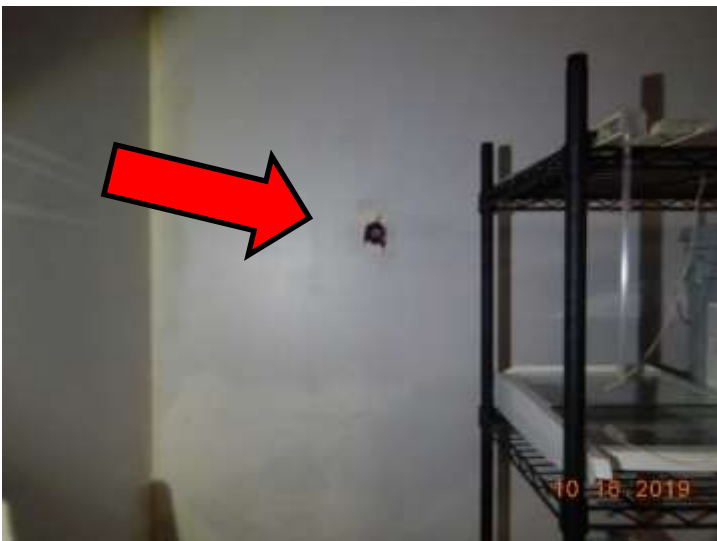
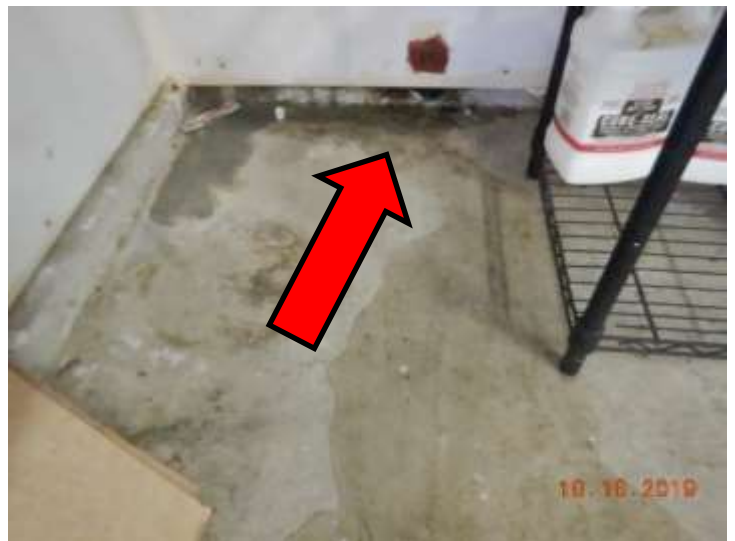
Hose Bibs: - The garage area hose bib is broken within the wall of the garage

Water poured from the wall when the shut off valve was turned to the on position

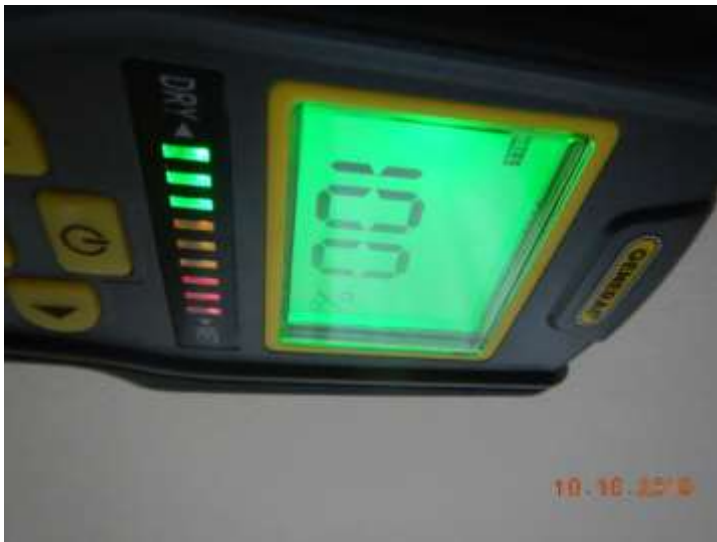
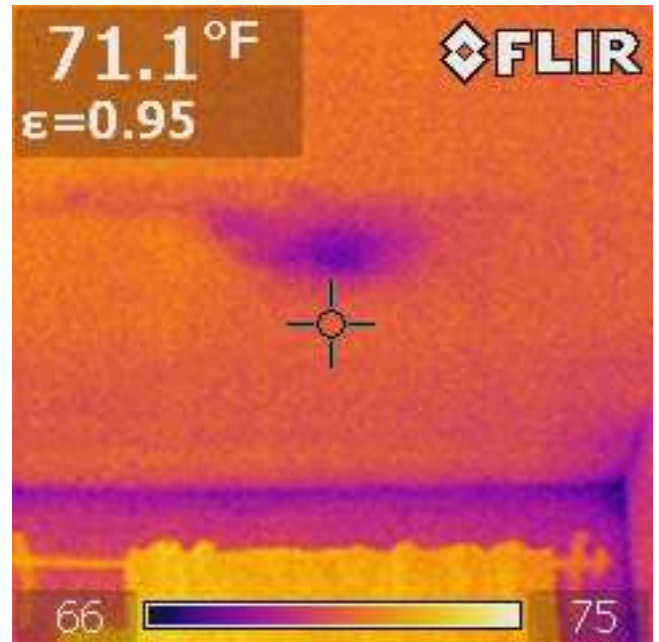
- Visibility: Rooms are vacant
- Structural Movement: No visible evidence of substantive structural movement
- Moisture Intrusion: - There is evidence of an active leak at the ceiling area of this room. The leak appears to be related to the shower in the Master bathroom above
- Walls: Satisfactory
- Ceiling: Satisfactory
- Flooring: Satisfactory

High moisture reading

Moisture at the ceiling
Approximately 4' from the wall, centered on the window

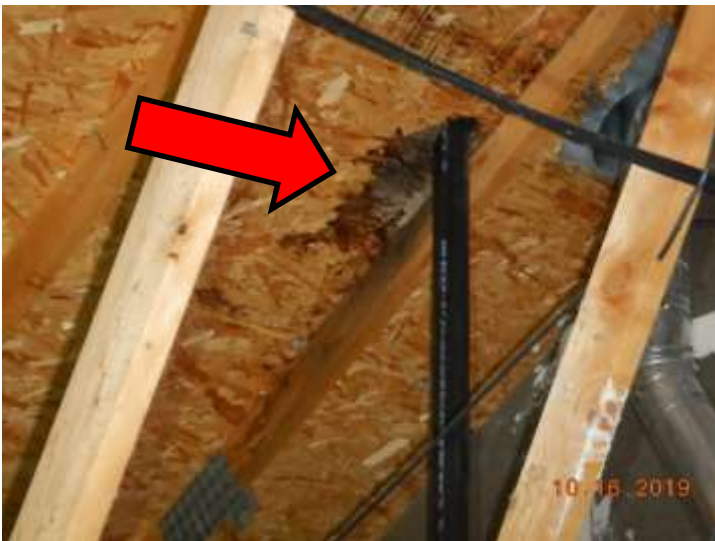
Roof Ventilation: - There is evidence of minor leakage surrounding a plumbing vent stack. The HOA should be advised of this condition
Moisture Intrusion: No visible evidence
Bathroom Vents: All vent to the outside where visible

Evidence of moisture seepage
