Client:
Address: xxxx , Sammamish

Property Description: (2) story single family home
Estimated property age: Built 2021 per King Co.
Occupancy Status: Occupied

Inspection Date: 09/23/2022
Inspection Time: 9:30 A.M. - 11:30 A.M. +-
Weather Conditions: Overcast, 65 deg f +-

Hergert Inspection LLC

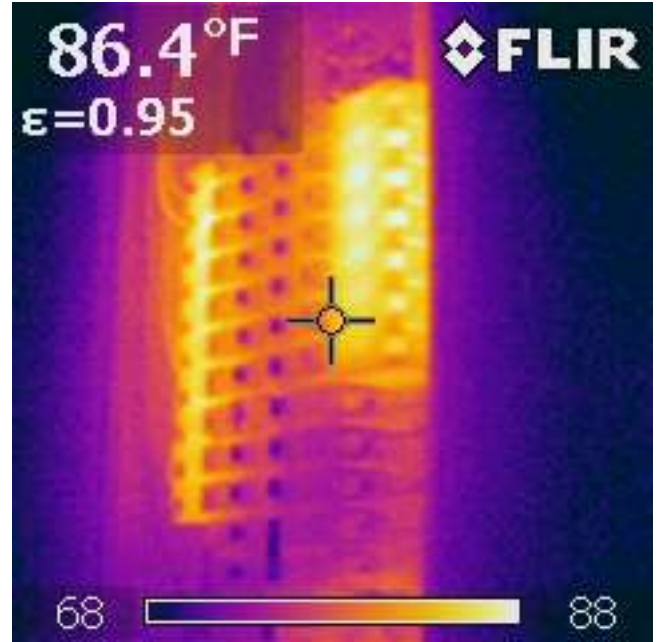
No evidence of overheating

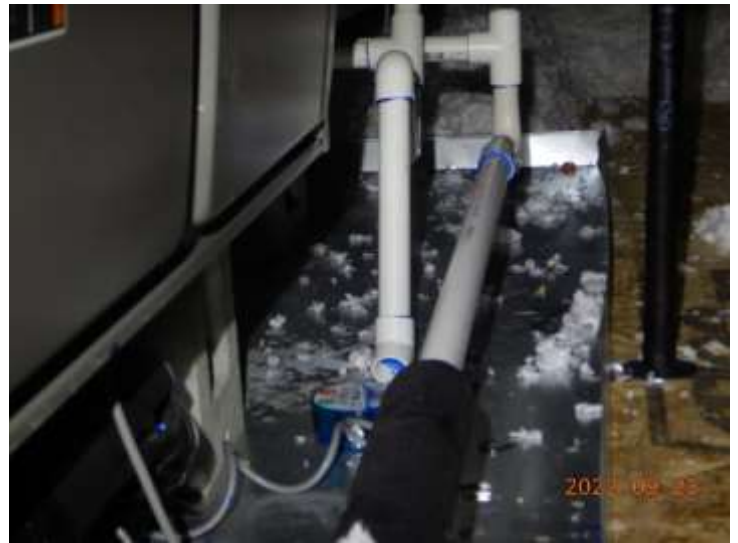
- The age of the furnace and air conditioning systems are approximately 1 year. The remaining anticipated useful life expectancy is 24 years based on industry standards.
- All debris should be removed from the drip pan located below the heating/cooling system.

Debris in the drip pan

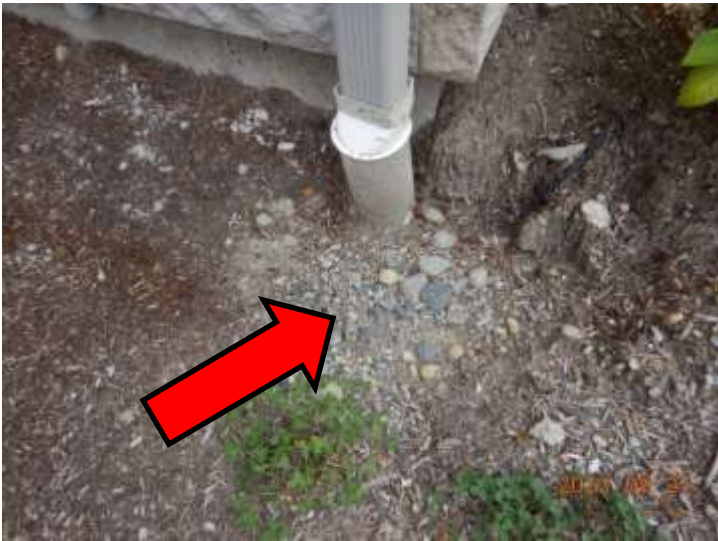
- There is evidence of water spillage from the downspout and/or underground drain located at the outer corner of the floor 1 bedroom. Recommend continue to monitor during periods of rainfall.
- The support for the rain barrel is not completed in a workmanlike manner (aesthetically).
- The nails should be removed from the side of the front porch.
- The gate at the North side yard does not fully open as designed.

Evidence of downspout and/or drainage system spillage

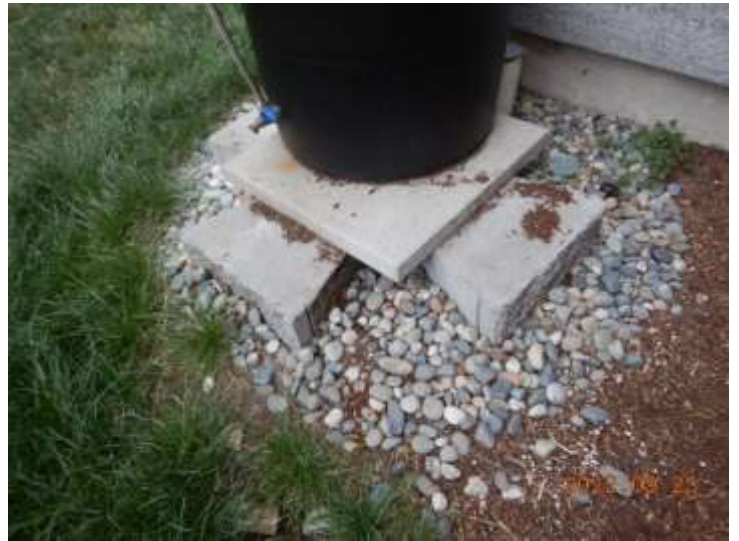
Supports for the rain barrel

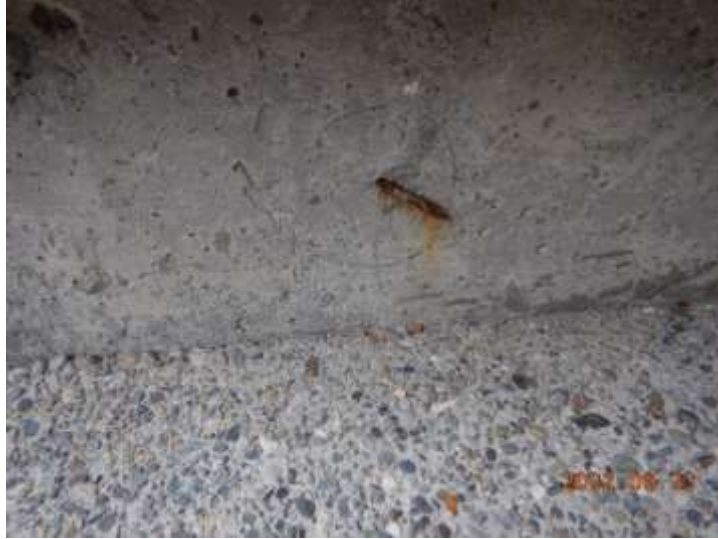
- Type: Concrete
- Condition: Overall satisfactory, except as noted below
- The nails should be removed from the side of the front porch.

Nails at the front porch

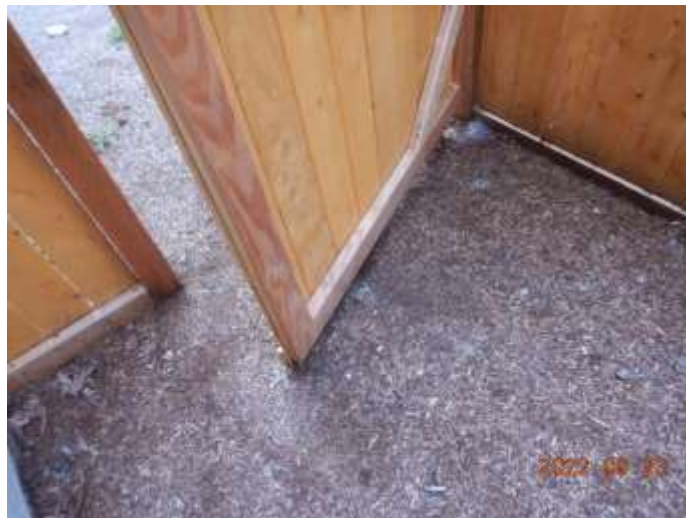
House Identification #: Installed
Overhead Power Lines: None on site
Retaining Walls: None that affect structure
Irrigation System: None located
Other: - The gate at the North side yard does not fully open as designed.

The North gate does not fully open

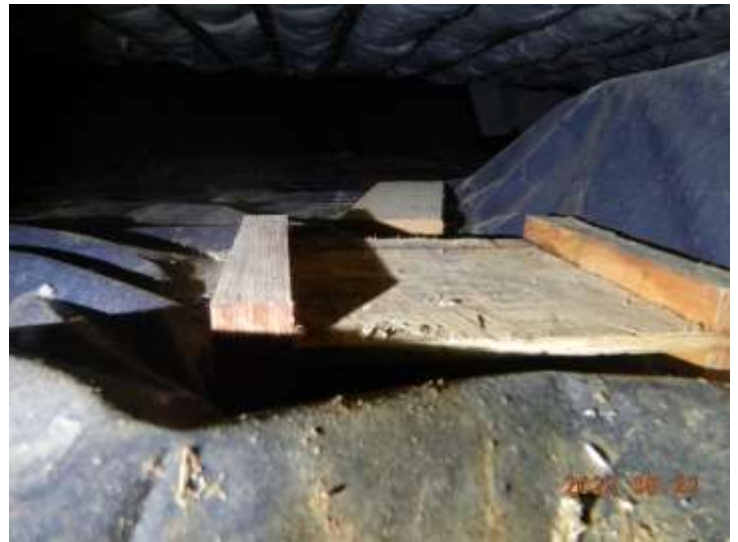
Visibility: Space is vacant, except as noted below
- All construction debris should be removed from the crawlspace.

Crawlspace debris (typical)

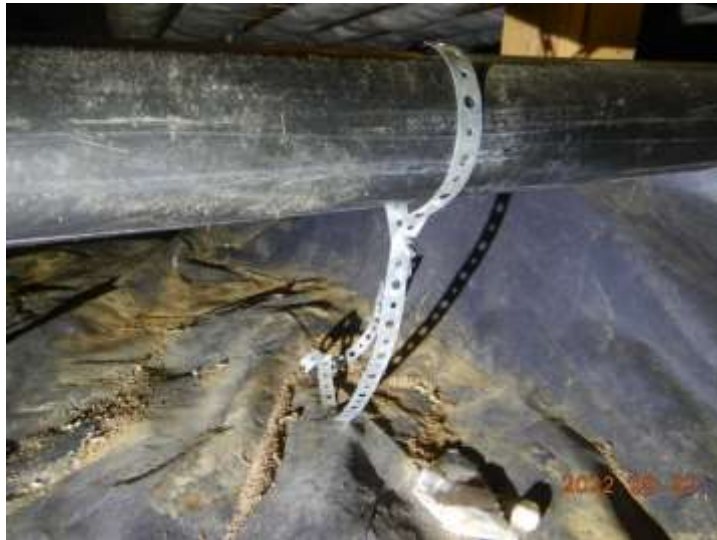
Waste lines: Appears satisfactory, except as noted below (the underside of the subfloor and waste line connections are typically not visible as underfloor insulation is not disturbed as part of a home inspection)
- A plumbing waste line is not properly supported as a support band is disconnected. Recommend review and repair by a licensed plumber.

Disconnected support band

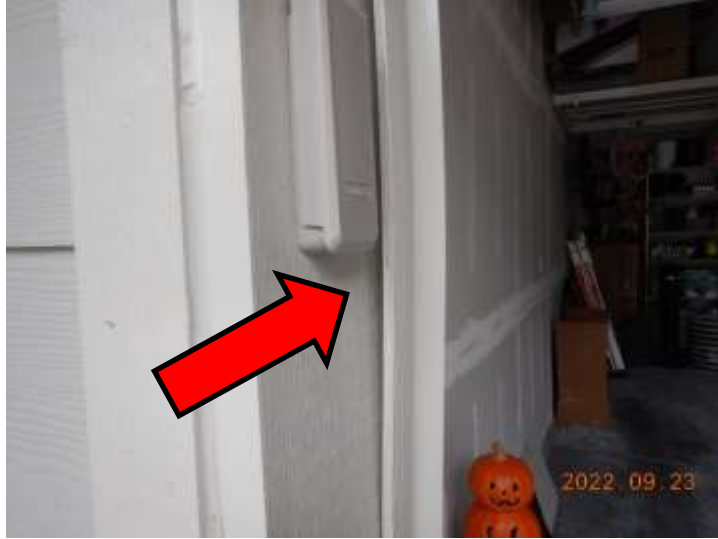
- Type: Metal roll up
- Door condition: No visible defects identified, except as noted below
- The weatherstripping at the side of the North garage door is loose.
- Springs and tracks: No visible defects identified
- Garage door openers: Yes
- Auto reverse of impact: The door was not tested for auto reverse on impact as this test can damage the door and/or opener
- Photo cell reverse sensors: The door(s) reversed when the photocell sensors were obstructed

Loose weatherstripping

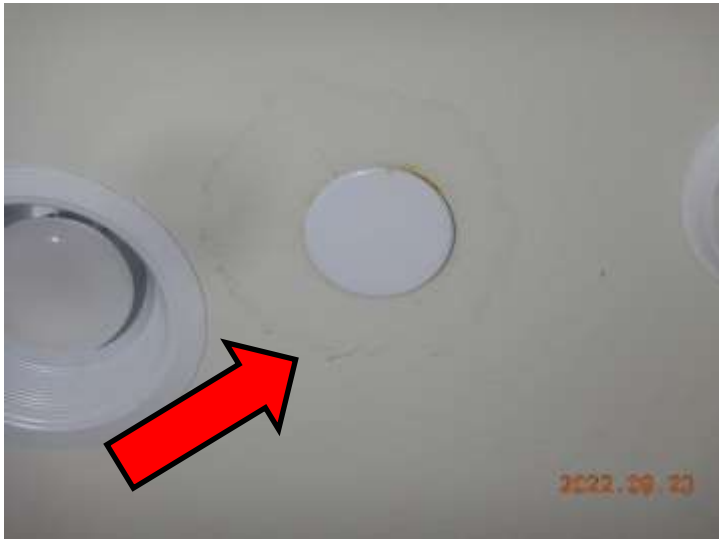
- There is evidence of leakage from a fire suppression head located at the Family room.
Recommend immediate review and repair as deemed necessary by a licensed plumber.

Moisture stains at the fire head

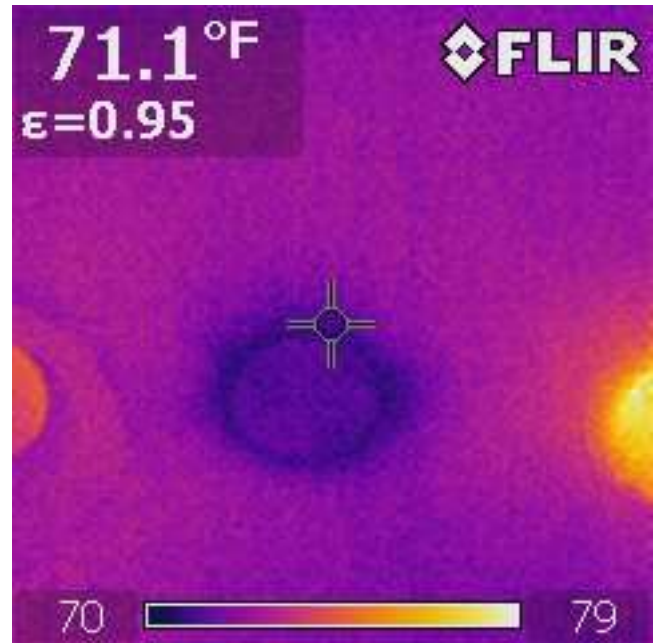
A moisture meter could not be used due to the metal trim plate, however this head gave a pronounced dark image compared to other heads when viewed with an infrared camera

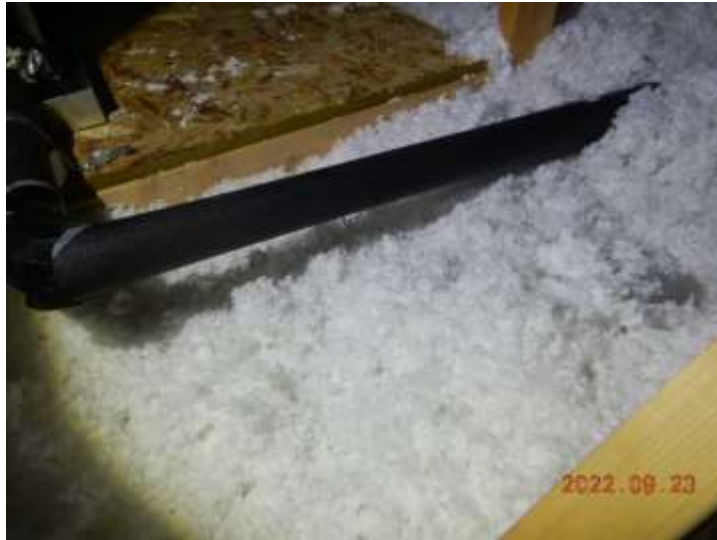
- Visibility: Space is vacant
Access location: Hallway
How viewed: From the attic access as traversing the attic will damage the blown in insulation
- The workspace in front of the furnace does not appear to be adequate or in compliance with IRC M1305 1.3.1. as a solid platform is to be installed from the attic access.

A solid platform is not installed
