Client:  
Address: xxxxxx, Black Diamond, WA 98010

Property Description: (2) story single family home  
Estimated property age: Built 2021 per King Co.  
Occupancy Status: Occupied

Inspection Date: 11/19/2022  
Inspection Time: 1:00 P.M. - 3:00 P.M. +-  
Weather Conditions: Overcast, 45 deg f +-

Hergert Inspection LLC

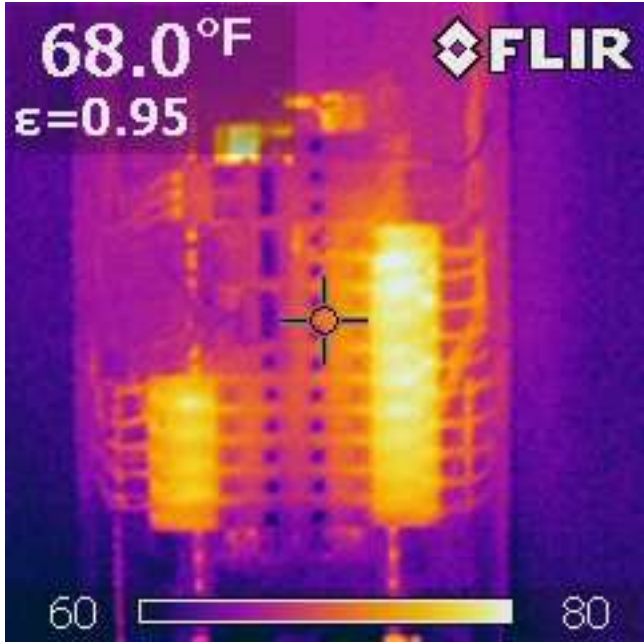
No evidence of overheating

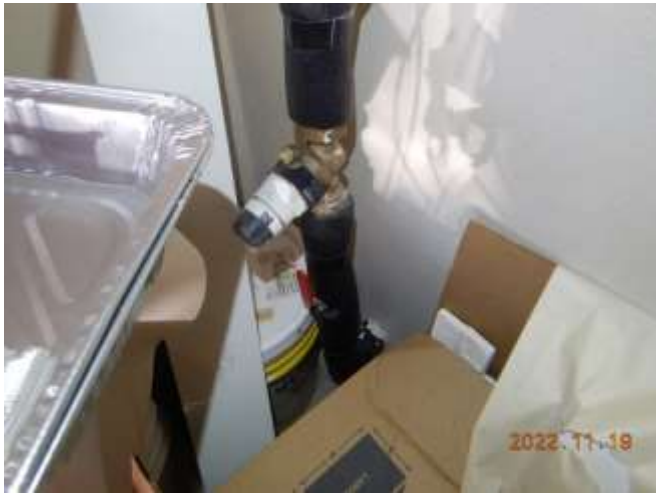
Domestic water shut off valve and pressure reducing valve

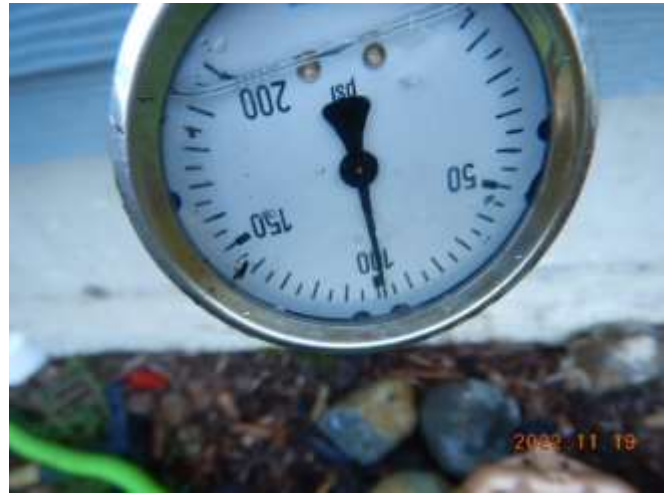
Measured water pressure: - The domestic water pressure of 100 PSI exceeds the maximum recommended pressure of 80 PSI. The excess pressure may result in premature pipe or plumbing fixture failure. Recommend adjustment to the pressure reducing valve or replacement of the valve if defective.

Water pressure is excessive (> 80 PSI)

- The domestic water pressure of 100 PSI exceeds the maximum recommended pressure of 80 PSI. The excess pressure may result in premature pipe or plumbing fixture failure. Recommend adjustment to the pressure reducing valve or replacement of the valve if defective.

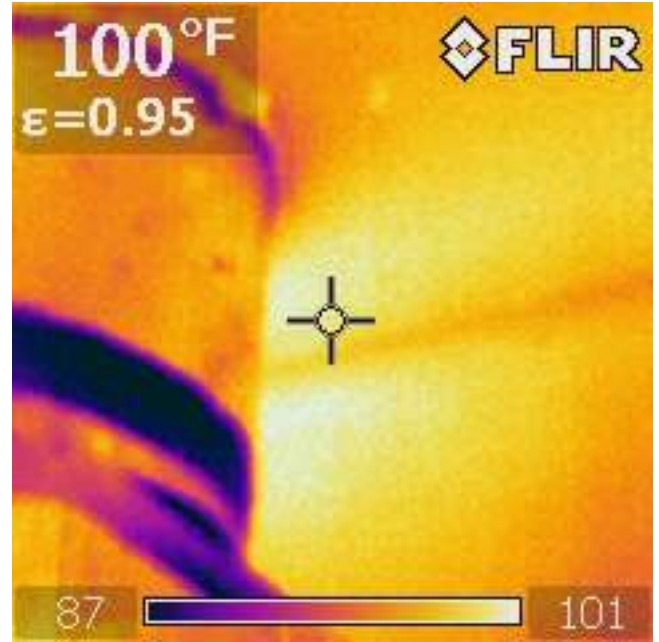
The furnace room is over 100 deg F

- There appears to be excessive heat produced from the heating system into the furnace room. Recommend review and repair as deemed necessary by a qualified technician.

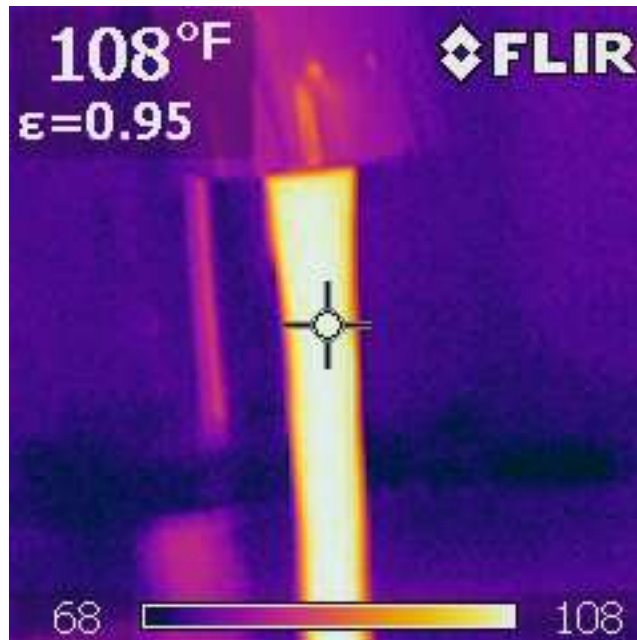
Measured temperature: 108 deg F

Hot water temperature

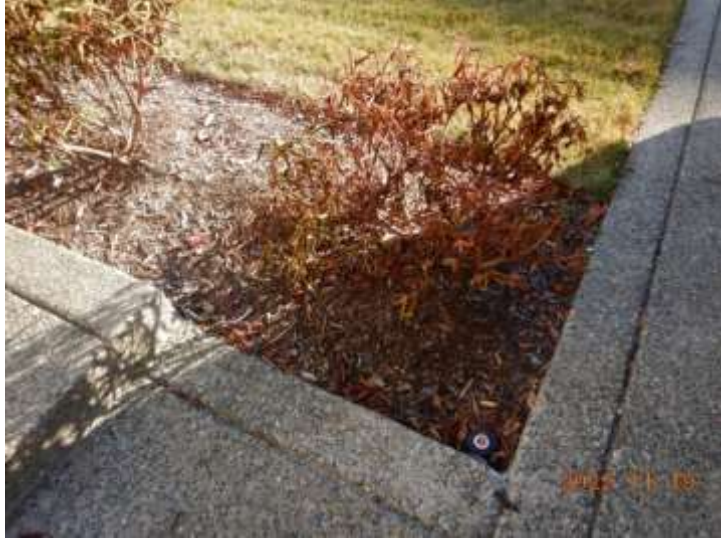
Dead landscaping

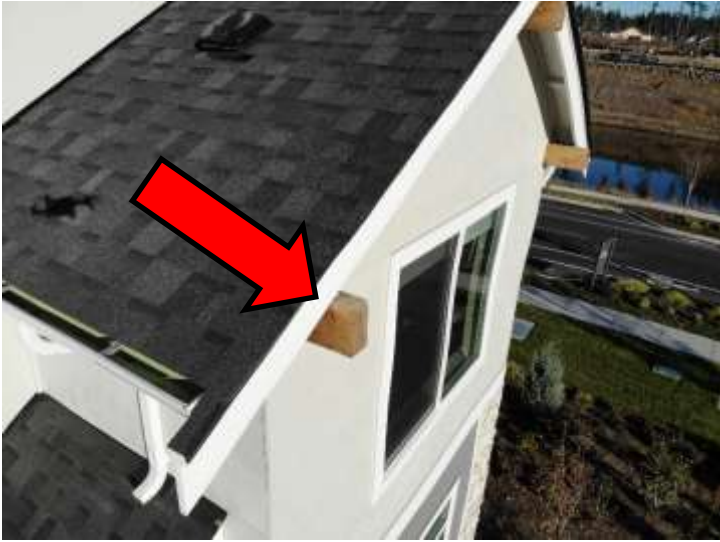
Exposed false beam

Exterior	EXT (1): Exposed top of false beams (typical)
Attic	There are no structural pests or substantive conducive conditions identified.
Interior/Garage	There are no structural pests or substantive conducive conditions identified.
Crawlspace	CRL (1): Missing vapor barrier

- The top of the false beams should be covered with metal flashing or roofing to prevent wood rot.
- There is debris build-up at the gutter located above the garage. Recommend this gutter be cleaned and verify that it is properly sloped.
- A cold weather shut off valve is provided for the front hose bib at the garage adjacent to the top of the stairs. This hose bib water supply should be shut off and the pipes drained at this time of year to prevent freezing related damage.

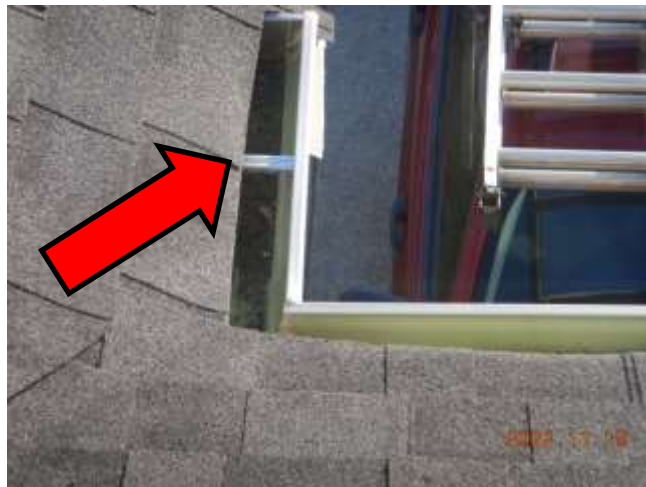
Debris build up at the gutter above the garage

- There is debris build-up at the gutter located above the garage. Recommend this gutter be cleaned and verify that it is properly sloped.

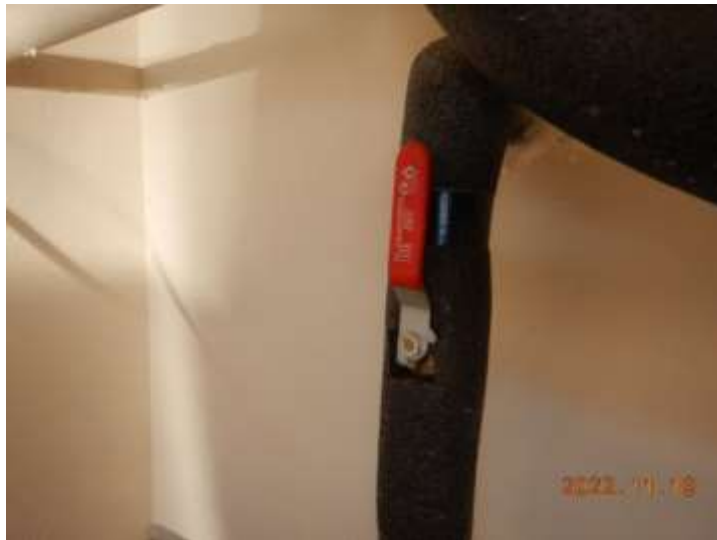
A cold weather shut off valve for the front hose bib is located in the garage

- A cold weather shut off valve is provided for the front hose bib at the garage adjacent to the top of the stairs. This hose bib water supply should be shut off and the pipes drained at this time of year to prevent freezing related damage.

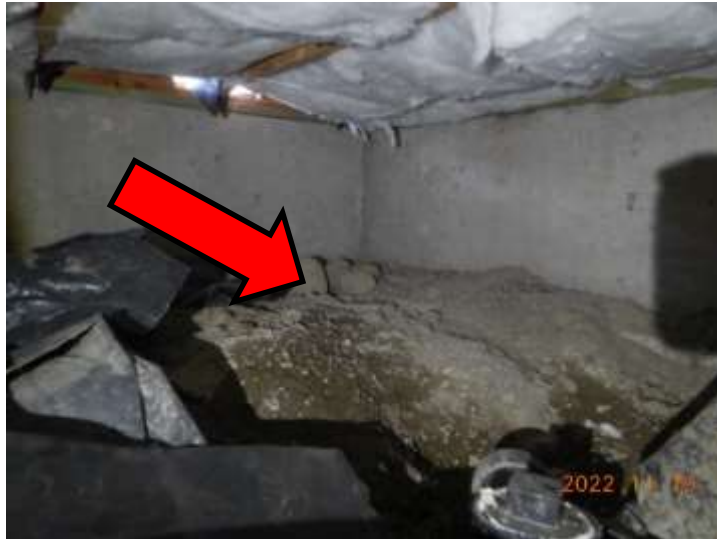
Ventilation: Appears adequate  
Vapor Barrier: Appears adequate, except as noted below  
- The vapor barrier is fully installed in the crawlspace at the area below the entryway. The purpose of the vapor barrier is to prevent moisture in the ground from rising up into the home.  
Moisture Intrusion: No visible evidence of current moisture intrusion  
Sump Pump: None located

Missing vapor barrier

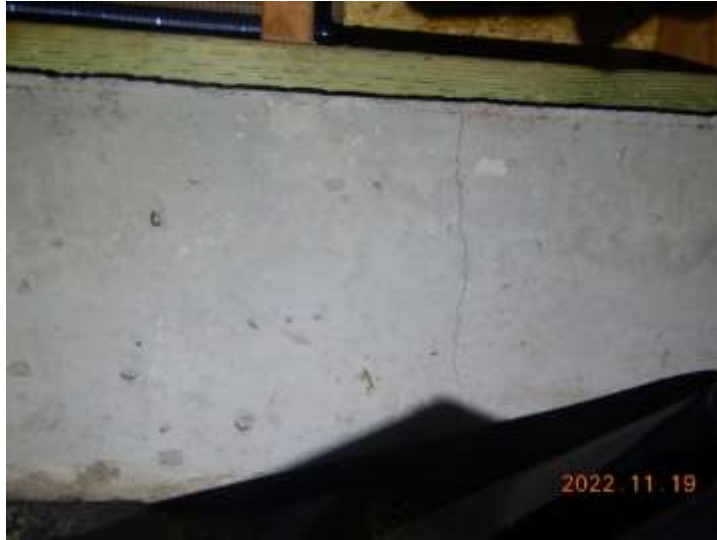
Minor crack at the foundation wall.,

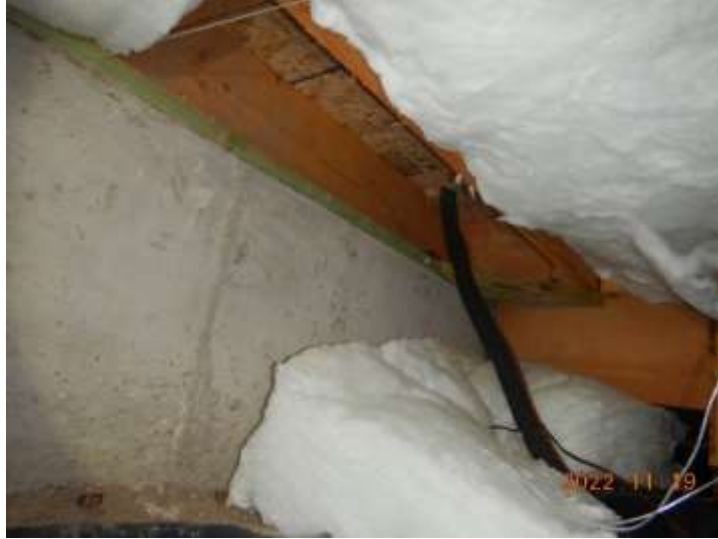
- There is a section of missing underfloor insulation (at the area where the air conditioning lines enter the underfloor).

Missing underfloor insulation

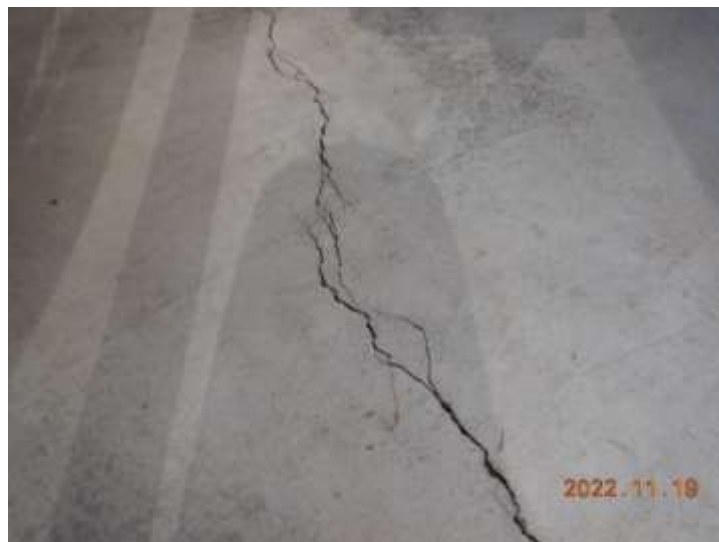
Crack at the garage slab

- Visibility: Space is occupied
- Structural Movement: No visible evidence of substantive structural movement
- Moisture Intrusion: No visible evidence identified
- Walls: No visible defects identified
- Ceiling: No visible defects, except as noted below
- The ceiling of the garage is not painted white. Per owner, the ceilings were all to be painted white per a paid upgrade.
- Slab: Overall satisfactory. Minor horizontal shrinkage cracks are typically not a concern
- There is a substantive crack at the garage slab. Recommend continue to monitor for vertical displacement.

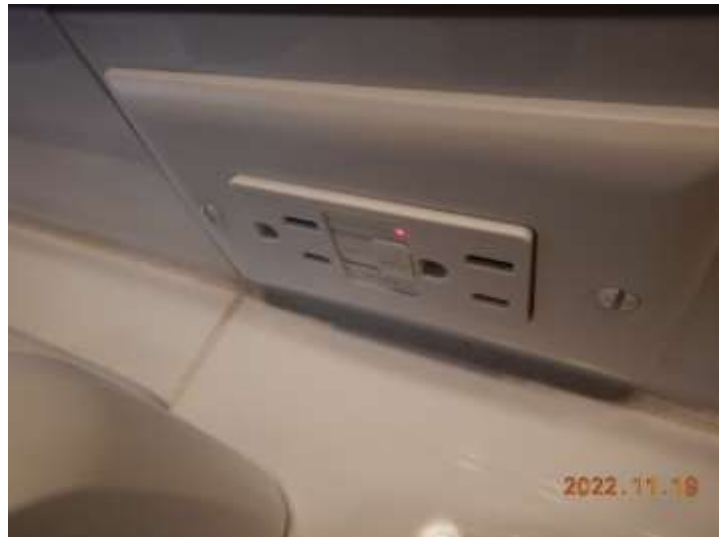
This GFCI reset outlet is the reset outlet for all of the bathroom electrical outlets throughout the home

- The GFCI reset outlet located in this space provides GFCI protection for all of the bathroom electrical outlets within the house. If electricity is inactive at any of the bathroom outlets, this GFCI reset likely needs to be re-set.
