(425) 652-6515
www.Hergert.com
Kevin @ Hergert.com
Wa. Home Inspector 619
WSDA Inspector 79988
WSDA Control # 11719AQ-021

Client:
Address: xxxxx, Marysville, Wa

Property Description: (2) story single family home
Estimated property age: Built 2021 +-
Occupancy Status: Occupied

Inspection Date: 12/29/2022
Inspection Time: 9:30 A.M. - 11:30 A.M. +-
Weather Conditions: Overcast, 45 deg f +-

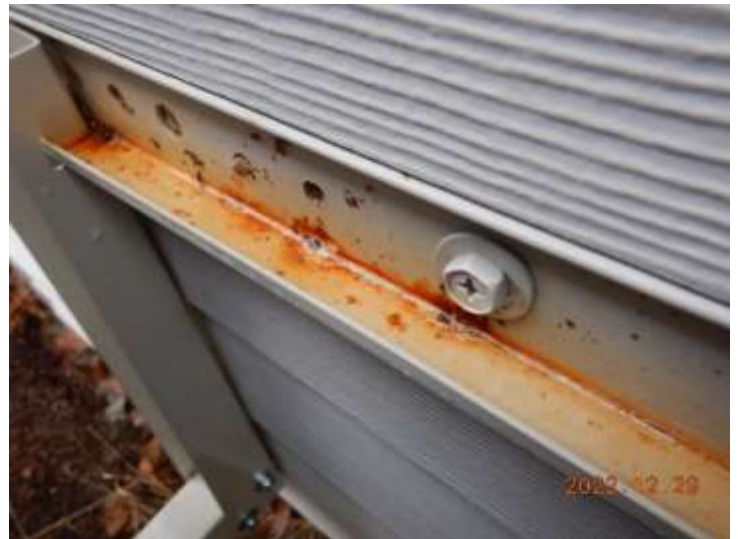
- There is discoloration at the mounting bracket located at the exterior component of the ductless heat pump. If this discoloration is rust, the materials should be properly treated to prevent deterioration.

Discoloration at the exterior mounting bracket

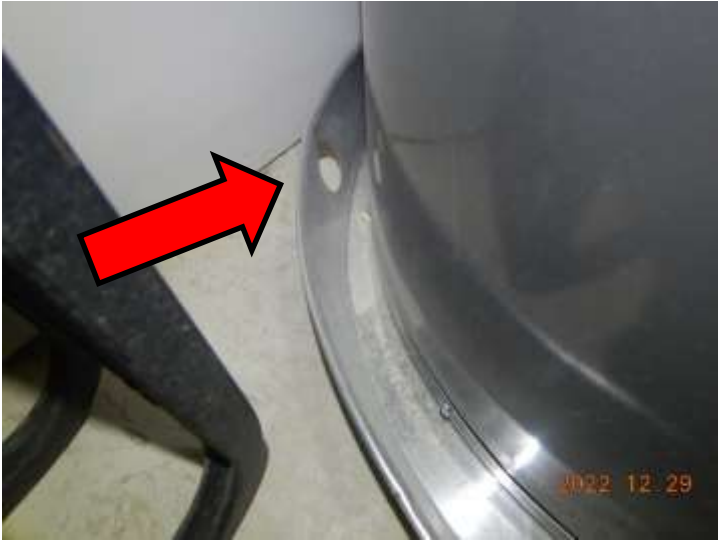
- The drip pan does not have an outfall to the exterior. The drip pan should be sealed and a drain line extended to the garage slab. As this tank is set on the sub-floor, leakage can result in damage to the adjacent living spaces.

Open drip pan

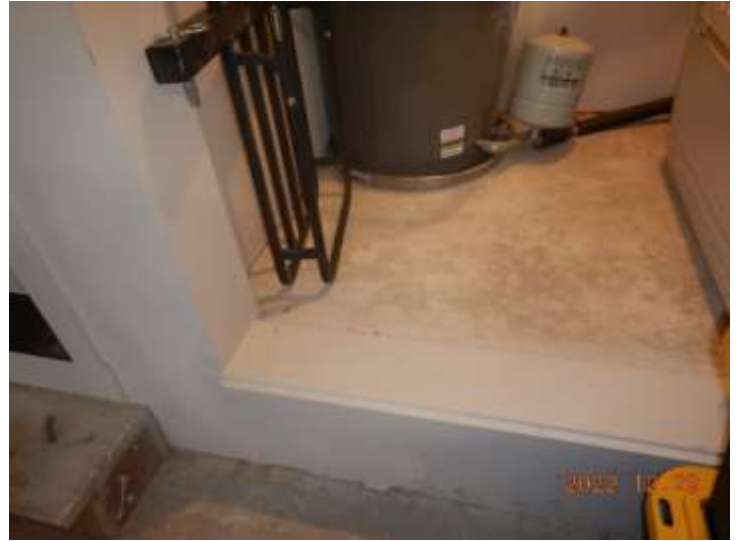
A drain line should extend to the garage slab

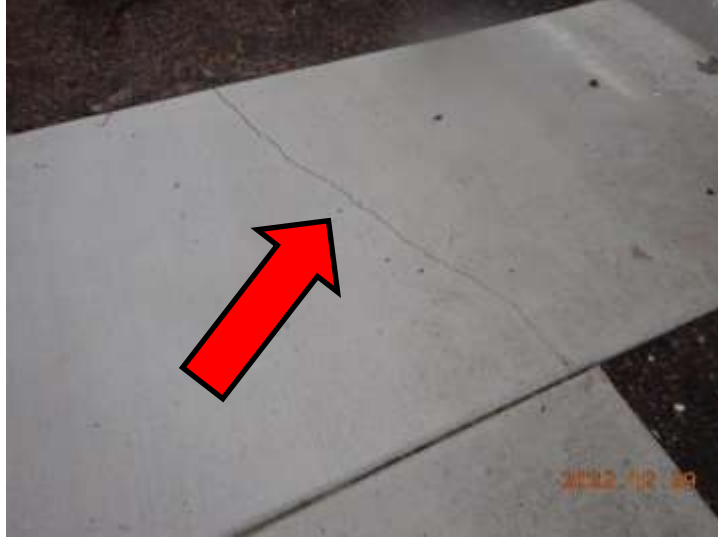
- There is a substantive crack located at the front walkway. This crack is likely related to inadequate compaction and or water saturation of the ground below the walkway.
- The sewer cleanout located adjacent to the floor 1 bedroom should be cut to grade and capped.
- A landscape plant located adjacent to the right side of the driveway appears to be dead.
- There is standing water above the top of the washed rock at the French drain located at the rear yard. This standing water indicates that the system is not functioning as designed. See the comment in the Crawlspace section regarding moisture.

Cracked walkway

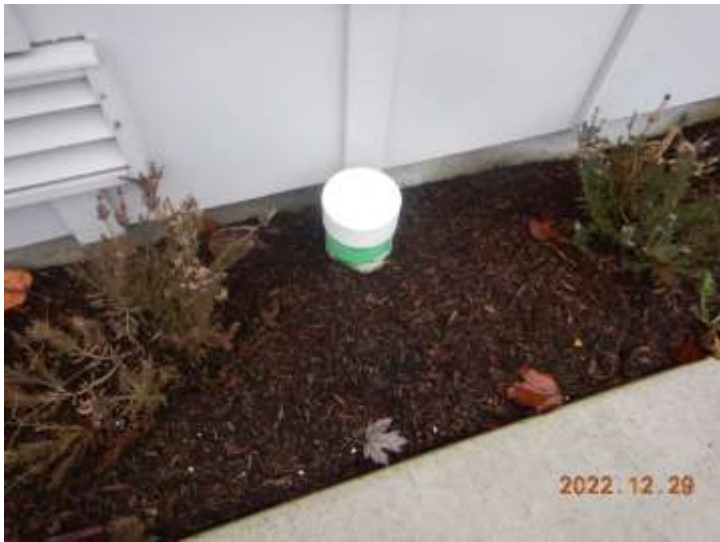
Sewer line cleanout above grade

- The sewer cleanout located adjacent to the floor 1 bedroom should be cut to grade and capped.
- A landscape plant located adjacent to the right side of the driveway appears to be dead.
- There is standing water above the top of the washed rock at the French drain located at the rear yard. This standing water indicates that the system is not functioning as designed. See the comment in the Crawlspace section regarding moisture.

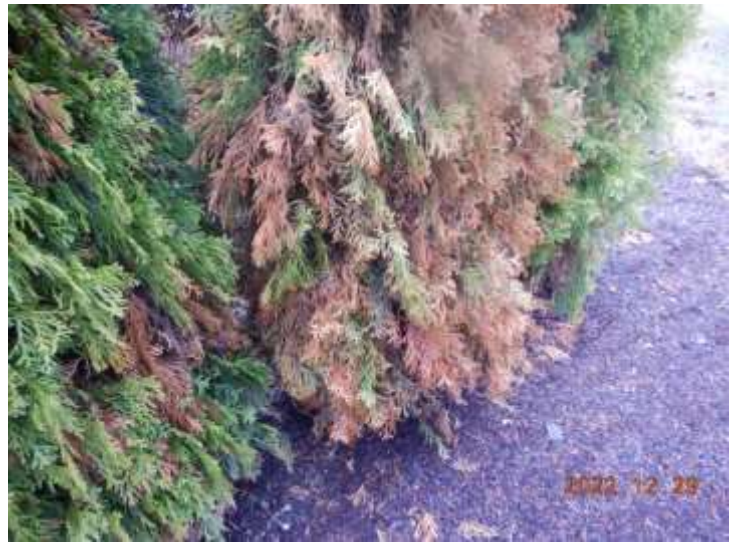
Dead vegetation

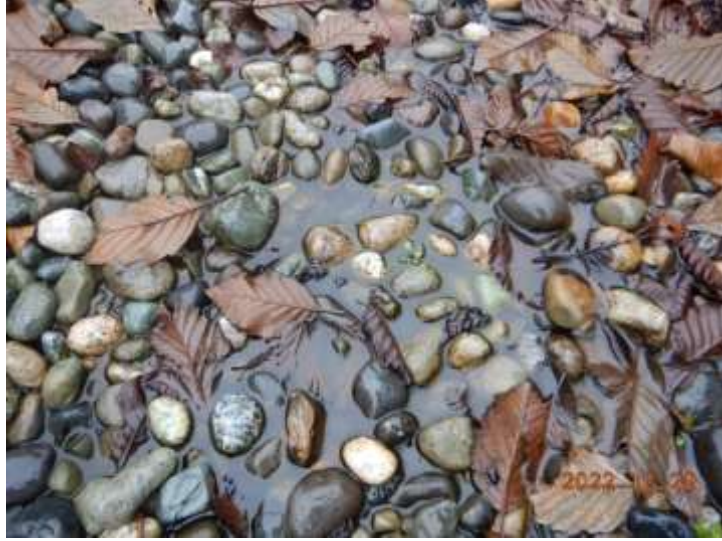
Standing water in the French drain
(multiple locations)

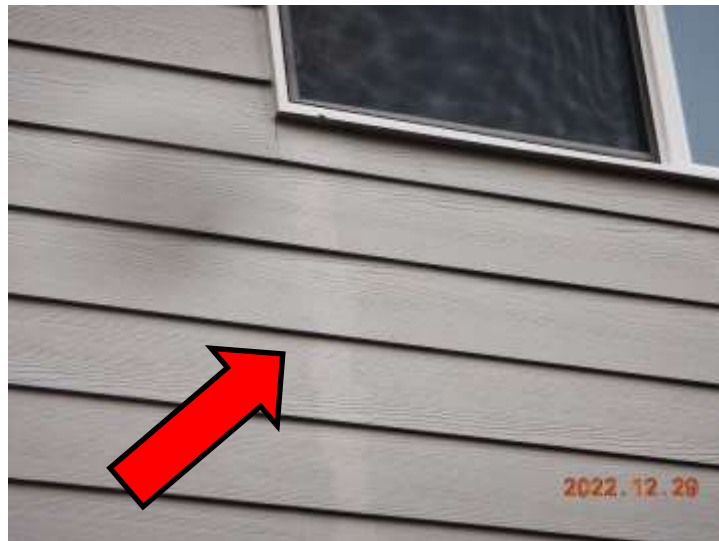
Discoloration of the paint

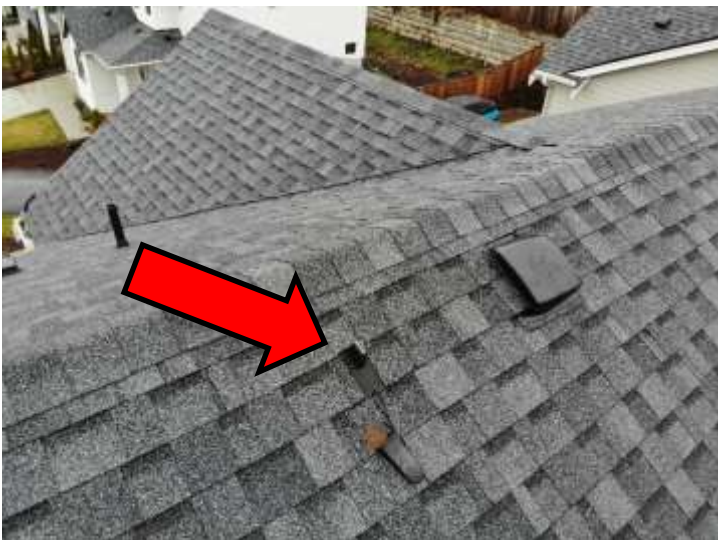
Fall protection anchor cover not installed

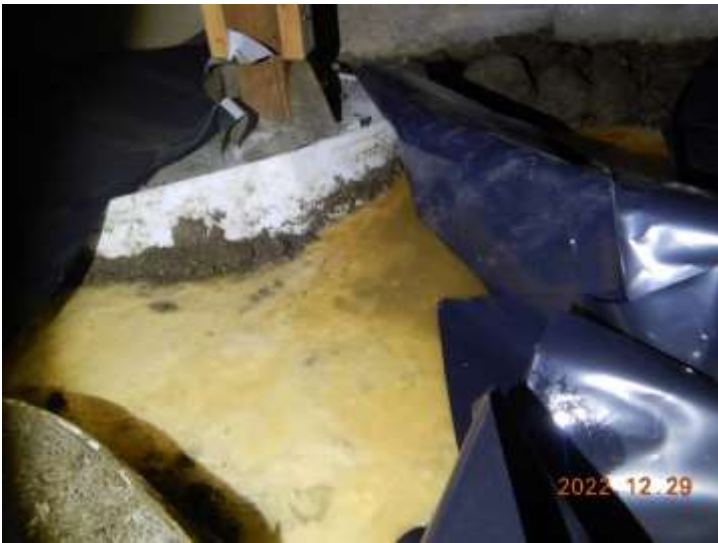
Ventilation: Appears adequate
Vapor Barrier: Appears adequate
Moisture Intrusion: - There is evidence of active moisture intrusion at the crawlspace at multiple locations. Recommend further review by a qualified drainage contractor. Note: the French drain located at the side yard appears to be very shallow, therefore will only contain surface water.
Sump Pump: None located

Standing water in the vicinity of the crawlspace access

- There is evidence of active moisture intrusion at the crawlspace at multiple locations. Recommend further review by a qualified drainage contractor. Note: the French drain located at the side yard appears to be very shallow, therefore will only contain surface water.
- There is no under floor insulation installed below a section of floor 1 at the area in the vicinity of the floor 1 bathroom.

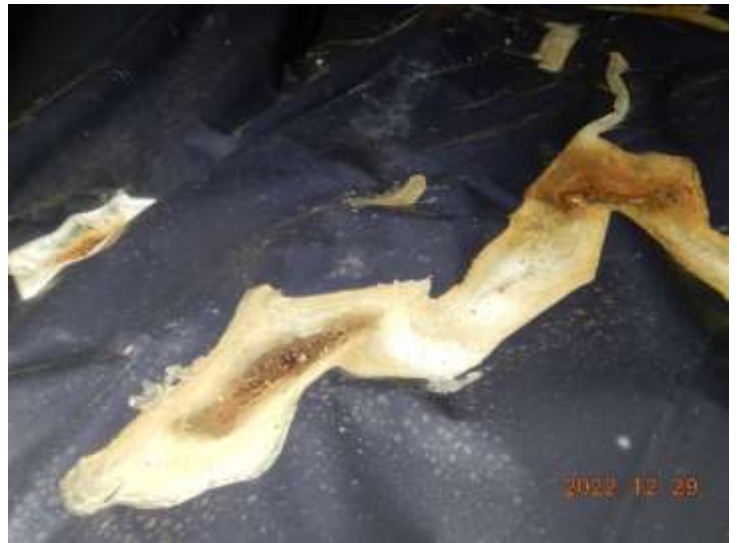
Moisture stains near a seam in the vapor barrier

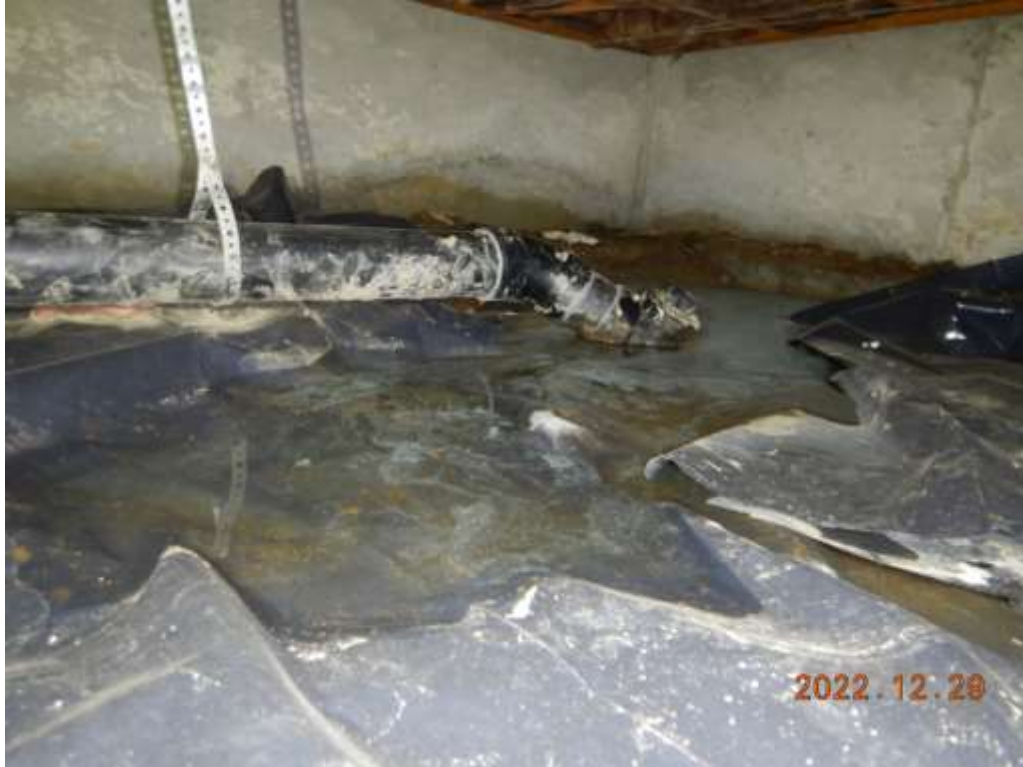
Standing water at the area below the floor 1 bedroom

| CRL (1): Standing water in the Crawlspace. WDO conducive condition. | |

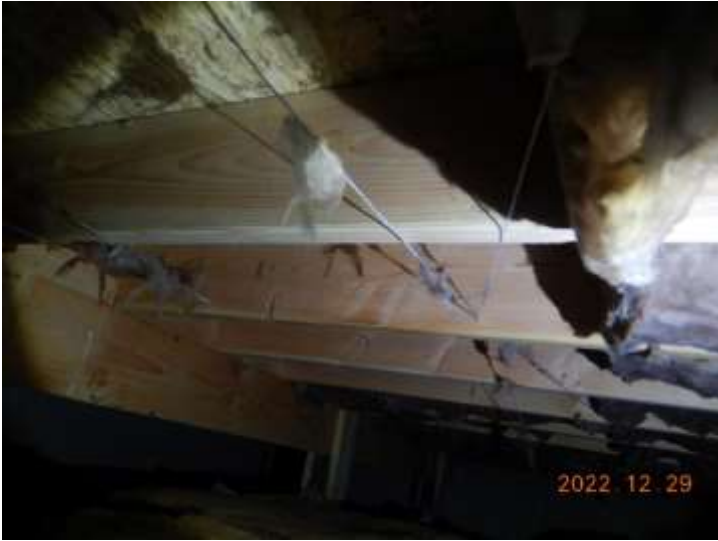
- Under-floor: Appears satisfactory, except as noted below
- There is no under floor insulation installed below a section of floor 1 at the area in the vicinity of the floor 1 bathroom.
- Domestic Water Pipes: Appears satisfactory

Missing insulation

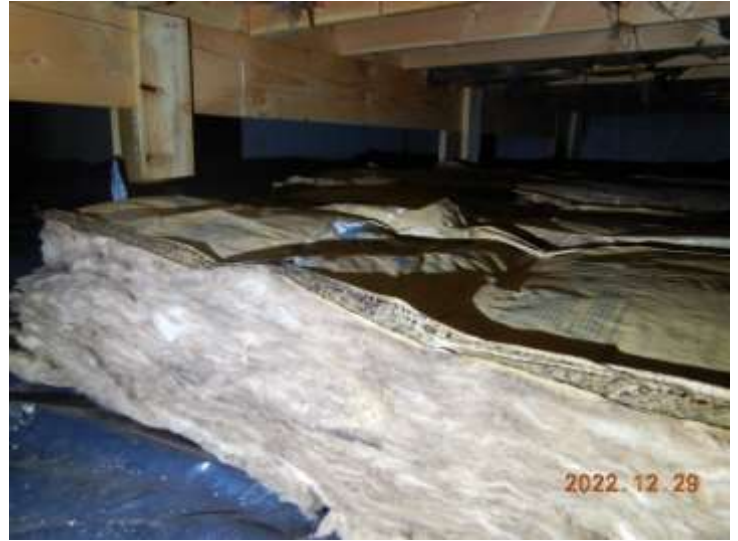
Insulation laying on the vapor barrier

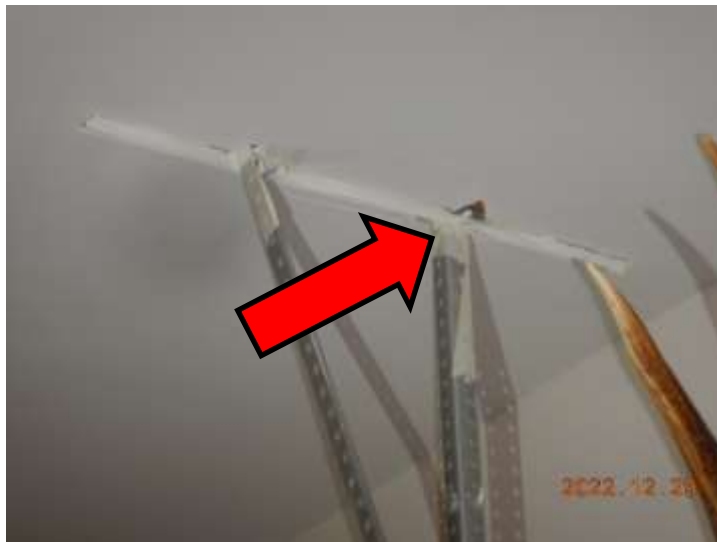
Holes at the ceiling of the garage

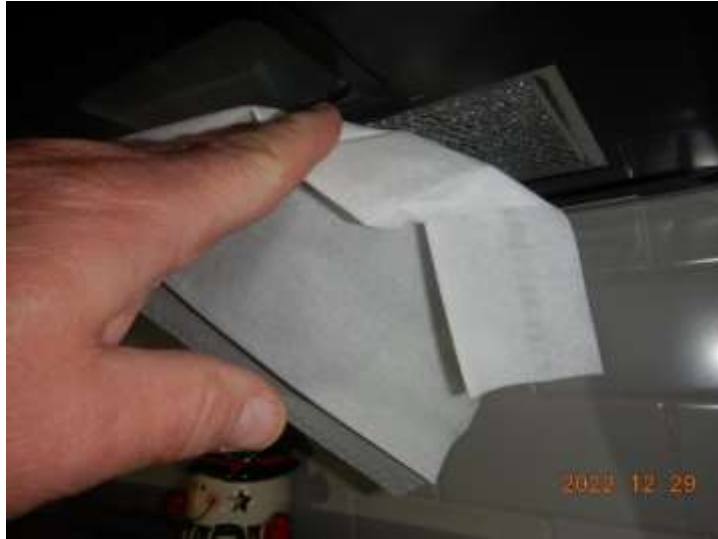
- There is no air draw at the ventilation system. Recommend review and repair by a qualified technician.

The ventilation system cannot lift a tissue when set to the “high” position
