(425) 652-6515
www.Hergert.com
Kevin @ Hergert.com
Wa. Home Inspector 619
WSDA Inspector 79988
WSDA Control # 10961AQ-02

Property Description: (1) story single family home
Estimated property age: Built 1956 per listing
Occupancy Status: Vacant

Inspection Date: 11/08/2018
Inspection Time: 1:00 P.M. - 3:00 P.M. +-
Weather Conditions: Clear, 50 deg f +-

Hergert Inspection LLC

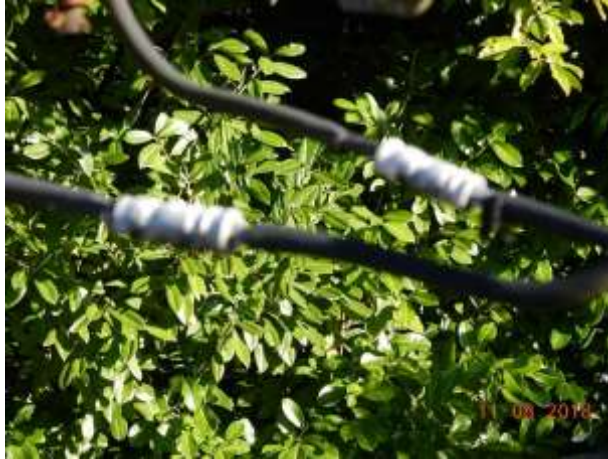
Type: Overhead
Meter Location: Rear of building
- The electrical connection from the service drop to the masthead should be wrapped with a non metallic material. This work should only be done by PSE or a licensed electrician

The connections are exposed

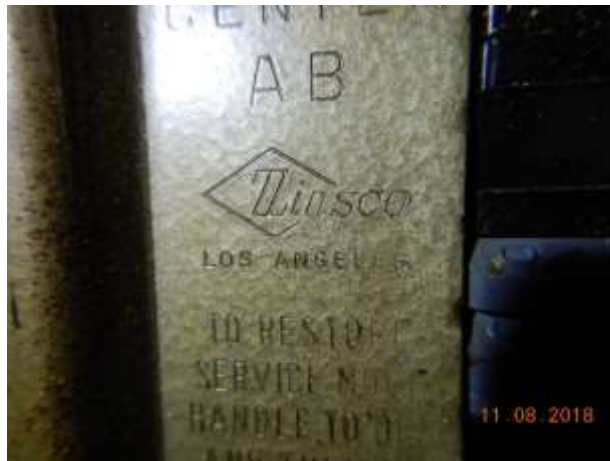
Location: Dining Room
Manufacturer: Zinsco
- The home is equipped with a Zinsco brand panel. Zinsco components are considered problematic by industry professionals due to their high failure rate. Failure of any component within the electrical system may result in fire and/or electrocution. Evaluation of the panel by a qualified electrician is advised to determine its safety, integrity and performance

Zinsco brand panel

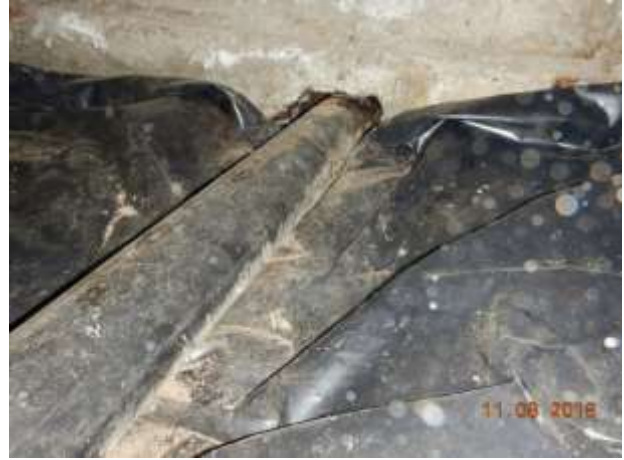
- Discharge: Public sewer per listing; not included in this inspection
House Piping: ABS, steel, and cast iron where visible
- Recommend a sewer scope due to the age of the property (or verification that the side sewer is "newer")

The side sewer may be “newer” as the pipe that exists the home is ABS (a newer material)

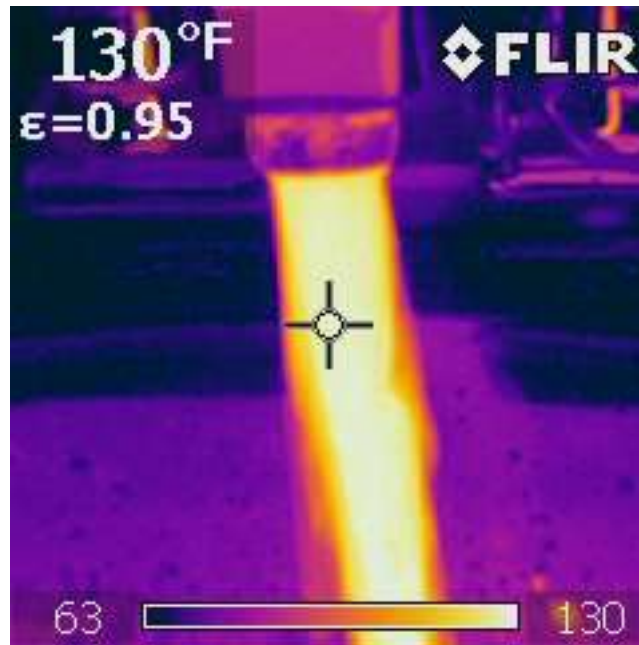
- TPR valve: As per required
Earthquake Straps: Installed
Safe water temperature: 120 deg F per industry standards
Measured temperature: - The water temperature was measured at 130 deg F; this temperature is above the recommended setting of 120 deg F. This adjustment is typically a simple adjustment to the water heater thermostat

Hot water temperature

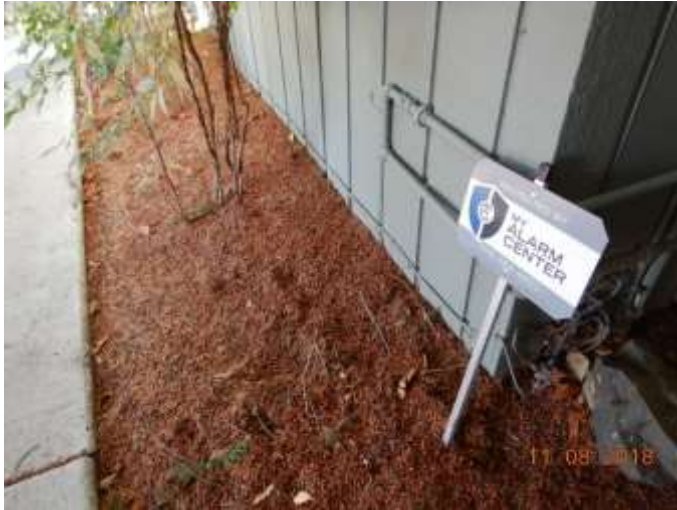
Ground in contact with the structure
(WDO conducive condition)

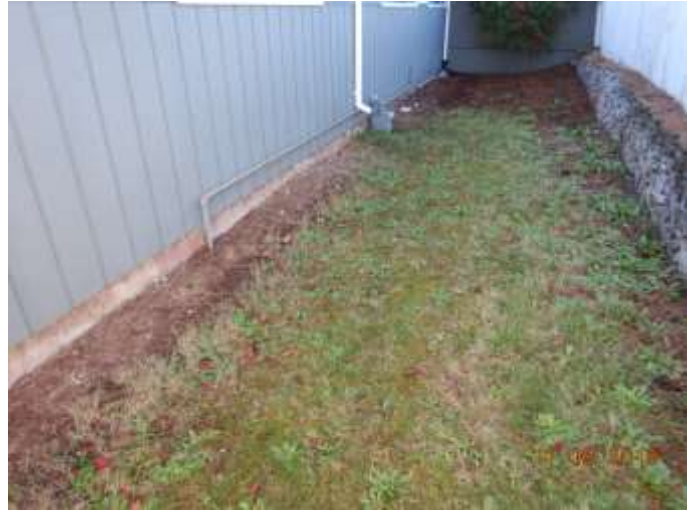
Reverse grade
(WDO conducive condition)

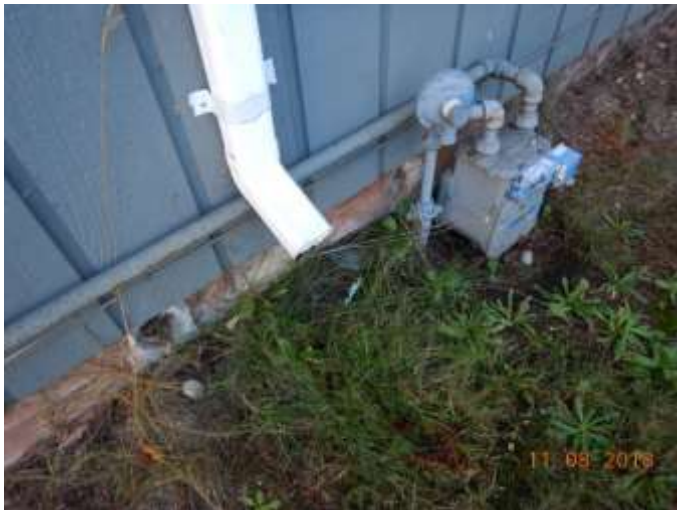
Splash blocks should be installed

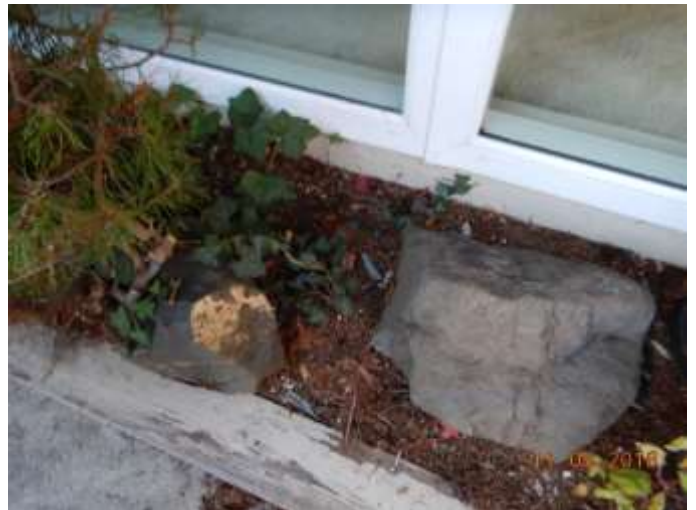
Ground in contact with the structure
(WDO conducive condition)

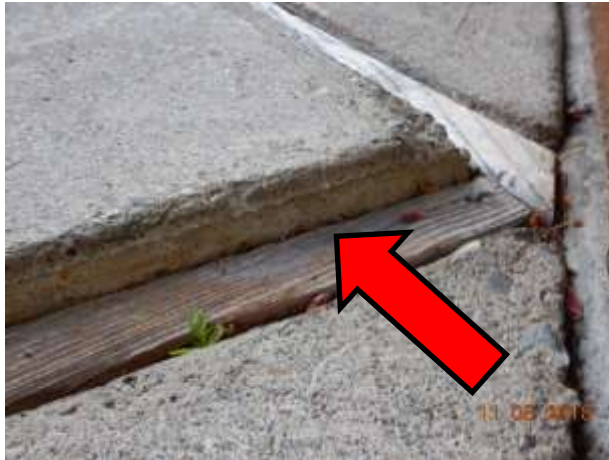
Type: Concrete
Condition: Satisfactory
Trip Hazard: - There is substantial vertical displacement of the South yard patio. A trip hazard exists due to the raised edges

Trip hazard

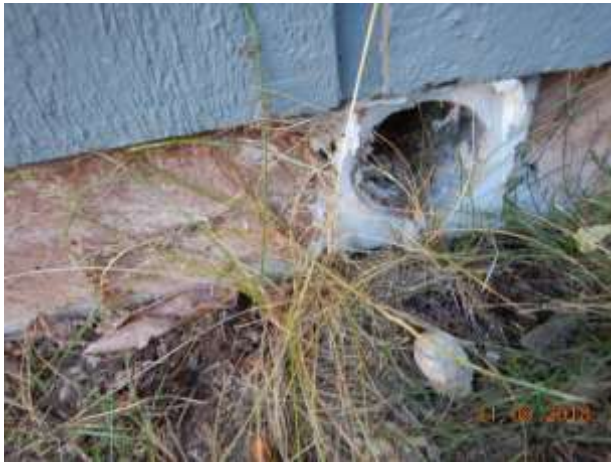
A vent flap is not installed

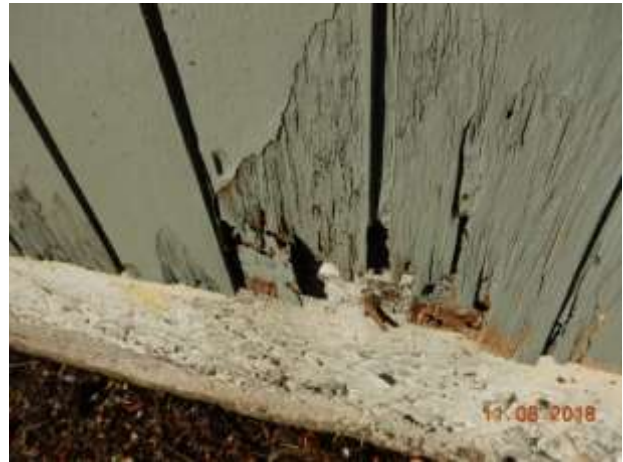
Wood rot at the garage siding

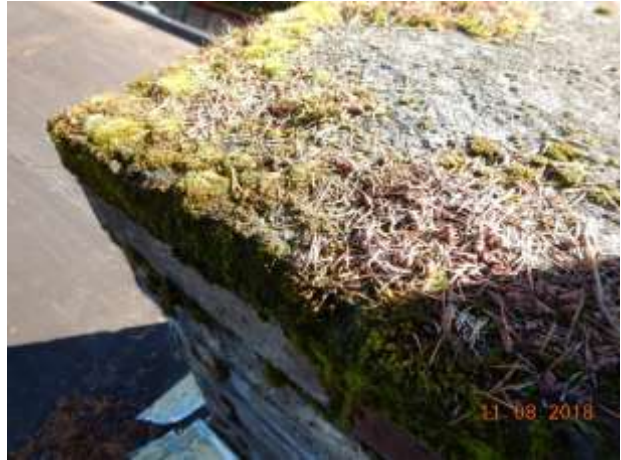
Moss on the chimney

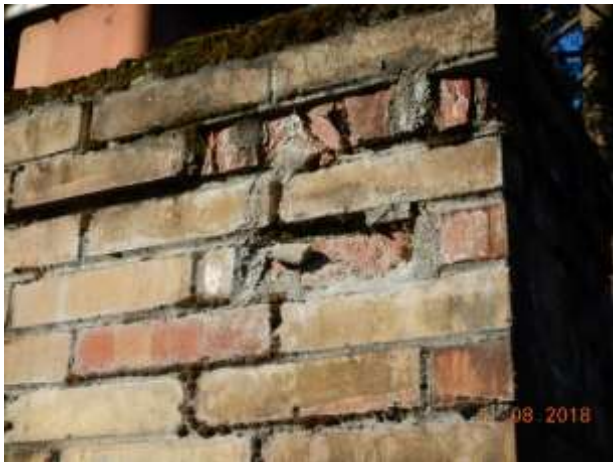
Evidence of spalling at the chimney

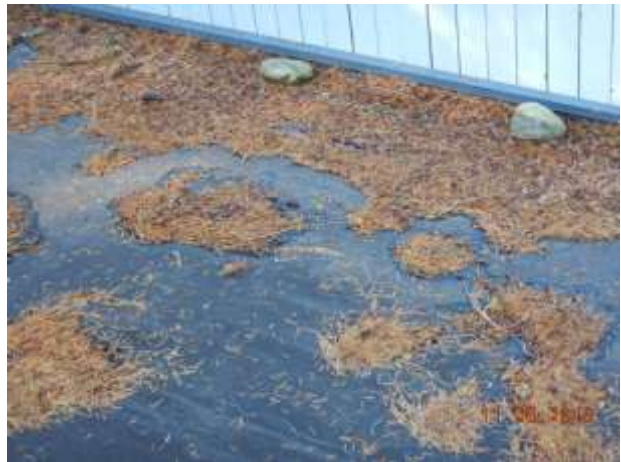
Debris on the roof

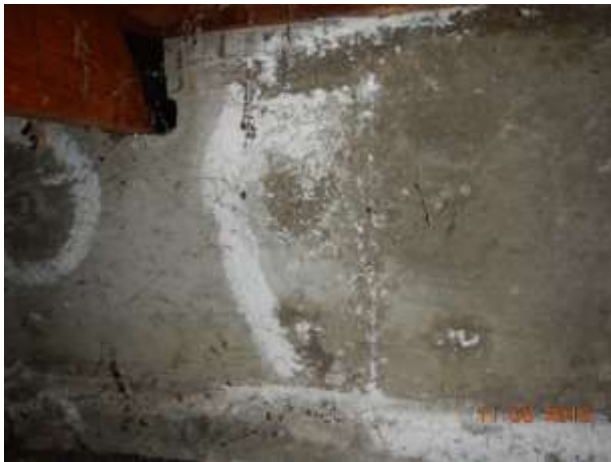
The white is evidence of excessive moisture at the exterior. No moisture intrusion is evident

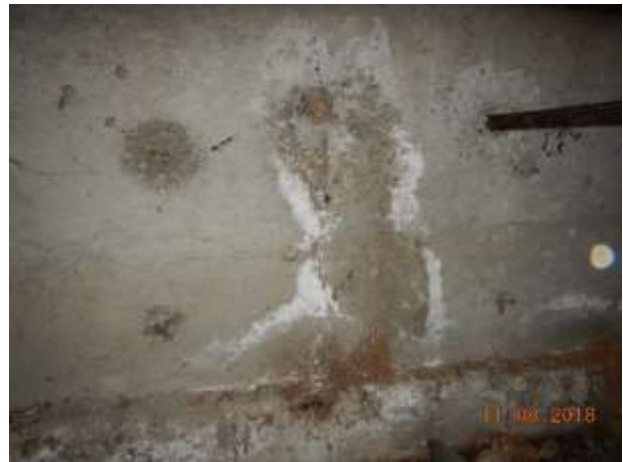
Minor area of concrete spalling off the wall

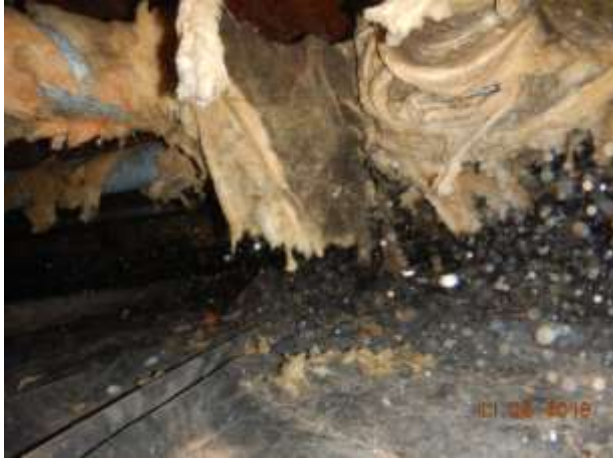
Visible Evidence: - There is evidence of rodent activity in the crawlspace. Recommend review of the crawlspace by a qualified exterminator to locate and seal all potential points of entry and extermination as needed. A gap is visible at a foundation vent at the North wall and the crawlspace access panel does not properly fit the access space
Tip: Rodents are a common problem in crawlspaces. Recommend a proactive approach by setting rodent traps

Torn insulation from rodents

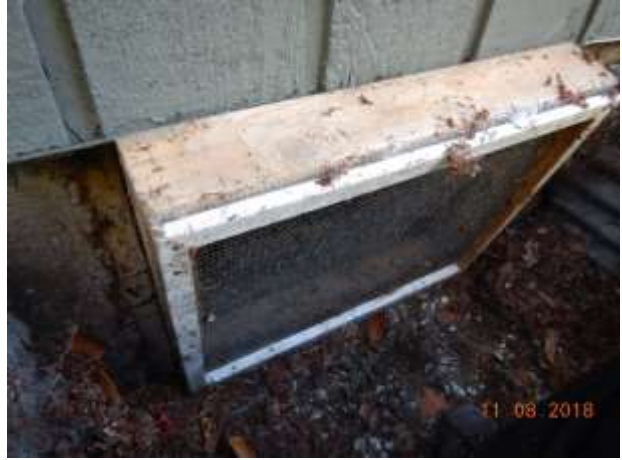
The access panel will not fit

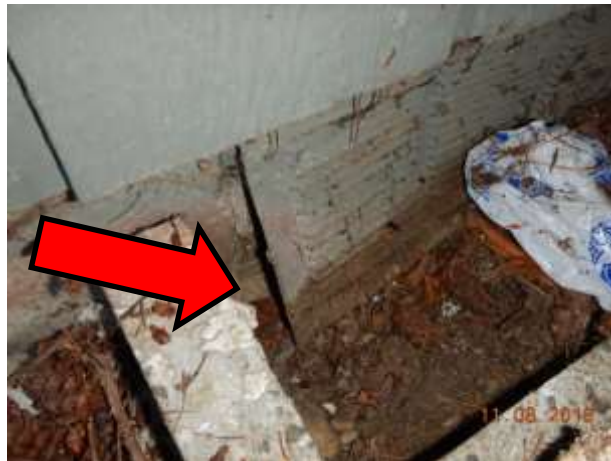
Gap at a crawlspace vent

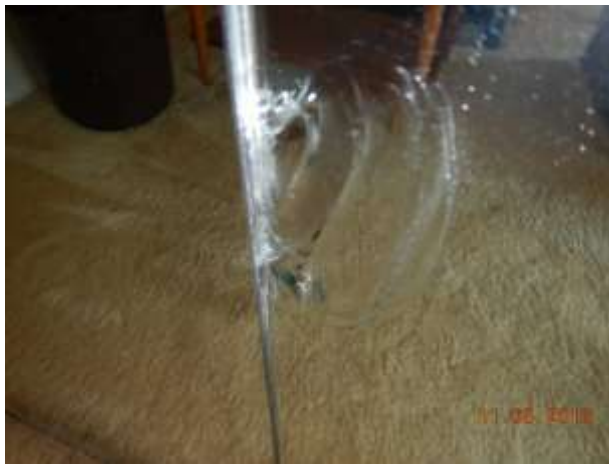
Visibility: Room is occupied
Structural Movement: No visible evidence of substantive structural movement
Moisture Intrusion: No visible evidence
Walls: - A section of the wall mounted mirror is broken
Ceiling: Satisfactory
Flooring: Satisfactory

Broken mirror

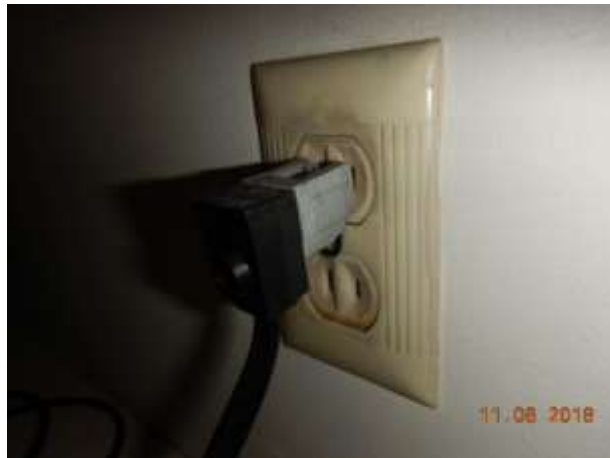
The electrical outlet for the clothes washer is not grounded

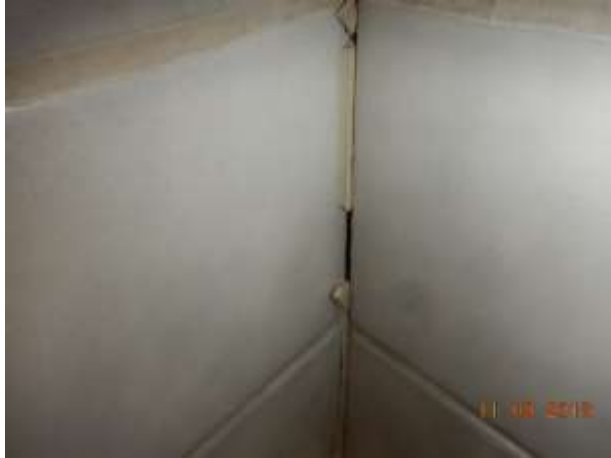
Overall functional flow: Appears adequate
Sink(s): No visible defects or leakage identified
Bathtub-Shower: No visible defects or leakage identified
- Recommend re-grouting the shower walls as needed
Toilet: No visible defects or leakage identified

Gaps at the shower wall grout

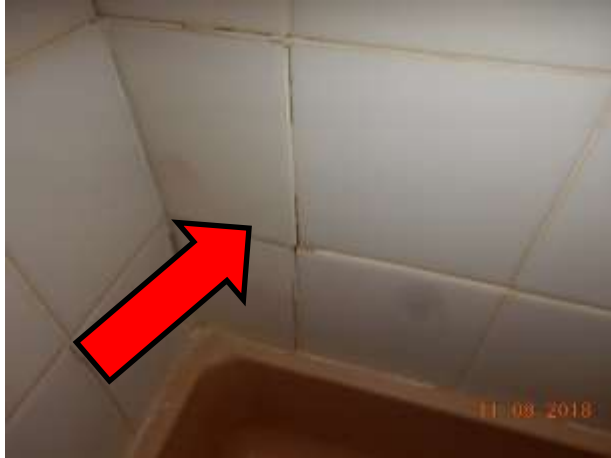
Overall functional flow: Appears adequate
Sink(s): No visible defects or leakage identified
Shower: - There are loose tiles at the shower walls. The wall behind these tiles is likely damaged
Shower Door: The shower door is in satisfactory condition
Toilet: No visible defects or leakage identified

Loose tiles at the shower wall
