Property Description: Multi-level home
Property age/ size: Built 1958, 2,320 s.f. per King County Assessor
Occupancy Status: Occupied

Inspection Date: 01/21/2012
Inspection Time: 2:00 P.M. – 3:30 P.M. +-
Weather Conditions: Overcast, 40 deg F +-

Hergert Inspection LLC

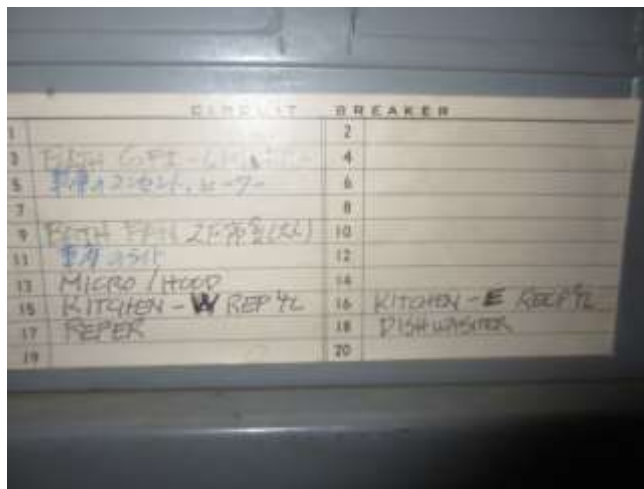
Location: Basement mechanical room
Manufacturer: Murray
Panel Rating: 100 AMP
Main Disconnect: 100 AMP
Serv. wire Size/ Rating: 100 AMP
Sub-panel: No
Grounding: Copper to plumbing, limited visibility
Panel Clearance: 30" wide, 3' in front as required
- Circuit breaker legend is not complete and not all written in English. Unable to verify purpose of each circuit and appropriate sizing of the breakers

Incomplete circuit legend

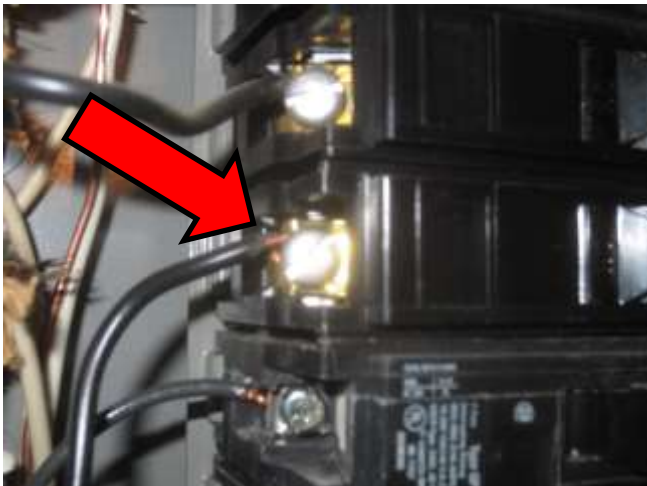
Type: Copper romex
Breakers: - Breakers is double tapped. Recommend review by a licensed electrician

Double tapped breaker

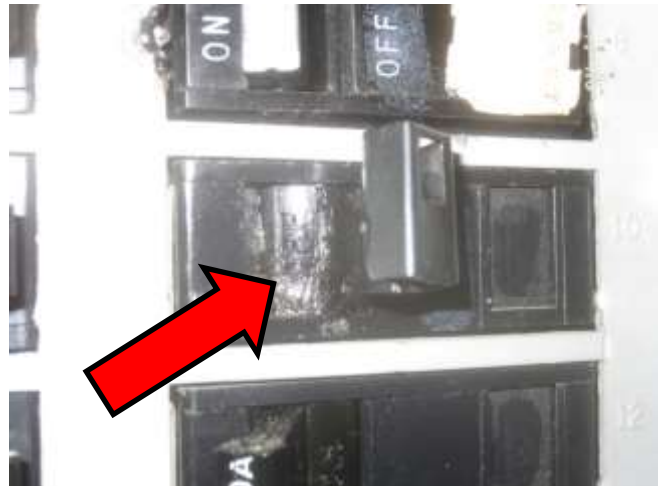
Breaker in off position
Unknown purpose of this breaker

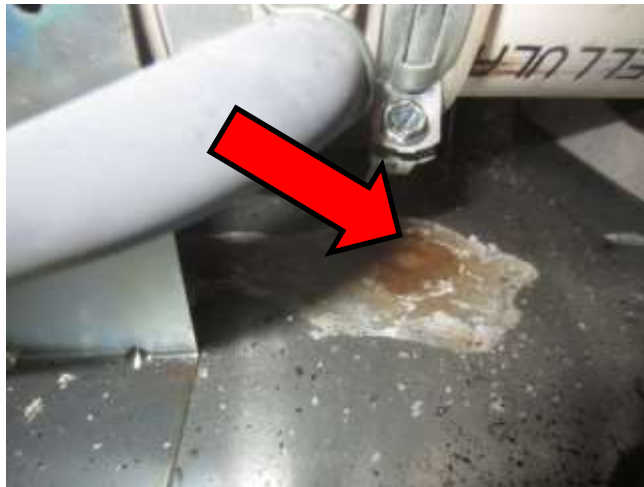
- Recommend servicing of furnace by a licensed furnace technician and every (2) years thereafter. There is no visible tag that this furnace has ever been serviced. Evidence of condensate leakage near flue inside furnace

Condensate inside of furnace

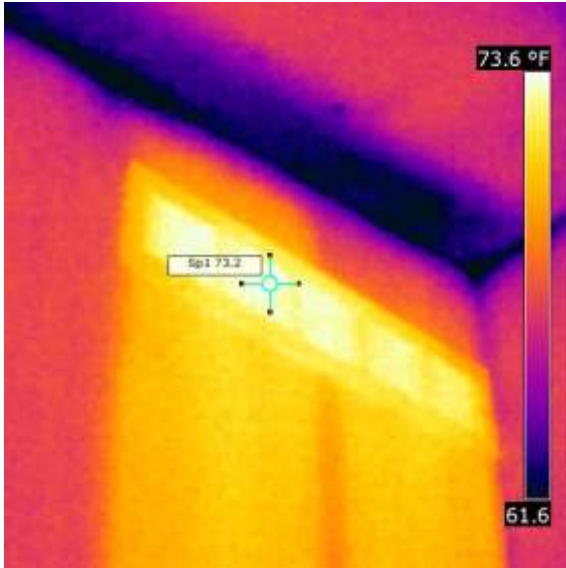
Rating: 40-70 deg F
@ return air: 72 deg F
@ nearest register: 106 deg F
Heat Gain: 34 deg F.- *Heat gain is below specifications of furnace. See comment above about furnace servicing*

Temperature measured at return air

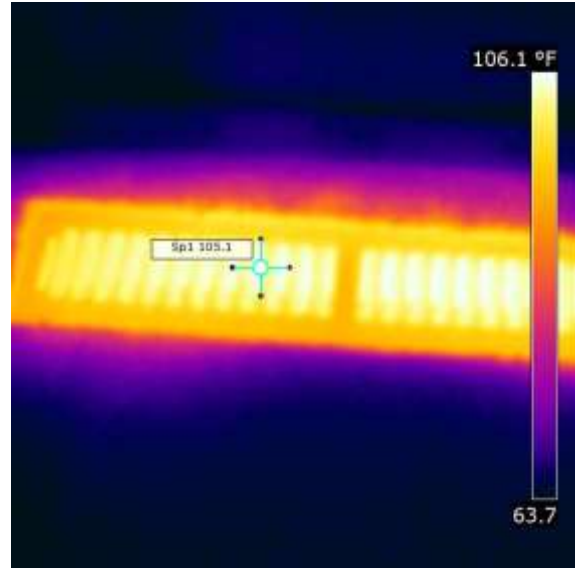
Temperature measured at heat register

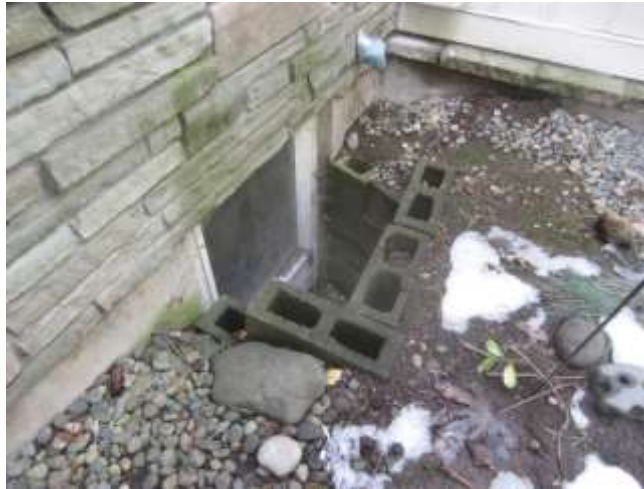
Fall hazard into window well and adjacent non-tempered glass window

Type: Concrete
Condition: Satisfactory
Trip Hazard: None
Barricades: As required
- Recommend safety barricade around window well to mechanical room

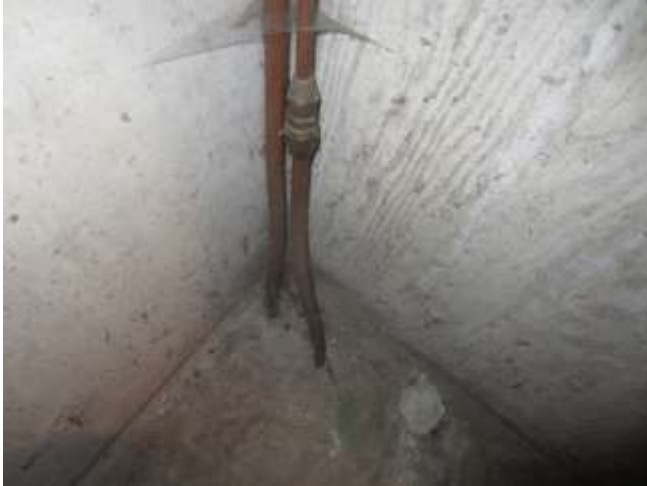
Overhead Power Lines: N/A
Retaining Walls: None that affect structure
Underground Oil Tank: - Evidence of prior exterior oil tank. Unable to locate vents for a buried tank
Irrigation System: None visible

Oil tank lines in basement

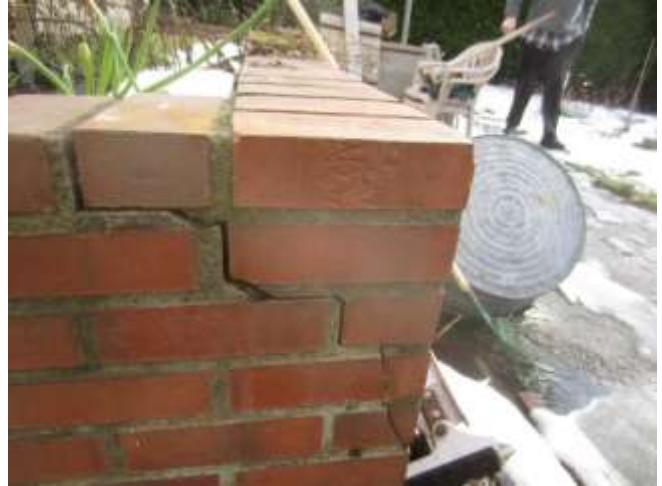
Cracks rear planter

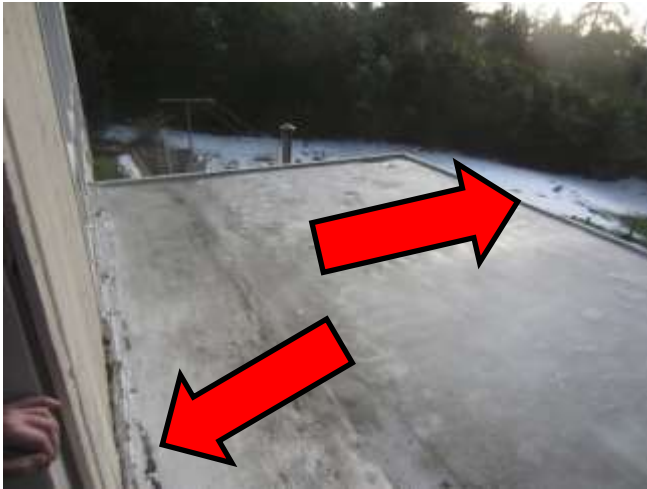
- Extreme fall safety hazard at roof area above the storage shed. This area is accessible from the rear patio and has no safety barricades. Fall is 7' + to a concrete surface below

No barricade to roof above storage shed

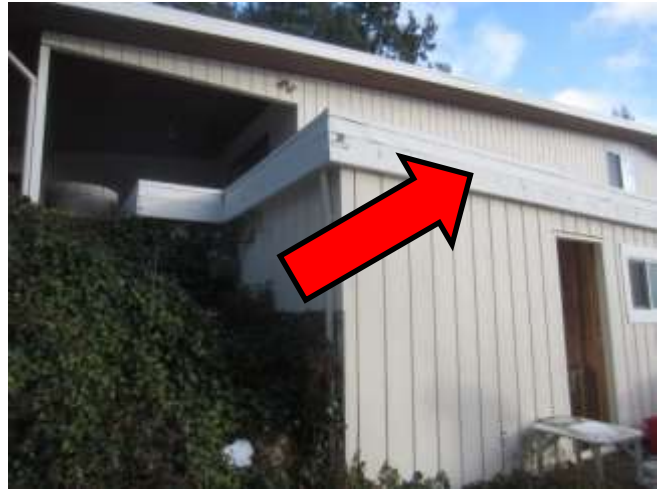
Fall hazard from storage shed

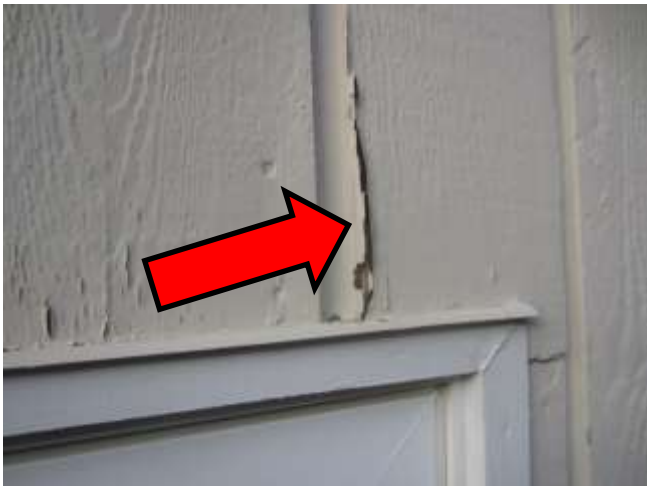
Type: Hardboard
Condition: - Paint at exterior siding is in poor condition at various areas, primarily the West facing wall. Wood rot at the base of the storage shed
Window/Door Flashing: Satisfactory
Caulking: Satisfactory

Deterioration of paint (typical)

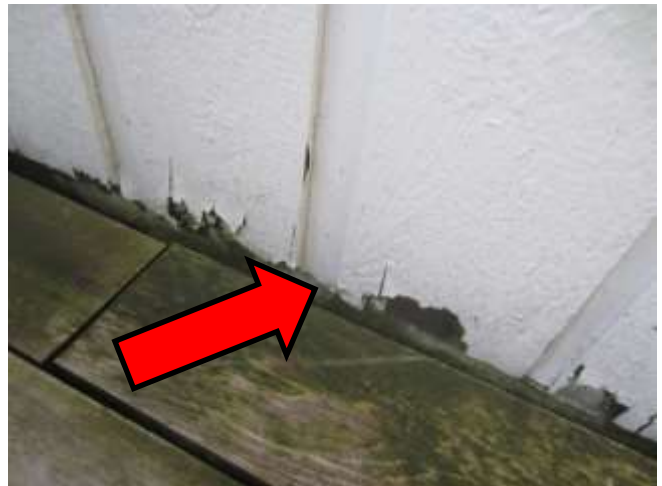
Wood rot at base of storage shed

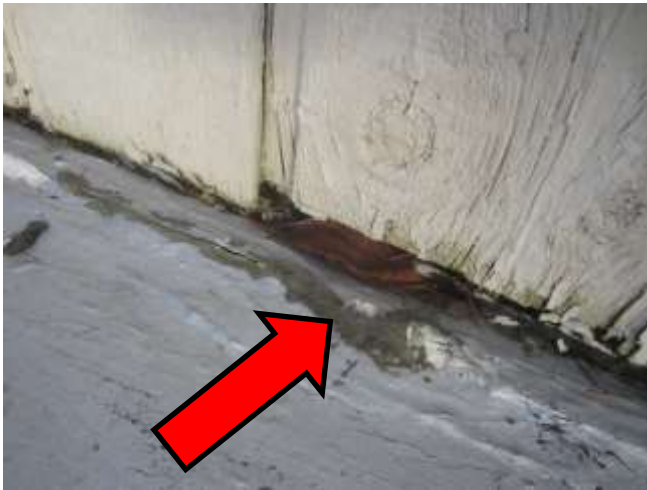
Siding to roof separation is negligible at shed roof

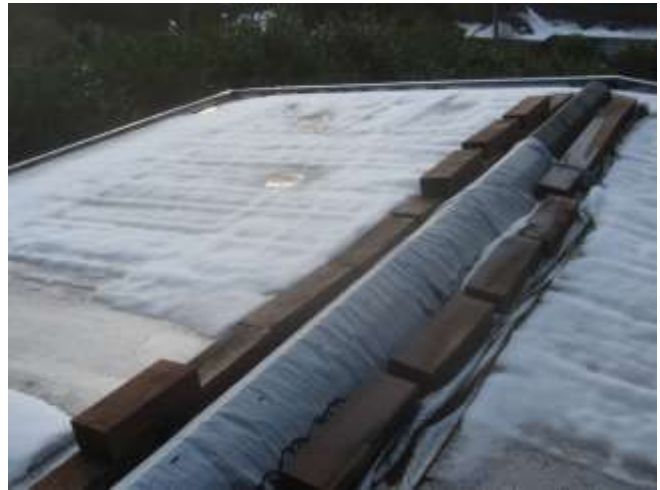
Blocked ridge ventilation

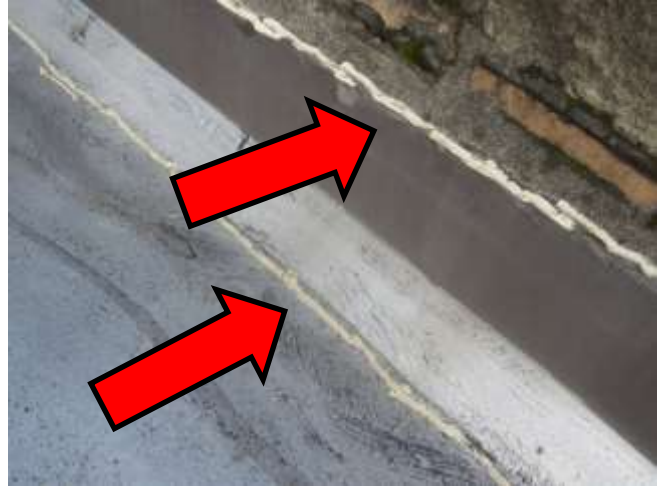
Caulking repair at chimney flashing

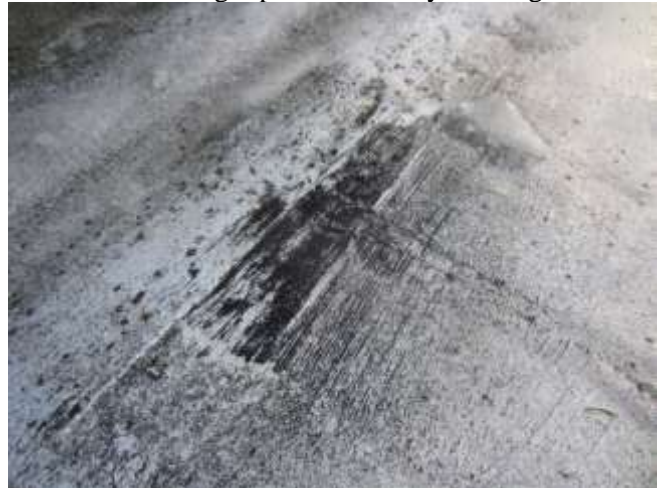
Estimated Pitch: 1-2:12
Material: Rolled
Layers: 1+
How Inspected: Traversed the roof - Limited visibility due to snow and ice
Condition: - Recommend re-coat roof (bare areas in several areas)
- Ridge ventilation is blocked
- Improper caulking or flashing above the storage shed area
Ventilation: Eave and ridge vent
Plumbing Vents: Satisfactory
Flues: - Handyman repair of flashing and mortar at the chimney
Flashing: - See comments above

Coating is worn at roof (typical)

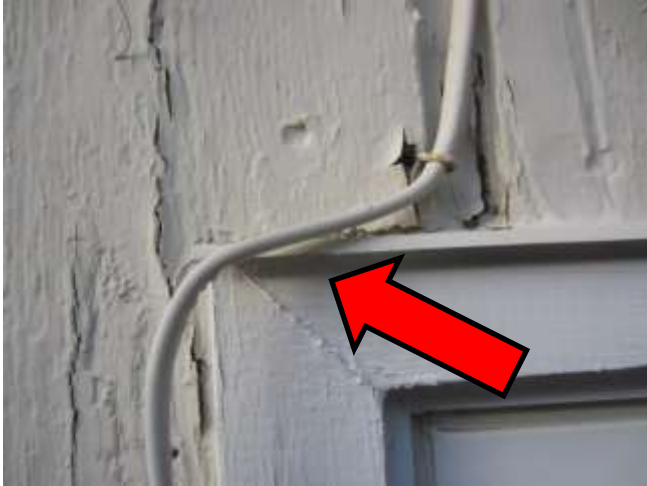
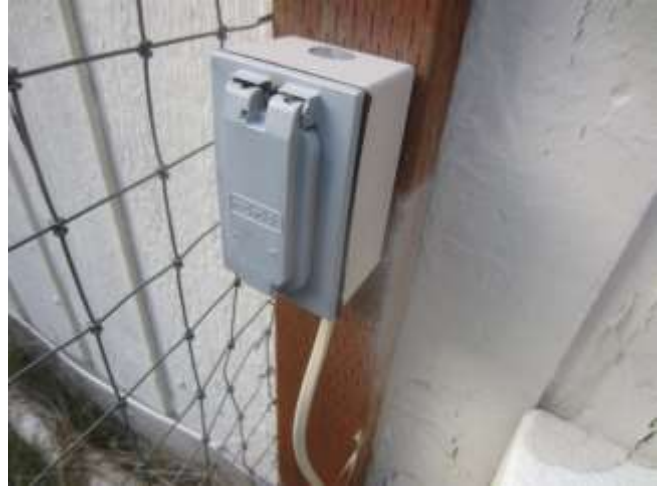
Outlets: - Extension cord wiring to exterior outlet
Switches/Lights: Tested

Extension cord wiring to exterior outlet

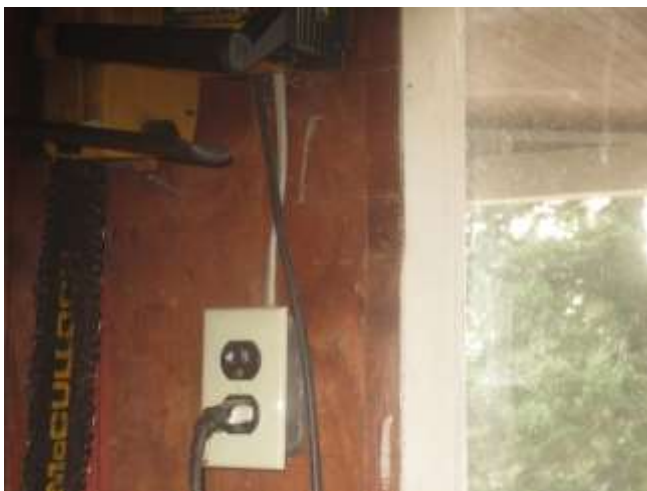
- A substantial amount of electrical wiring has been added to the garage. Per the occupant-installer, there was no electrical permit obtained for this work. There are numerous NEC code violations including exposed junction boxes, improper wire splices, loose wiring, surface mounted wiring, extension cord wiring, non-GFCI protected outlets. The circuit for this wiring is also likely overloaded. This wiring should be reviewed and corrected by a licensed electrician and inspected under an electrical permit by the City of Bellevue. See appendix A

New electrical outlet

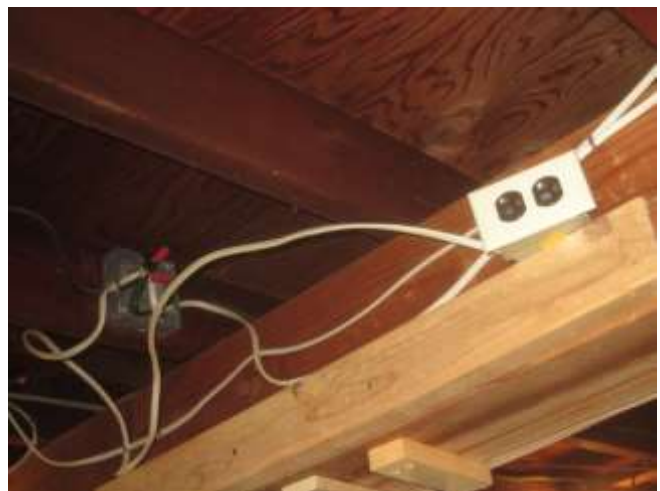
New wiring in the garage

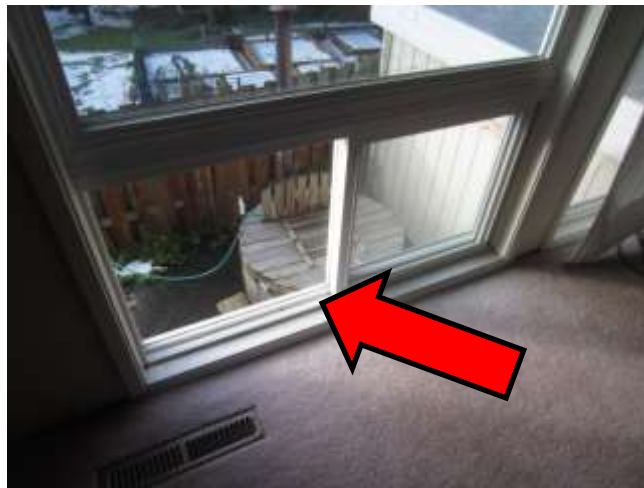
Glazing: No visible defects
Tempered: Not required
- The lower windows of the Living room are at floor level and open to width and height large enough for an adult to fall out. This condition is an extreme safety hazard, primarily with infants and toddlers
Operation: Tested

Windows open at floor height

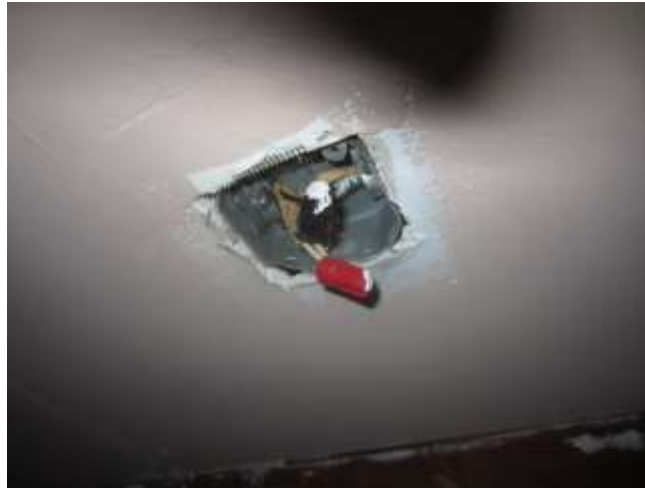
Switches/Lights: All visible tested
- Exposed electrical wires in the N.E. bedroom closet
Outlets: All visible tested
Smoke Detector: *- None*

Exposed electrical wires in closet

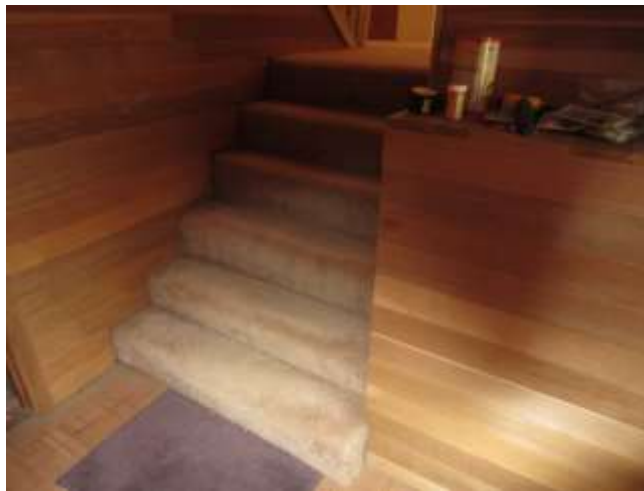
Handrails: - Graspable handrail not installed to basement
Barricades: As required
Balusters: As required
Trip Hazard: - Substantial trip hazard at stair to lower basement due to inconsistent riser height

No handrail to basement
Inconsistent riser height

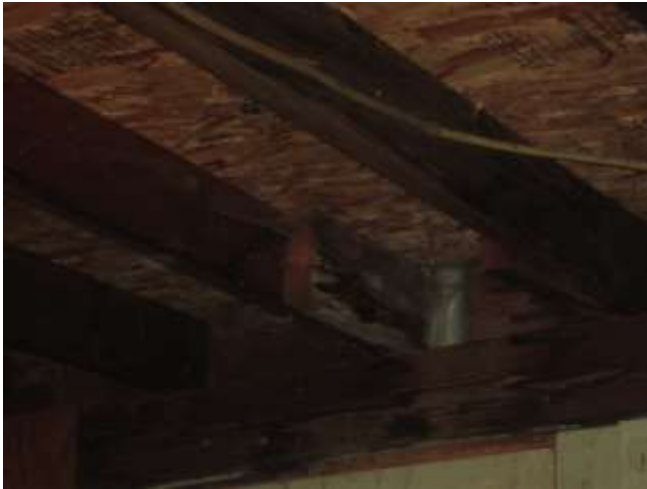
Visibility: Room is occupied (storage room is substantially occupied)
Structural Movement: No visible evidence
Moisture Infiltration: - Evidence of prior moisture intrusion at ceiling area near shed. Recommend continue to monitor
Walls: Satisfactory
Ceiling: - *Incomplete*
Flooring: Satisfactory

Moisture stains at area adjacent to shed

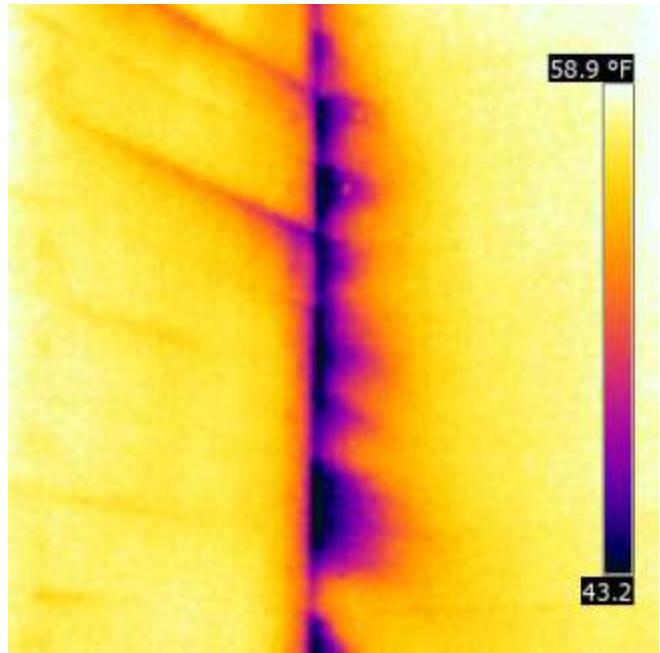
Air infiltration at N.W. corner of Great Room

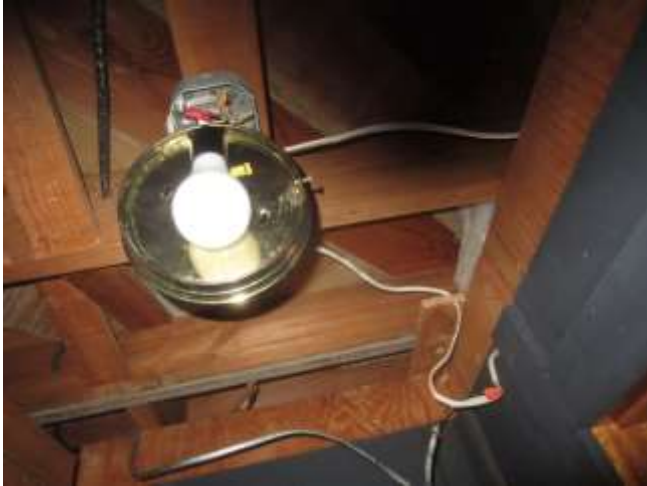
Switches/Lights: All visible tested
Outlets: - (3) prong electrical outlets are not grounded at most outlets
- A substantial amount of electrical wiring has been added to the basement including the bathroom addition to the attached storage shed. Per the occupant-installer, there was no electrical permit obtained for this work. There are numerous NEC code violations including exposed junction boxes, improper wire splices, loose wiring, and surface mounted wiring. The circuit for this wiring is also likely overloaded. This wiring should be reviewed and corrected by a licensed electrician and inspected under an electrical permit by the City of Bellevue
Smoke Detector: - *None*

Light fixture hanging in storage room

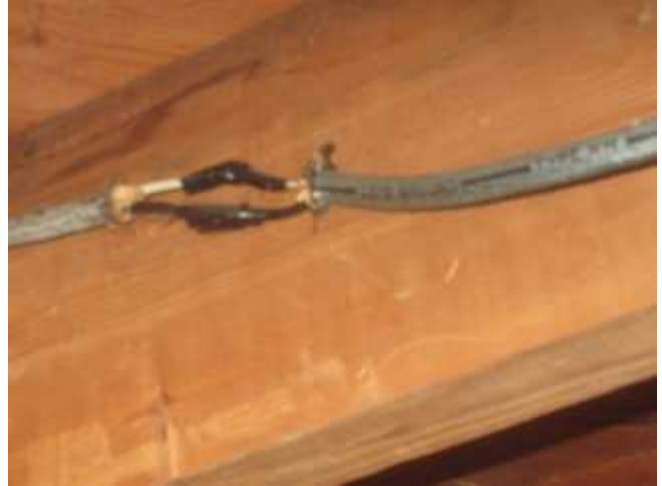
Wire splice in great room

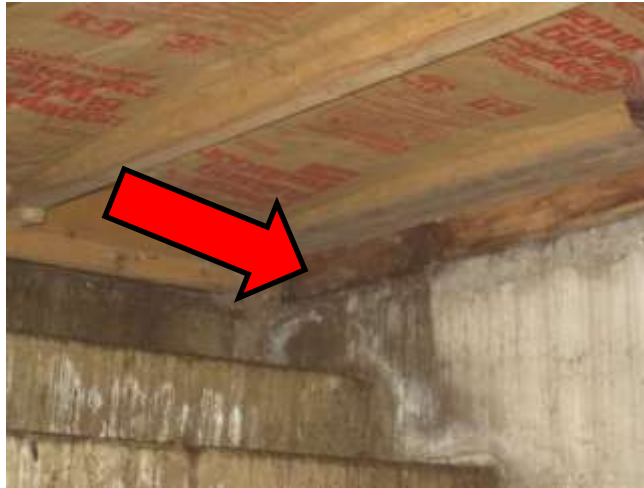
- Visibility: Room is occupied
- Rear storage shed has been added as habitable space. Unknown if an appropriate building permit was obtained from the City of Bellevue. Construction is not consistent with current building codes
- Structural Movement: No visible evidence
- Moisture Infiltration: No visible evidence
- Walls: Satisfactory
- Ceiling: Satisfactory
- Flooring: Satisfactory
- Cabinets: Satisfactory
- Countertops: Satisfactory
- Mirrors: Satisfactory

Wood rot and moisture intrusion visible

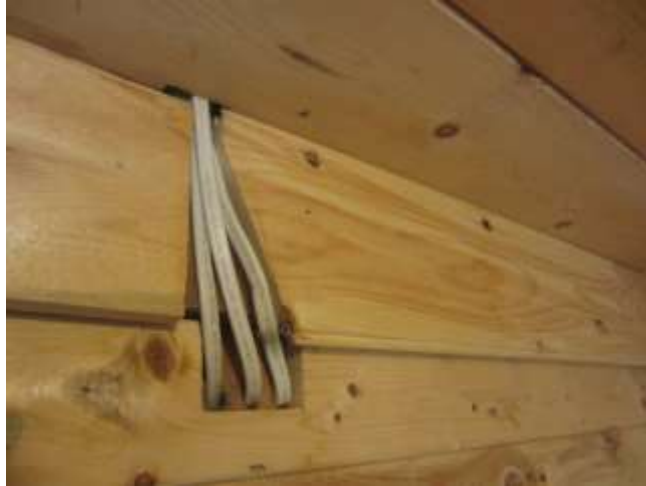
Surface mounted electrical wires

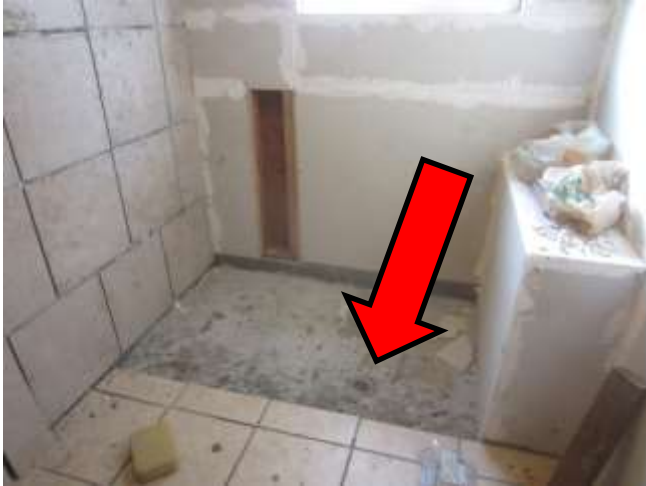
- A substantial amount of plumbing has been added to the remodeled storage shed including waste lines and incomplete domestic water pipes. Per the occupant-installer, there was no plumbing permit obtained for this work. The waste line is no longer visible. This plumbing should be reviewed and corrected by a licensed plumbing contractor and inspected under a plumbing permit by the City of Bellevue. See appendix B

Waste line is covered by concrete floor
