Property Description: (1) story single family home
Property age/ size: Built 1959, 1,310 s.f. per listing
Occupancy Status: Vacant

Inspection Date: 12/19/2011
Inspection Time: 11:00 A.M. – 2:00 P.M. +-
Weather Conditions: Overcast, 50 deg F +-

Hergert Inspection LLC

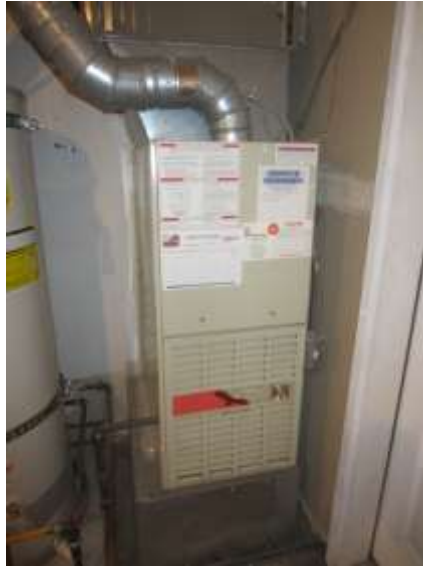
Furnace

Location: Garage
Make/ Model: Payne s/n 0493A06985 , last service date posted 12/29/2009
Fuel Type: Natural gas
BTUH Input: 92,000
BTUH Output: - *Not noted on furnace*
Efficiency Rating: Mid-efficiency
- Substantial air loss at the base of the furnace. Recommend have furnace serviced and seal all air leakage by a licensed heating contractor - technician
