Property Description: (1) story single family house w/ attached carport  
Property age/ size: 1,880 s.f., built 1966 per listing  
Occupancy Status: Vacant

Inspection Date: 07/31/2011  
Inspection Time: 10:00 A.M. – 12:30 P.M.  
Weather Conditions: Overcast, 65 deg F +-

Hergert Inspection LLC

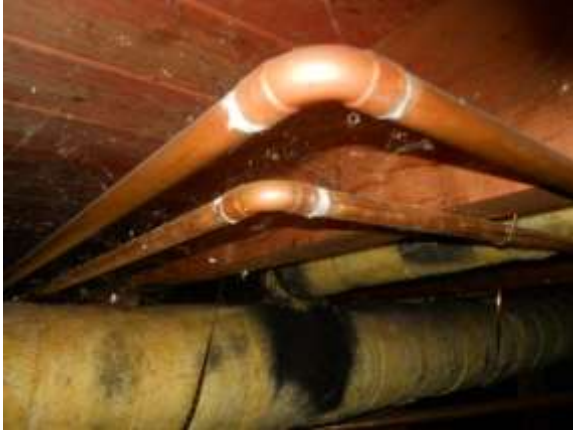
Copper domestic water pipes

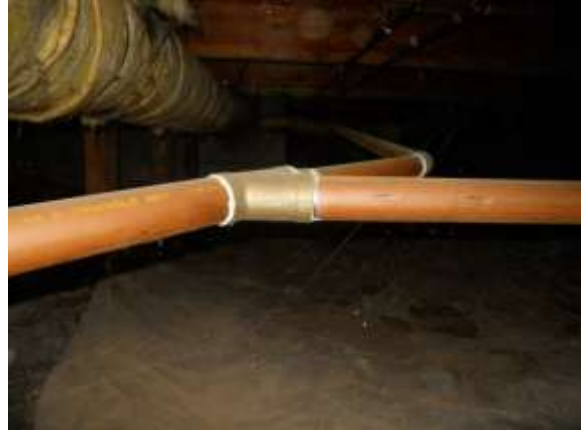
Copper waste lines

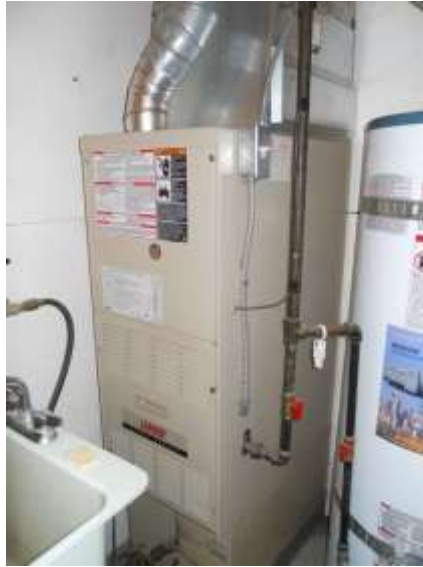
Est. Useful Life new: 25 years  
Est. age of furnace: 8 years +-  
- Recommend service of furnace. Draft induction fan is very loud. Furnace should be serviced every (2) years

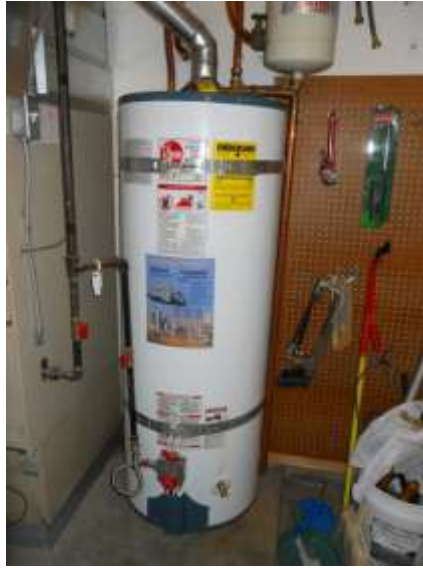
Est. Useful Life new: 12 years  
Est. age of heater: 10 years +-  
*- Water heater is nearing the end of its anticipated useful life expectancy. No evidence of rust at tank*
