(425) 652-6515
Kevin@Hergert.com
Wa. Home Inspector 619
WSDA Inspector 79988
WSDA Control # 1295AQ-038

Property Description: (1) story single family home
Property age/ size: Built 1958, 1,214 s.f. per listing
Occupancy Status: Vacant; in process of remodeling/ repairs

Inspection Date: 11/08/2011
Inspection Time: 1:00 P.M. – 4:00 P.M. +-
Weather Conditions: Clear 55 deg F +-

Hergert Inspection LLC

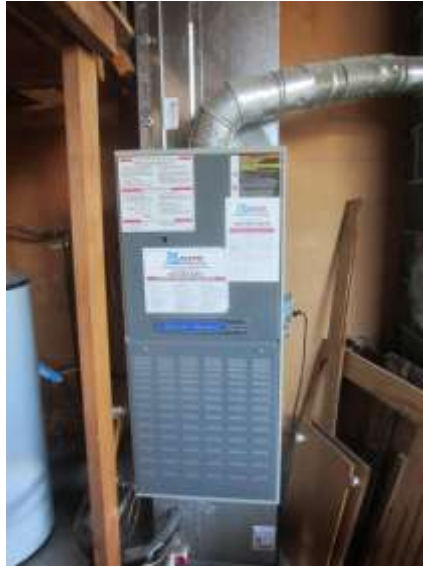
Furnace

Location: Garage
Make/ Model: American Standard Freedom 80 manufactured 11/2004
Fuel Type: Natural gas
BTUH Input: 80,000
BTUH Output: - Not noted on furnace
Efficiency Rating: Mid-efficiency
- Air conditioning not tested due to exterior temperature (< 65 deg F)

Visible Inspection: No visible defects, limited visibility
Gas detection test: No gas leak detected
Burner test: No burner irregularities detected

Thermostat: @ floor 1 hall
- Recommend replacement of thermostat with programmable type
Combustion Air: Appears adequate
Filter: Located above furnace

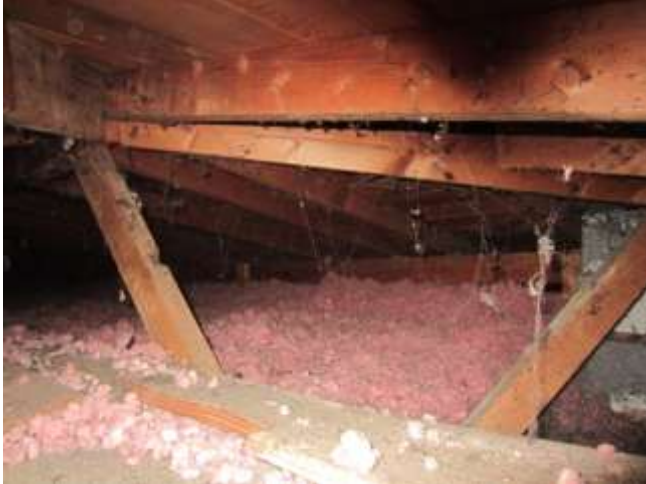
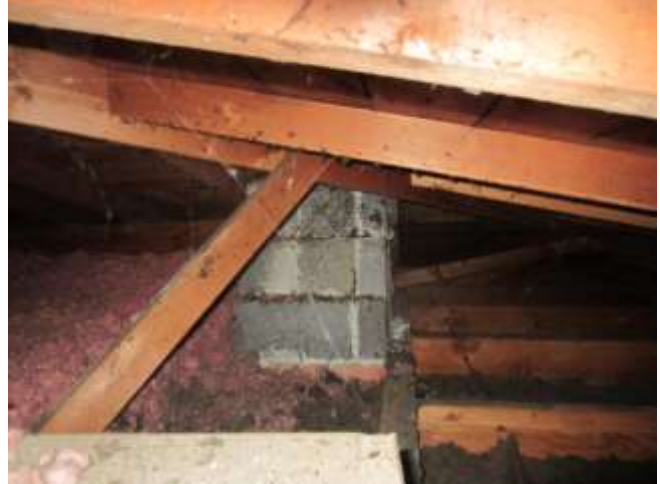
General

Visibility: Space is vacant
Access location: Garage
How viewed: From access due to limited headroom

Roof Ventilation: Appears adequate where visible
Moisture Intrusion: No visible evidence
Bath/Kitchen fans : - Not visible
