(425) 652-6515
www.Hergert.com
Kevin @ Hergert.com
Wa. Home Inspector 619
WSDA Inspector 79988
WSDA Control # 11262AQ-06

Property Description: (2) story single family home
Estimated property age: Built 1988 per King Co.
Occupancy Status: Occupied

Inspection Date: 04/04/2020
Inspection Time: 2:00 P.M. - 4:00 P.M. +-
Weather Conditions: Overcast, 50 deg f +-

Hergert Inspection LLC

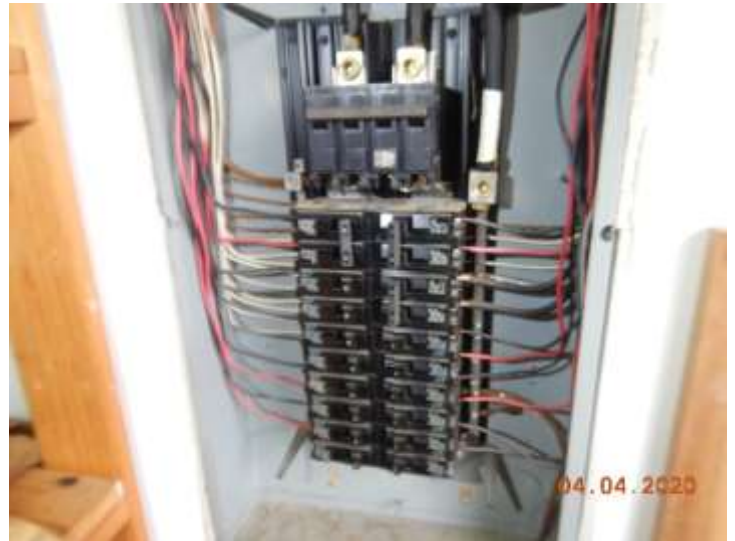
Electrical panel

- Knockout covers are missing at the electrical panel cover. Live electrical components are exposed and are a risk for electrocution

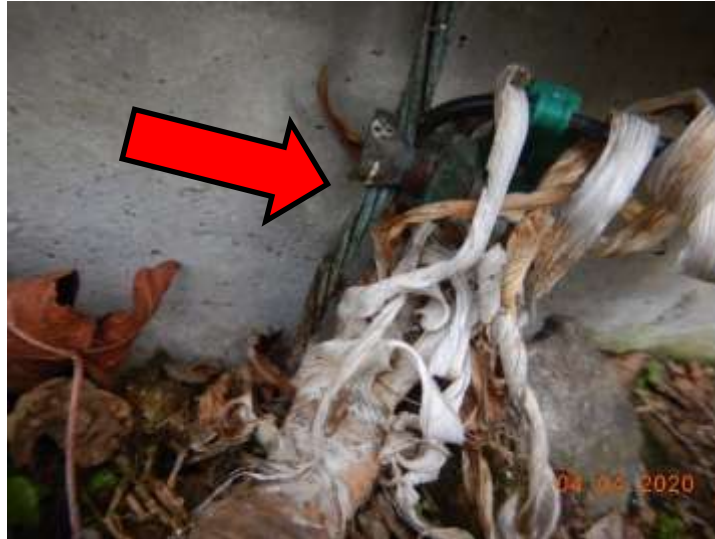
Electricval system grounsing

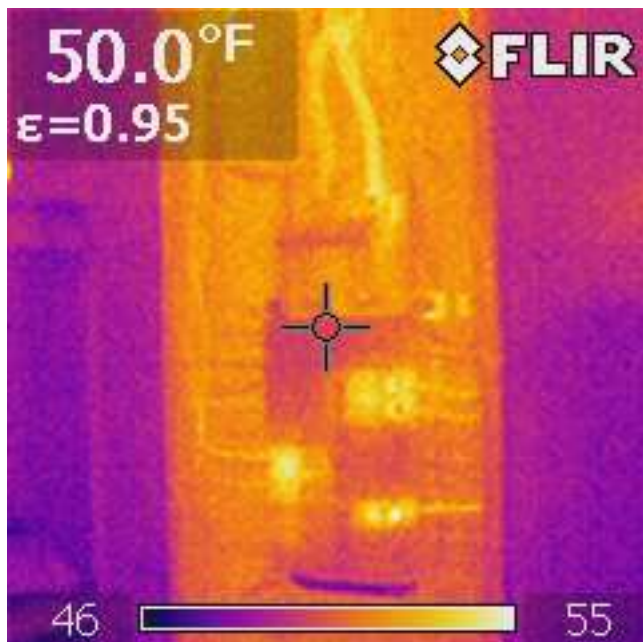
No evidence of overheating

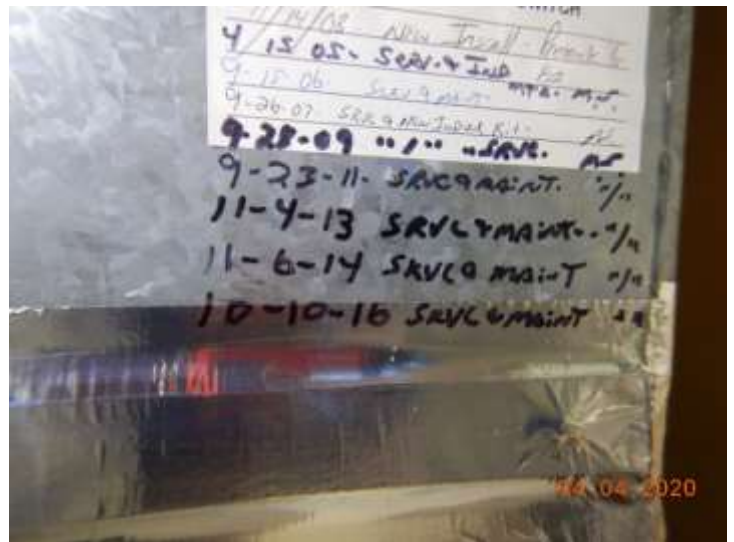
Service tag

- The heating system for this home is natural gas. The listing stated a geothermal system in error
- The age of the furnace is approximately 17 years. The remaining anticipated useful life expectancy is 8 years
- Recommend furnace to be cleaned, serviced, and shown to be in good working order by a qualified furnace technician. The last service date for the furnace was in 2016 per the tag on the furnace

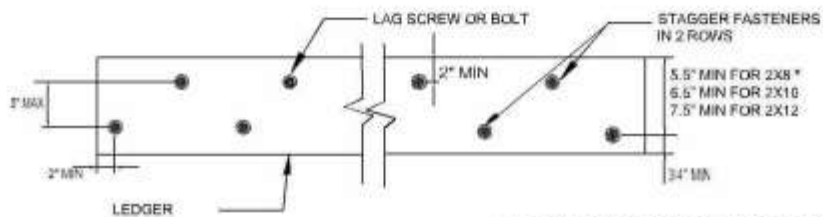
Placement of Lag Screws and Bolts in Ledgers

- a. Lag screws or bolts must be staggered from the top and bottom along the horizontal run. See figure below.
- b. Maximum 5 inches.
- c. For engineered rim joists, the manufacturer's recommendations govern.
- d. The minimum distance from the bottom row to the top edge of the ledger must be in accordance with figure below.
- e. 2 inches may be reduced to 3/4 inch when the band joist is directly supported by a mudsill, header, or by double top wall plates.

- Recommend GFCI protection for the exterior electrical outlets
- Recommend the installation of lag bolts to fasten the deck ledger to the home. Although likely not required at the time of construction of the home, this fastening system is a new “code” requirement to reduce the likelihood of failure of a deck structure

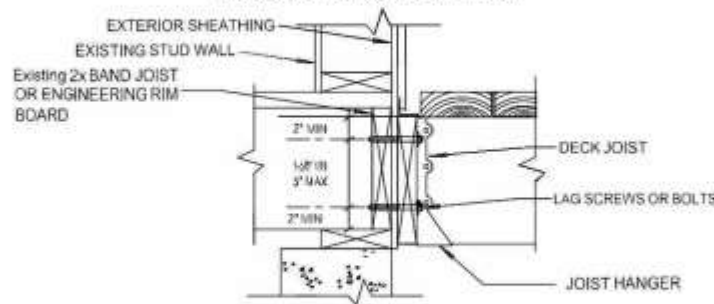
Placement of Lag Screws and Bolts in Ledgers

*DISTANCE CAN BE REDUCED TO 4.5" IF LAG SCREWS ARE USED OR IF BOLT SPACING IS REDUCED TO THAT OF LAG SCREWS TO ATTACH 2X8 LEDGERS TO 2X8 BAND JOISTS.

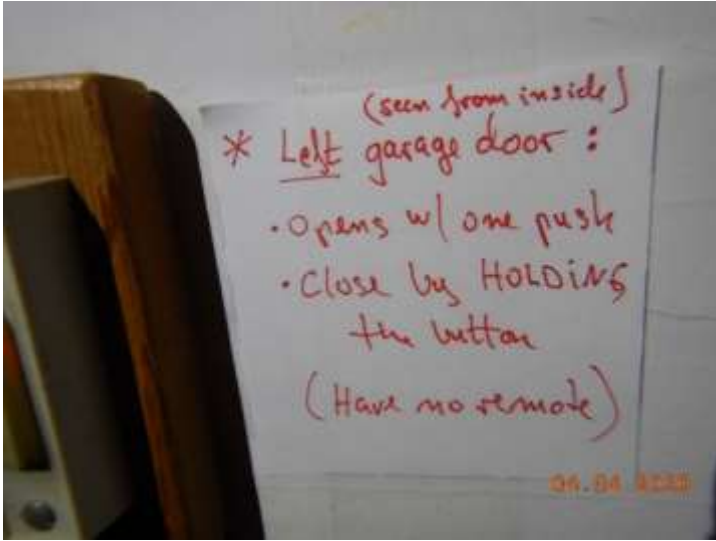
- Type: Wood roll up
- Door condition: The doors are in satisfactory condition
- Springs and tracks: The springs and tracks appear to be in satisfactory condition
- Garage door openers: Yes
- The West garage door only closes with the button held down. There is evidence that the door is rubbing on the door wrap or the opening mechanism. Recommend servicing
- Auto reverse of impact: - The East garage door does not auto reverse with reasonable force. Recommend adjustment to the auto reverse sensitivity setting. Unable to test the West door for auto reverse due to the condition noted above
- Photo cell reverse sensors: - The garage door openers do not have photocell reverse sensors. These sensors are a highly recommended safety feature and are required for all new garage door opener installations

Note posted near the openers

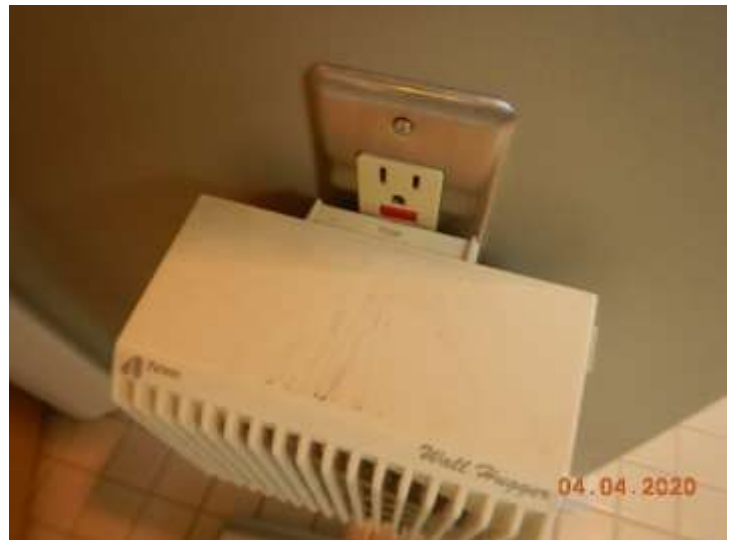
The tub motor is properly GFCI protected by this outlet
