(425) 652-6515
www.Hergert.com
Kevin @ Hergert.com
Wa. Home Inspector 619
WSDA Inspector 79988
WSDA Control # 11150AQ-029

Property Description: (1) story "split entry" single family home with daylight basement
Estimated property age: Built 1979 per listing
Occupancy Status: Occupied

Inspection Date: 10/04/2019
Inspection Time: 11:00 A.M. - 1:00 P.M. +-
Weather Conditions: Overcast, 55 deg f +-

Hergert Inspection LLC

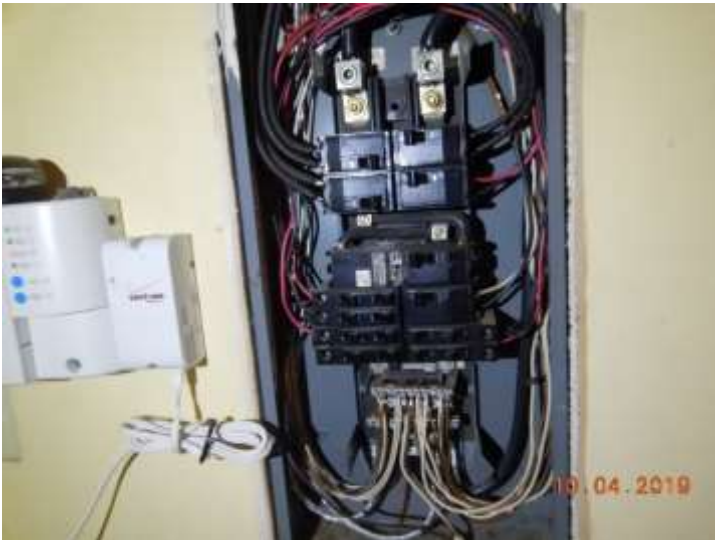
Electrical panel

Type: Copper romex and multi-strand aluminum
Breakers: No visible defects
Circuit breaker legend: Appears proper and complete. Individual circuit breakers are not tested
-

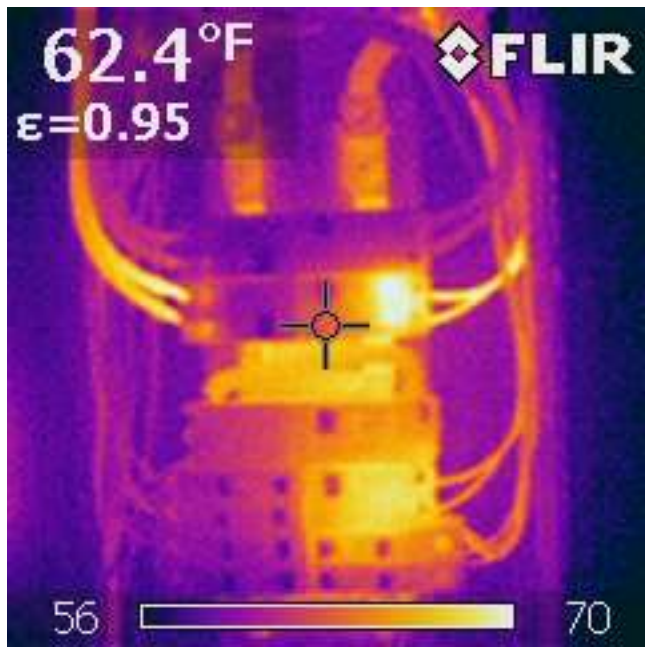
No evidence of overheating

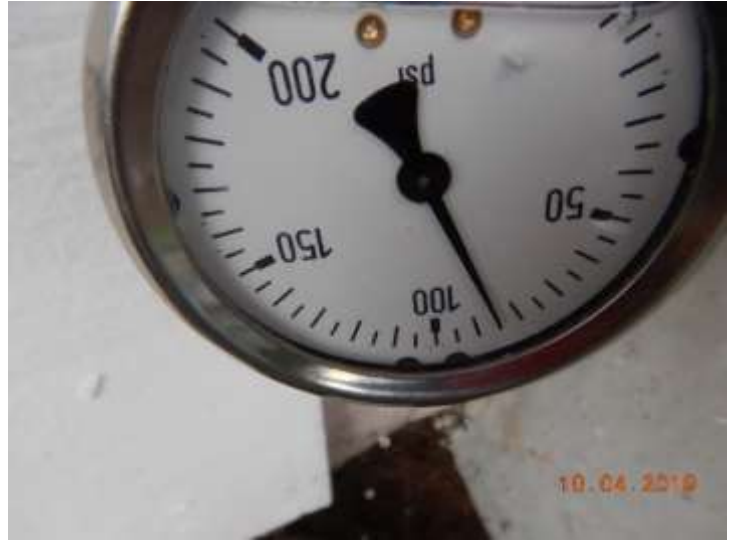
Water pressure is adequate and not excessive

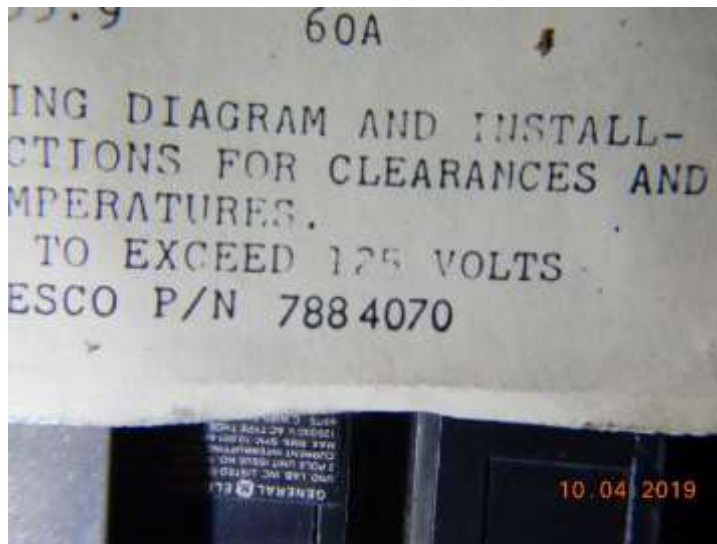
Furnace data plate

Est. Useful Life new: 25 years
Serial number/year: 7884070
Est. age of furnace: 41 years based on the serial number
Est remaining life: - The furnace is fully functional, however is past the end of its anticipated useful life expectancy by 16 years
Servicing: - Recommend furnace to be cleaned, serviced, and shown to be in good working order by a qualified furnace technician. There is no tag on the furnace which indicates any prior servicing of the furnace

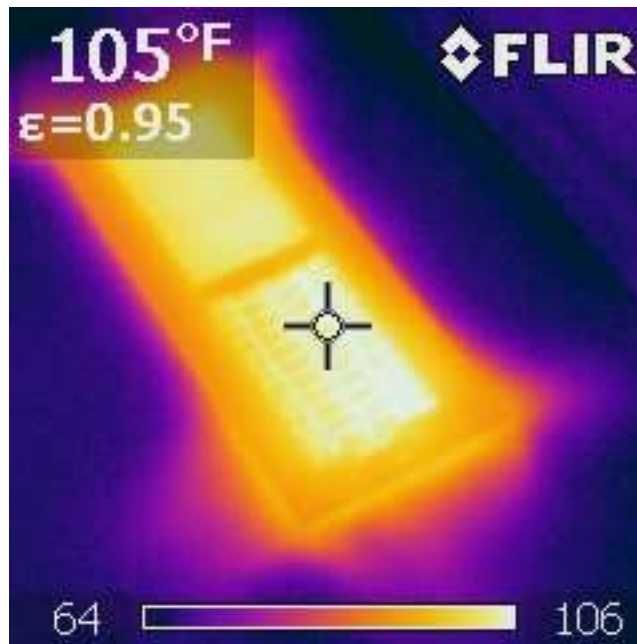
Temperature measured at a heat register

Rating: Not specified
@ return air: 70 deg F
@ nearest register: 105 deg F
Heat Gain: 35 deg F. Heat gain is within specifications of the furnace

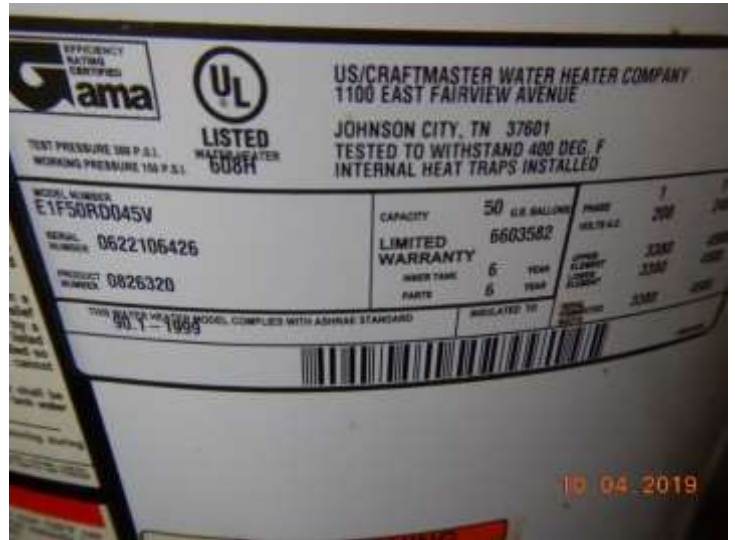
Data plate

- The water heater is fully functional with no visible evidence of rusting, however is past the end of its anticipated useful life expectancy by 1 year
- Recommend installing a drip pan below the water heater with a moisture alarm in the drip pan, or a moisture activated shut off valve in the drip pan
- The TPR drain line should extend to the exterior

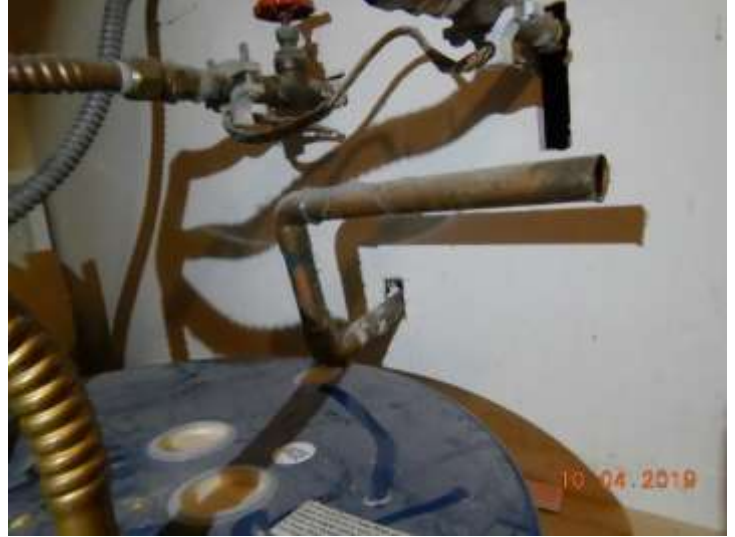
Connection for the TPV valve (not used)

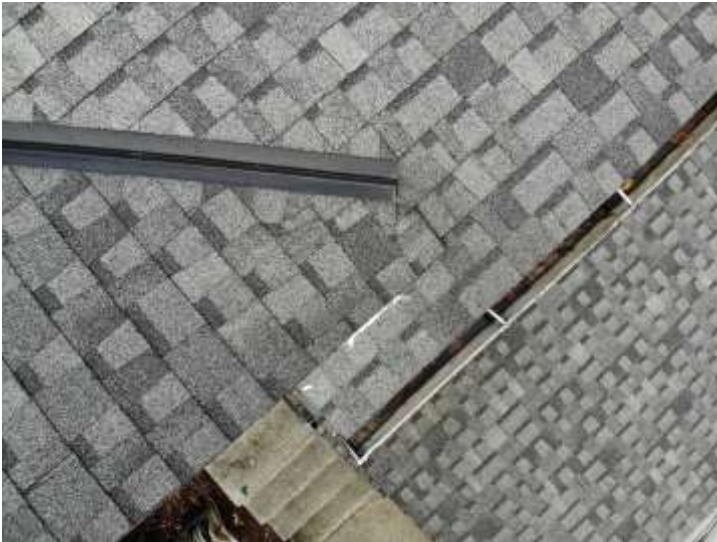
Roof (typical)

- Estimated Pitch: 4:12
- Material: Composition
- Layers: 1+
- How Inspected: Traversed the roof and a drone
- Roof access condition: Reasonable and safe access
- Condition: Overall satisfactory
- Ventilation: Eave and roof hat vents
- Plumbing Vents: Satisfactory
- Flues: Satisfactory
- Flashing: - The roof to wall metal at the lower front roof should be secured to lay flat
