(425) 652-6515
www.Hergert.com
Kevin @ Hergert.com
Wa. Home Inspector 619
WSDA Inspector 79988
WSDA Control # 11168AQ-017

Property Description: (2) story single family home
Estimated property age: Built 1997 per listing
Occupancy Status: Occupied

Inspection Date: 10/09/2019
Inspection Time: 1:00 P.M. - 3:15 P.M. +-
Weather Conditions: Overcast, 55 deg f +-

Summary of Inspection

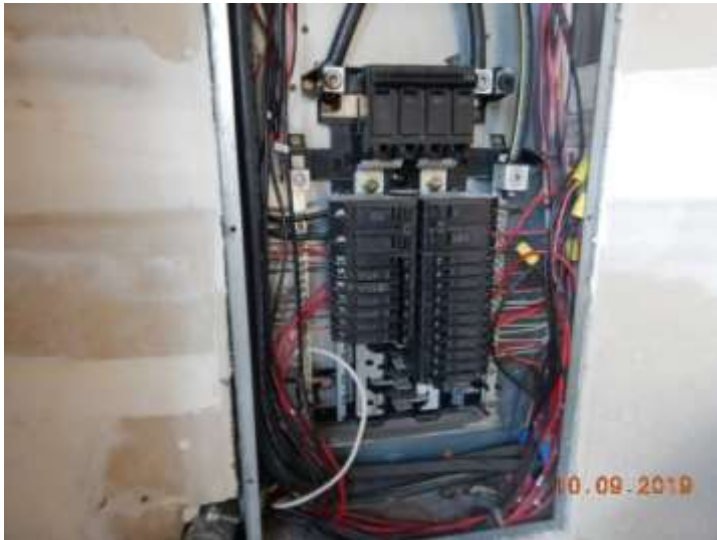
Type: Copper romex and multi-strand aluminum
Breakers: No visible defects
Circuit breaker legend: Appears proper and complete. Individual circuit breakers are not tested
-

Electrical panel

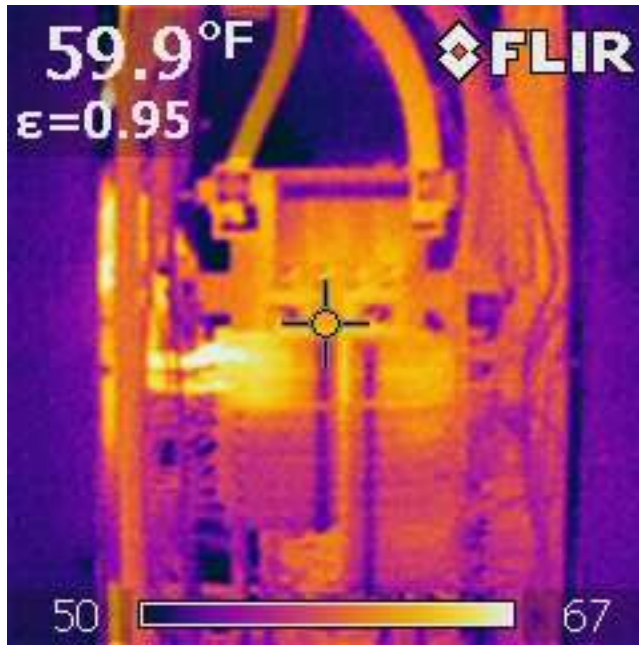
No evidence of overheating

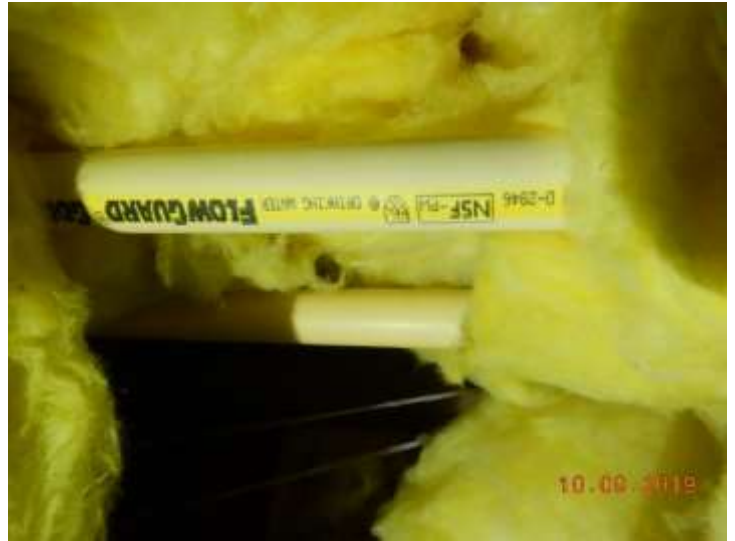
- The plumbing pipes within the home are CPVC. This type of pipe is not listed as a known defect; however the pipes can become brittle with age and fail, especially when impacted. <https://www.classaction.org/cpvc-pipe-lawsuits>. A prior repair or modification is visible in the crawlspace

CPVC domestic water distribution pipes

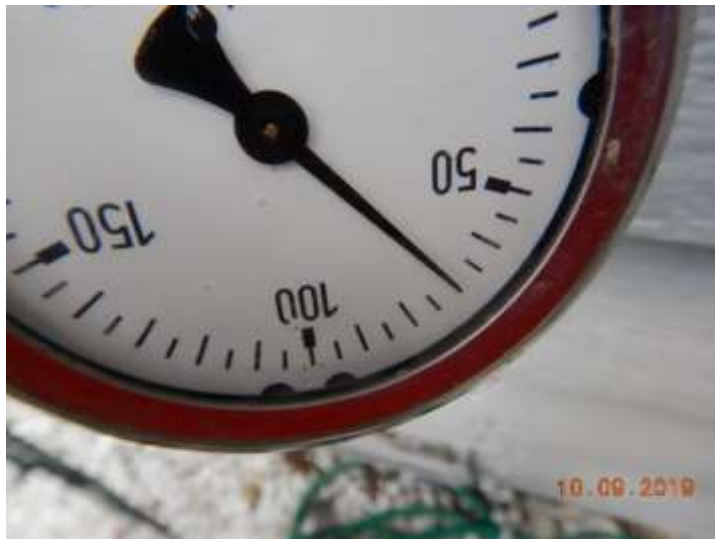
Measured water pressure: 70 P.S.I. Water pressure is adequate and not excessive

Water pressure is adequate and not excessive

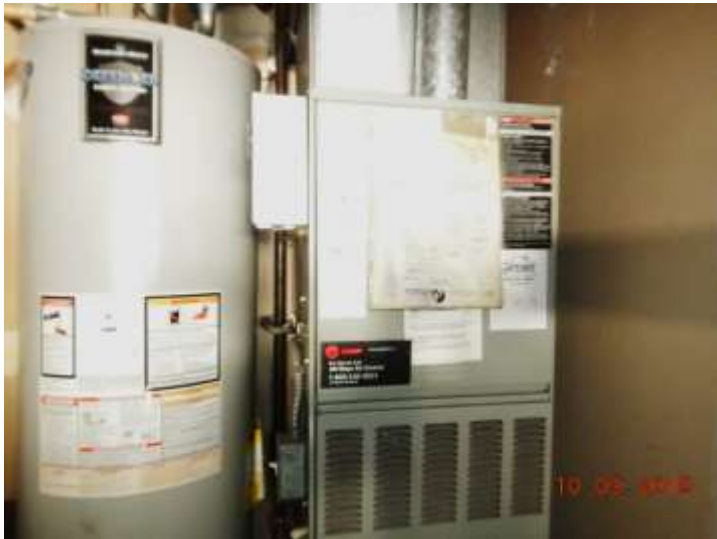
- The age of the furnace is 22 years. The remaining anticipated useful life expectancy is 3 years
- Recommend furnace to be cleaned, serviced, and shown to be in good working order by a qualified furnace technician. The last service date for the furnace was in 2015 per the tag on the furnace
- The access to install a furnace filter appears to be obstructed by the water heater expansion tank

Est. Useful Life new: 25 years
Serial number/year: Le55txc1g ansi 1993
Est. age of furnace: 22 years based on the age of construction of the home
Est remaining life: - The age of the furnace is 22 years. The remaining anticipated useful life expectancy is 3 years
Servicing: - Recommend furnace to be cleaned, serviced, and shown to be in good working order by a qualified furnace technician. The last service date for the furnace was in 2015 per the tag on the furnace
- The inspection of the heat exchanger involves dismantling of the components of the furnace and is beyond the scope of a Home Inspection

Furnace

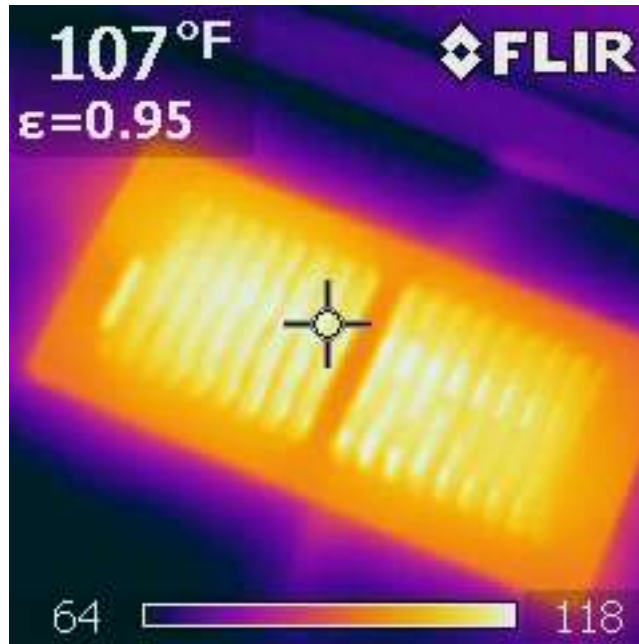
Rating: 35-65 deg F
@ return air: 70 deg F
@ nearest register: 107 deg F
Heat Gain: 37 deg F. Heat gain is within specifications of the furnace

Temperature measured at a heat register

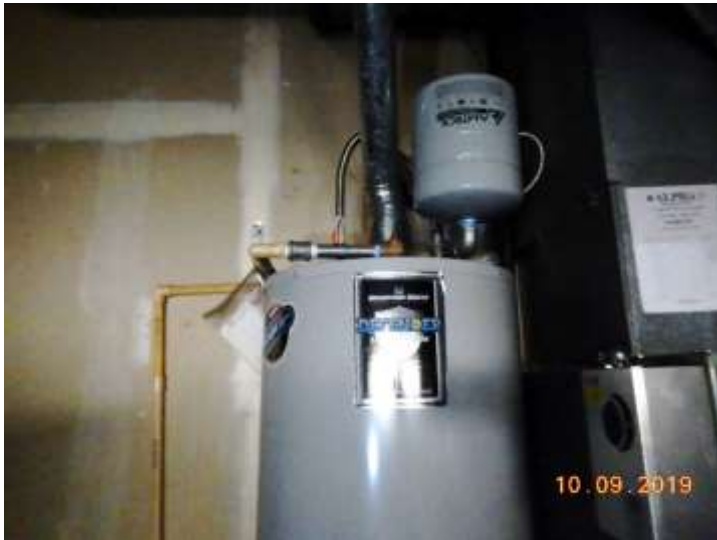
Water Heater

Flue secure: Inspected
Clearances: As required where visible
Draft Hood: Inspected
Water connection: Inspected
Expansion Tank: Yes
Drip pan: - **Recommend installing a drip pan below the water heater with a discharge drain to the garage floor. Leakage from this heater could result in damage to the adjacent living spaces**

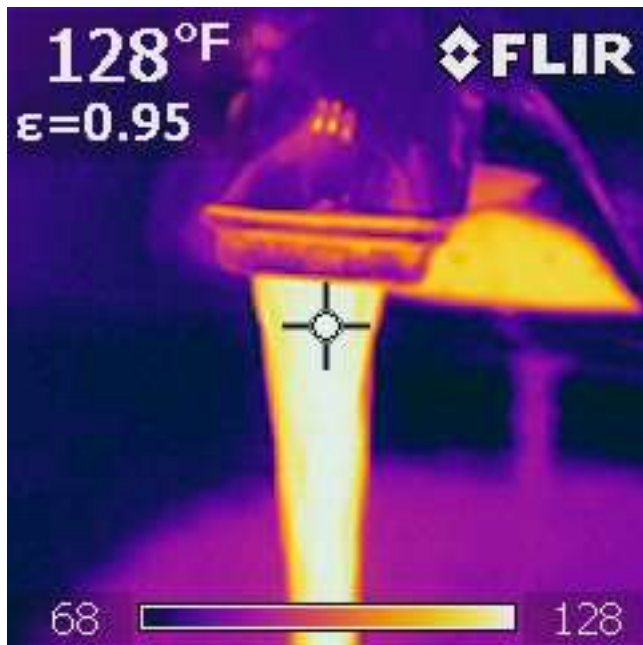
- TPR valve: As per required
- Earthquake Straps: - Earthquake restraints in compliance with WAC 51-56-0507.2 are not installed. Water heaters shall be anchored or strapped to resist horizontal displacement due to earthquake motion. Seismic straps (min 3/4" x 22 gauge metal) shall be located within upper and lower 1/3 of tank height. 4" min above controls
- Safe water temperature: 120 deg F per industry standards
- Measured temperature: - *The water temperature was measured at 128 deg F; this temperature is above the recommended setting of 120 deg F. This adjustment is typically a simple adjustment to the water heater thermostat*

Hot water temperature

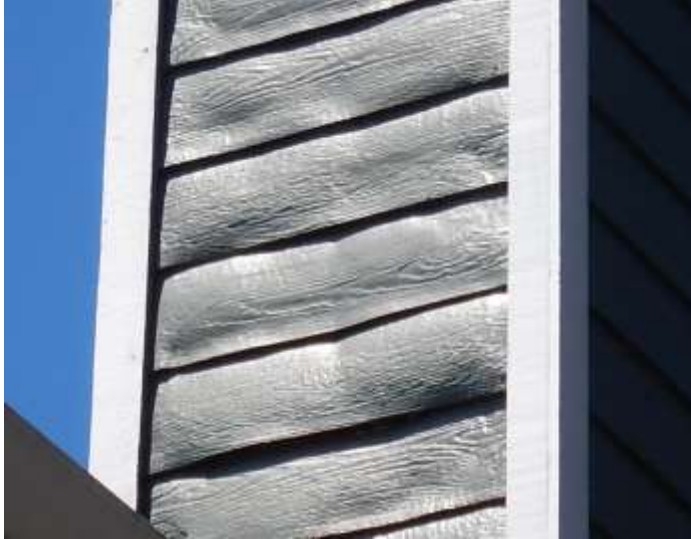
- The composition type siding is a known defect as the siding tends to retain moisture and begins to swell, crack and rot. There are varying degrees of failure visible at multiple locations of the siding. Many areas have moderate swelling and cracking at the base of the siding, however are still solid enough such that a metal probe cannot be pushed into the siding. There areas should be acceptable for several years with proper maintenance (keeping the lower edges of the siding painted). Areas that are heavily exposed to the weather and sun show more substantive deterioration. These areas are located primarily at the side walls at the Living room, dining room, and Family room. A probe can be pushed into the lower edge of many siding boards at these locations.

Condition: - The composition type siding is a known defect as the siding tends to retain moisture and begins to swell, crack and rot. There are varying degrees of failure visible at multiple locations of the siding. Many areas have moderate swelling and cracking at the base of the siding, however are still solid enough such that a metal probe cannot be pushed into the siding. There areas should be acceptable for several years with proper maintenance (keeping the lower edges of the siding painted). Areas that are heavily exposed to the weather and sun show more substantive deterioration. These areas are located primarily at the side walls at the Living room, dining room, and Family room. A probe can be pushed into the lower edge of many siding boards at these locations.

COMPOSITE SIDING

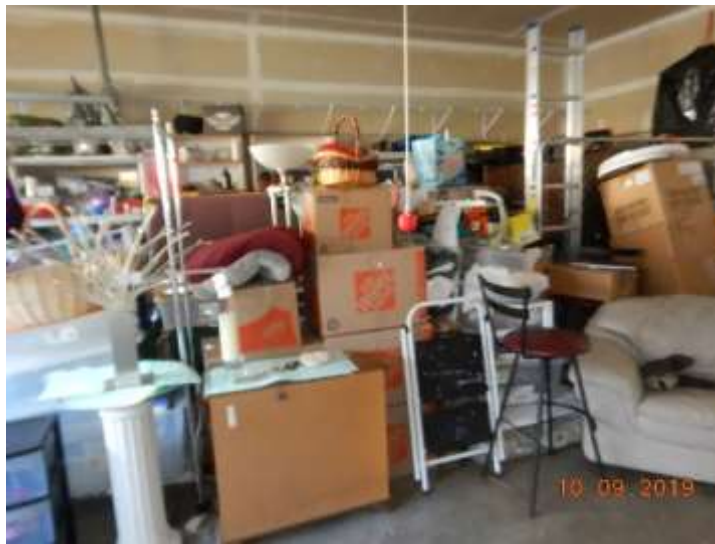
The garage is substantially occupied

- The outlets were not tested for GFCI protection as a reset outlet was not located in this heavily occupied garage. If tested, several personal items may need to be moved to reset the GFCI outlet; if any

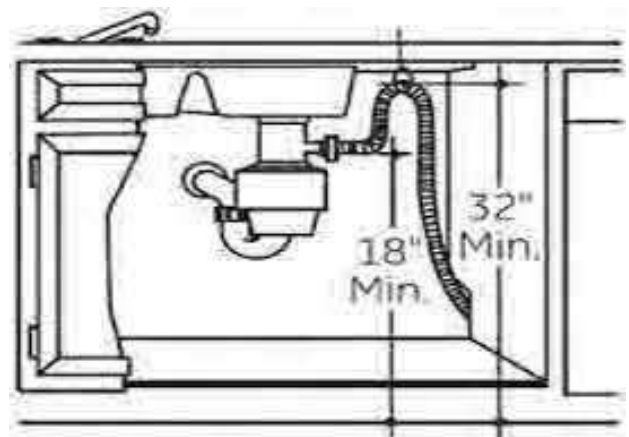
- The dishwasher drain should be secured to the underside of the countertop to prevent cross contamination of waste water with the dishwasher (high loop)
- The door handle of the refrigerator is loose

Proper dishwasher high loop
