(425) 652-6515  
www.Hergert.com  
Kevin @ Hergert.com  
Wa. Home Inspector 619  
WSDA Inspector 79988  
WSDA Control # 10760AQ-090

Property Description: (2) story single family home  
Estimated property age: Built 2017 per listing  
Occupancy Status: Staged

Inspection Date: 11/29/2017  
Inspection Time: 9:00 A.M. - 11:30 A.M. +/-  
Weather Conditions: Overcast, 55 deg f +/-

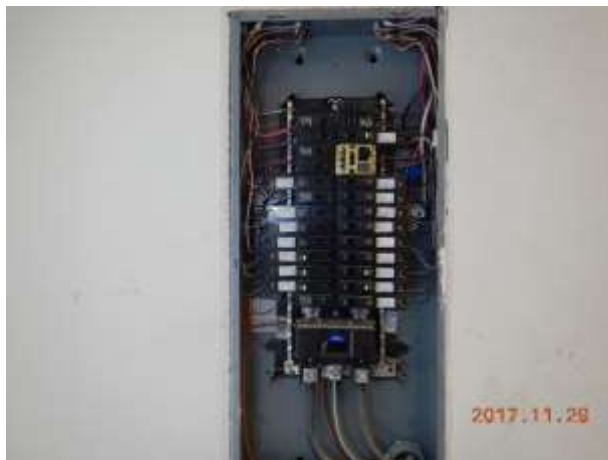
Electrical panel

Type: Copper romex and multi-strand aluminum  
Breakers: No visible defects  
Arc fault breakers: Tested  
*An Arc Fault Circuit Interrupter (AFCI) is a circuit breaker designed to prevent fires by detecting an unintended electrical arc and disconnecting the power before the arc starts a fire. An AFCI must distinguish between a harmless arc that occurs incidental to normal operation of switches, plugs and brushed motors and an undesirable arc that can occur, for example, in a lamp cord that has a broken conductor in the cord.*  
Circuit breaker legend: Appears proper and complete. Individual circuit breakers are not tested

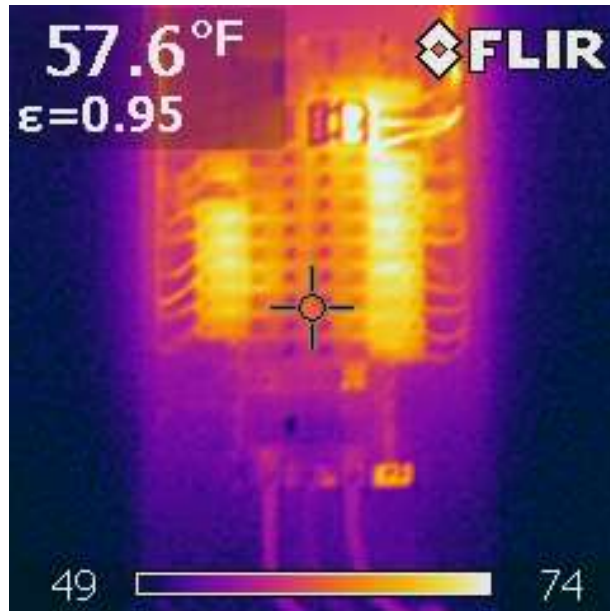
No evidence of overheating

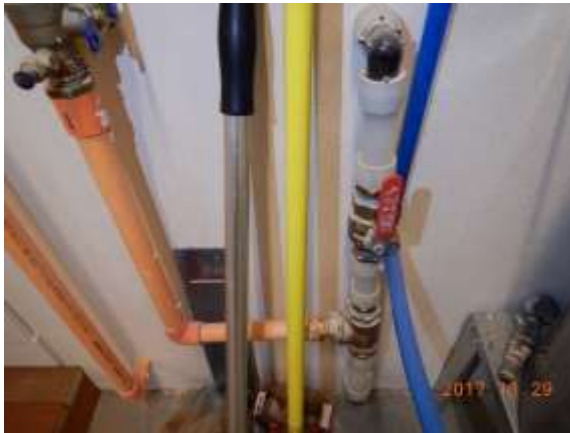
Domestic Water Shut off

- Supply: Public water per listing, not included in this inspection  
Supply Pipe: Poly pipe where visible  
House Piping: Copper pipe where visible  
Main Water Shut off: @ entry closet  
Measured water pressure: - The domestic water pressure substantially exceeds the maximum pressure of 80 PSI. The excess pressure may result in premature pipe or plumbing fixture failure. Recommend installation of a pressure reducing valve (this type of valve was not located)

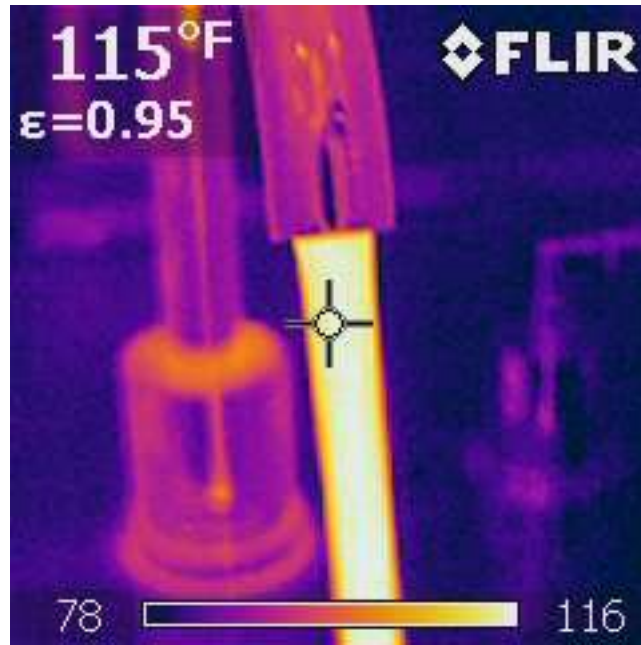
Hot water temperature

TPR valve: As per required  
Earthquake Straps: Installed  
Safe water temperature: 120 deg F per industry standards  
Measured temperature: 115 deg F

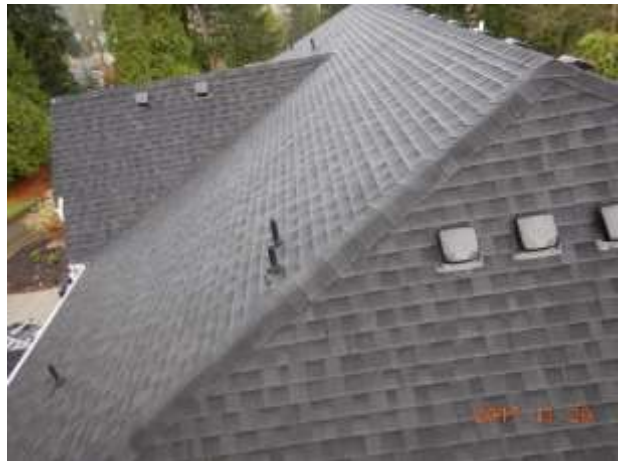
Estimated Pitch: 5:12  
Material: Composition  
Layers: 1+  
How Inspected: From floor 2, the street, rear yard, and a pole mounted camera  
Roof access condition: Roof was not traversed as traversing the roof is deemed unsafe by the inspector  
Condition: Satisfactory  
Ventilation: Eave and ridge vent  
Plumbing Vents: - A flashing (boot) at a plumbing vent located above the S.W. side of the home is bent upwards which could result in moisture intrusion. This vent may be positioned the wrong direction  
Flues: Satisfactory  
Flashing: Satisfactory  
- The weather-proof cover is not installed at a roof fall protection anchor located at the East facing roof area

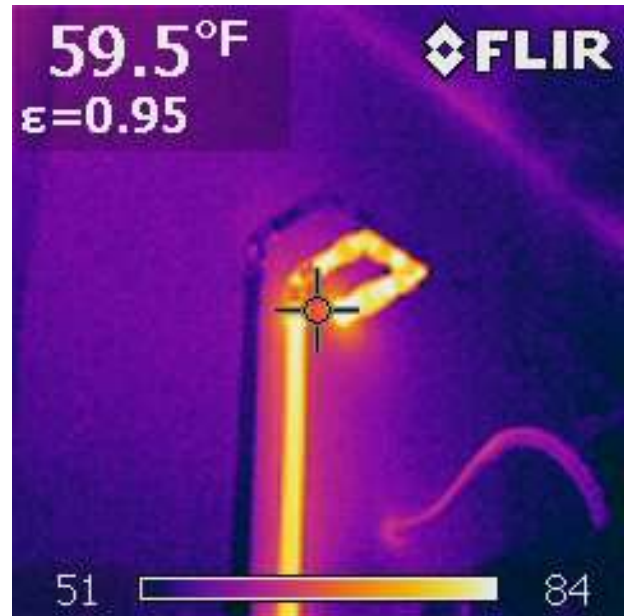
Domestic water pipes

- The garage doors do not auto reverse with reasonable force. Recommend adjustment to the auto reverse sensitivity setting
- All domestic water pipes within the garage should be insulated
