(425) 652-6515
www.Hergert.com
Kevin @ Hergert.com
Wa. Home Inspector 619
WSDA Inspector 79988
WSDA Control # 11168Q-014

Property Description: Upper level condominium
Estimated property age: Built 1995 per info on web
Occupancy Status: Vacant

Inspection Date: 10/12/2019
Inspection Time: 2:00 P.M. - 3:30 P.M. +-
Weather Conditions: Overcast, 60 deg f +-

Hergert Inspection LLC

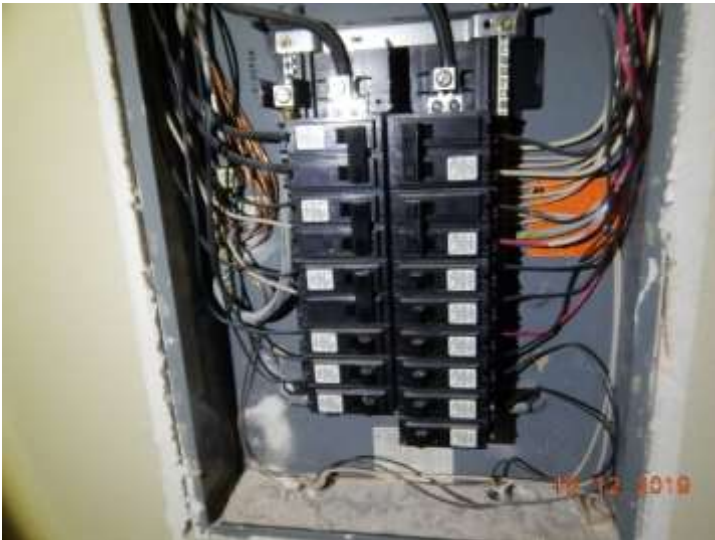
Electrical panel

Type: Copper romex and multi-strand aluminum
Breakers: No visible defects
Circuit breaker legend: Appears proper and complete. Individual circuit breakers are not tested
-

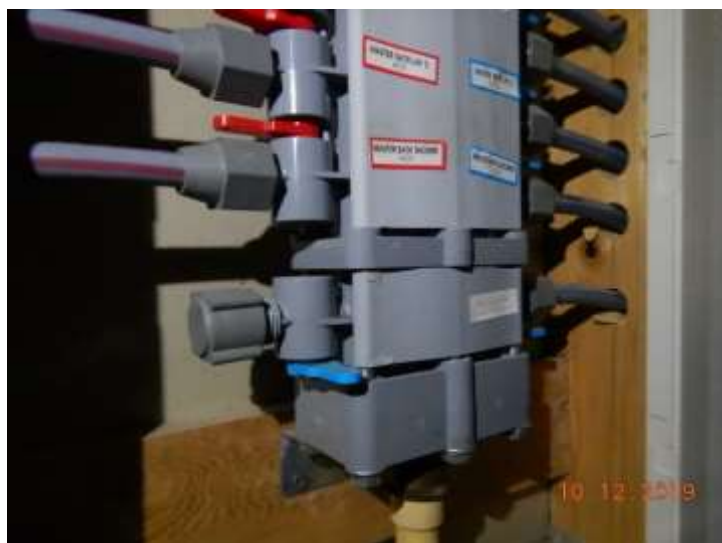
Domestic water shut off

Main Water Shut off: @ laundry room

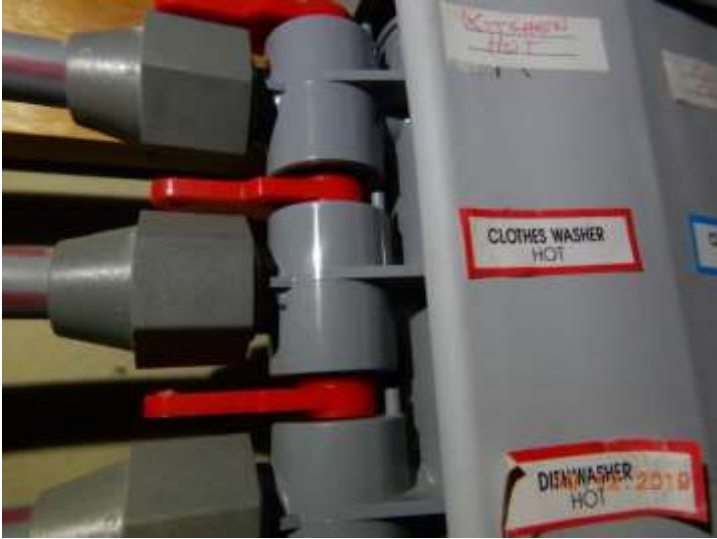
Domestic water supply pipe

- The water distribution pipes within the home are polybutylene. The system is a manifold system with individual supply shut off valves at the manifold. This type of piping is a known defect

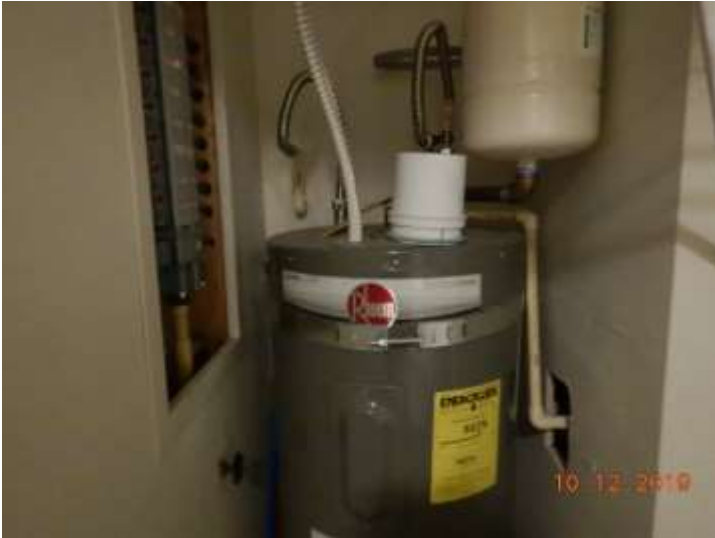
Water Heater

Location: Laundry room
Manufacturer: Rheem
Fuel Type: Electric
Capacity: 50 gallon

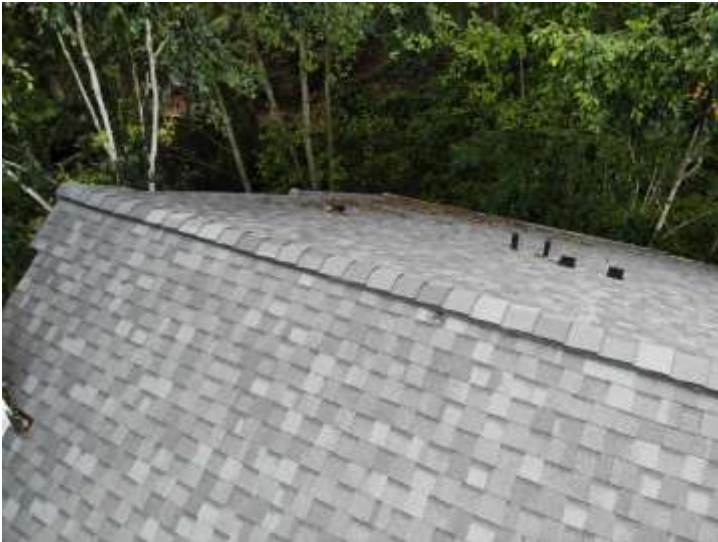
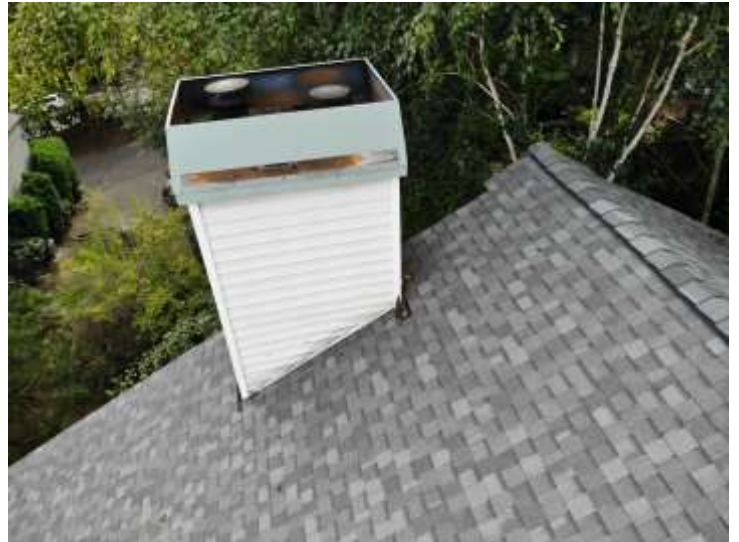
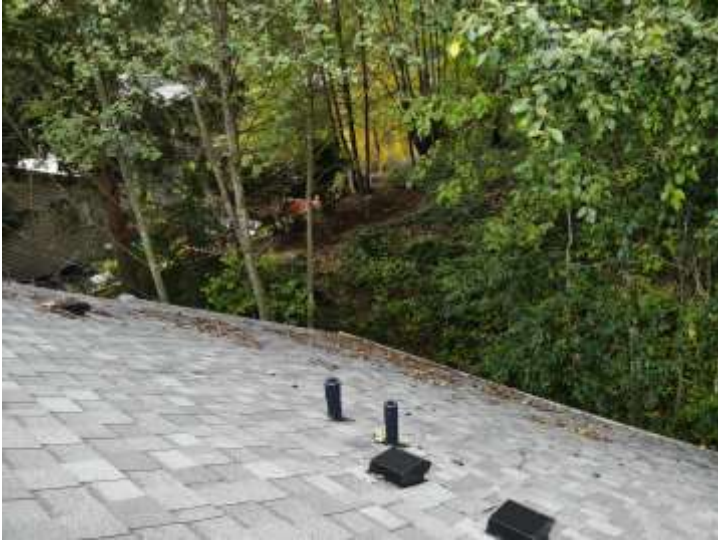
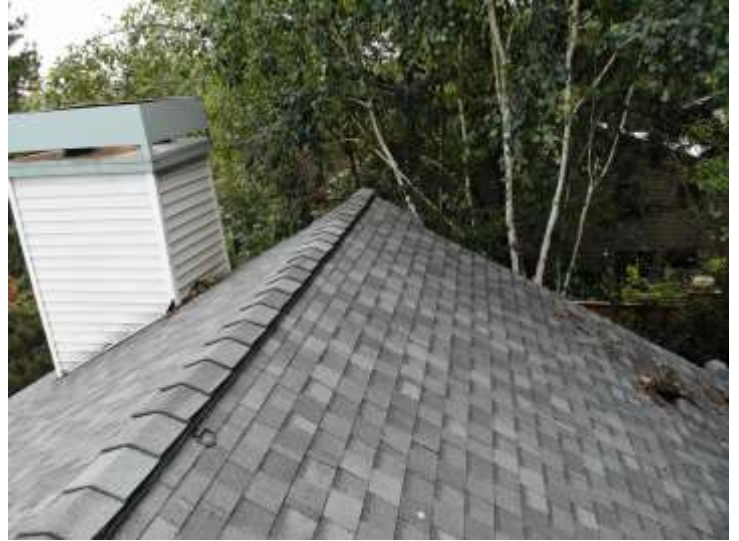
Estimated Pitch: 4:12
Material: Composition
Layers: 1+
How Inspected: From the deck eave, the street, rear yard, and a drone
Roof access condition: Roof was not traversed as traversing the roof is deemed unsafe by the inspector
Condition: Overall satisfactory
Ventilation: Eave and ridge vent
Plumbing Vents: Satisfactory
Flues: Satisfactory
Flashing: Satisfactory

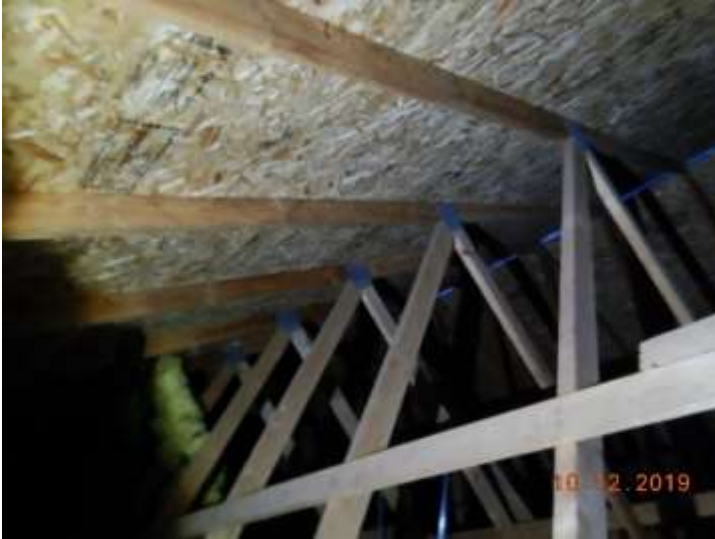
Attic (typical)

Visibility: Space is vacant
Access location: Master Bedroom closet
How viewed: From the attic access as all accessible areas are visible from the access
