Property Description: Townhouse style condominium
Estimated property age: Built 1998 per listing
Occupancy Status: Vacant

Inspection Date: 10/16/2019
Inspection Time: 3:00 P.M. – 5:00 P.M. +-
Weather Conditions: Overcast, 55 deg f +-

Hergert Inspection LLC

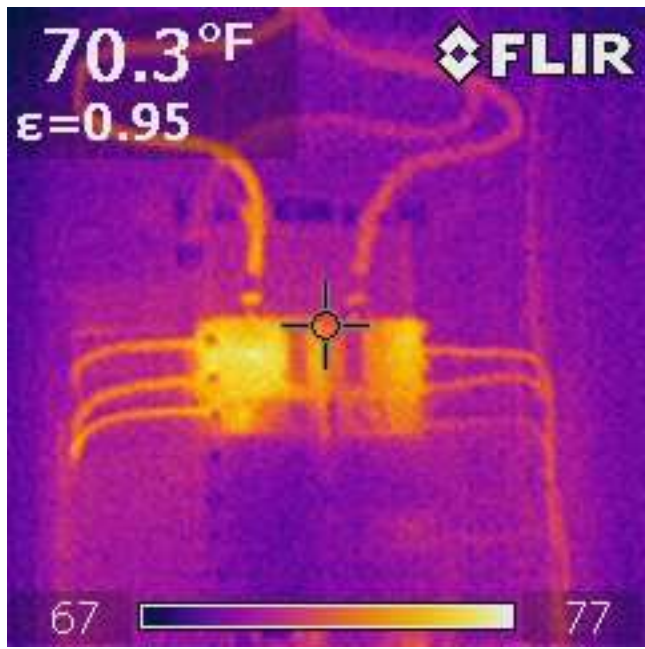
No evidence of overheating

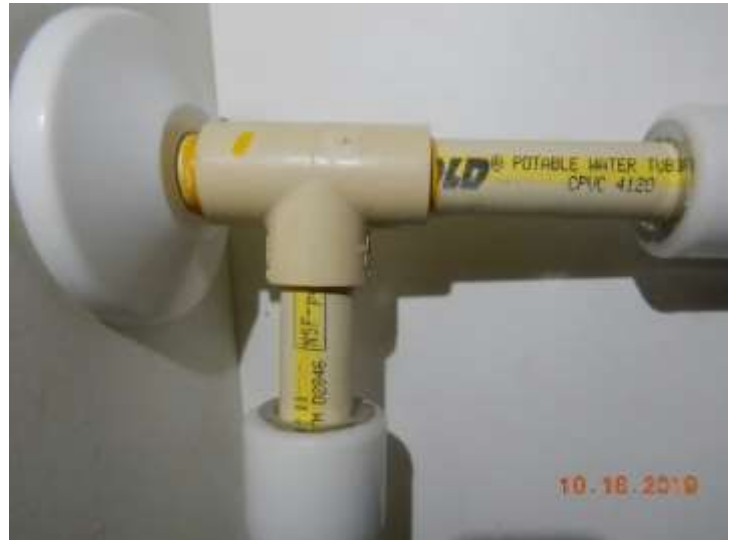
Domestic water distribution pipes

- CPVC water pipes are not considered a known defect, however the pipe as the pipe can become brittle with age, especially the hot water pipes

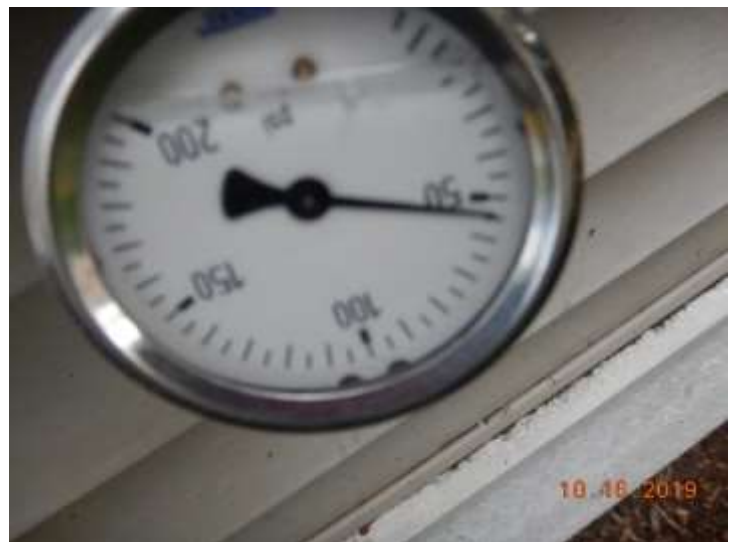
Measured water pressure: 55 P.S.I. Water pressure is adequate and not excessive

Water pressure is adequate and not excessive

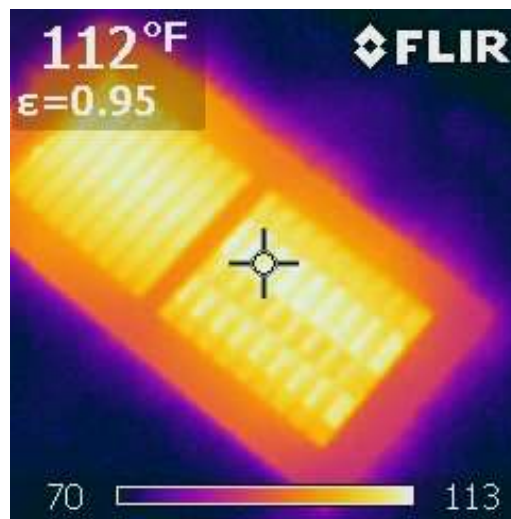
Heat Gain: 42 deg F. Heat gain is within specifications of the furnace

Temperature measured at a heat register

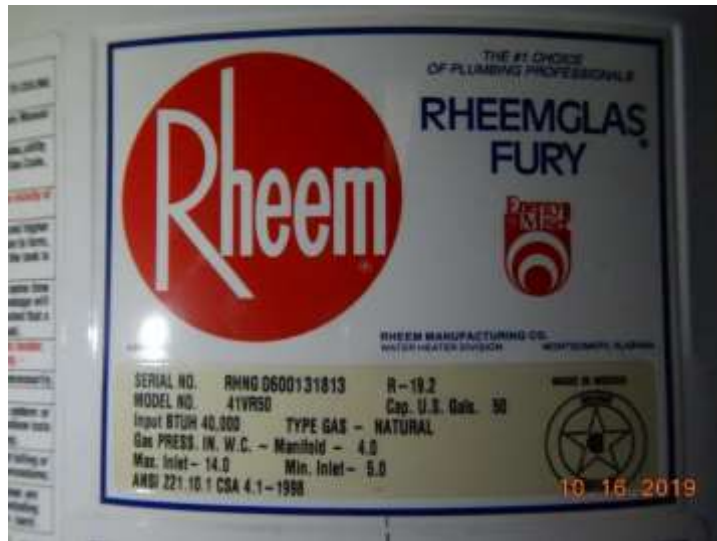
Data plate

Est. Useful Life new: 12 years
Serial number/year: Rhng 0600131813. Ansi 1998
Est. age of heater: 19 years based on the serial number
Est. remaining life: - The water heater is fully functional with no visible evidence of rusting, however is past the end of its anticipated useful life expectancy by 7 years

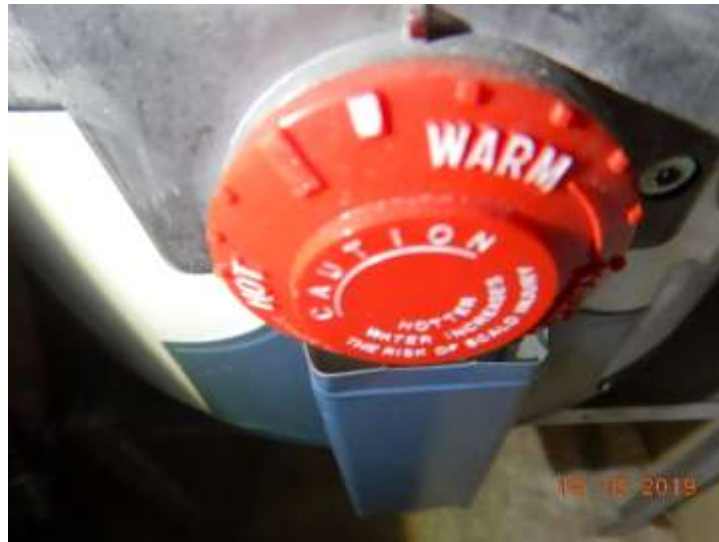
Temperature setting

TPR valve: As per required
Earthquake Straps: Installed
Safe water temperature: 120 deg F per industry standards
Measured temperature: The water heater is set to vacation; not measured

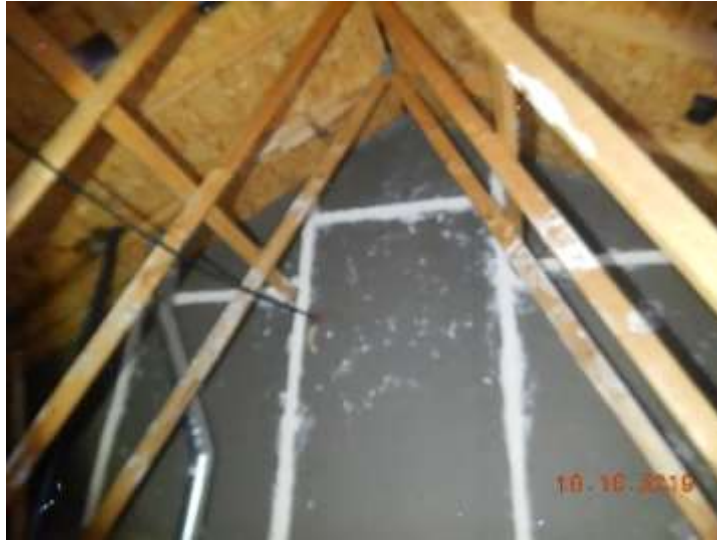
A unit to unit firewall is installed

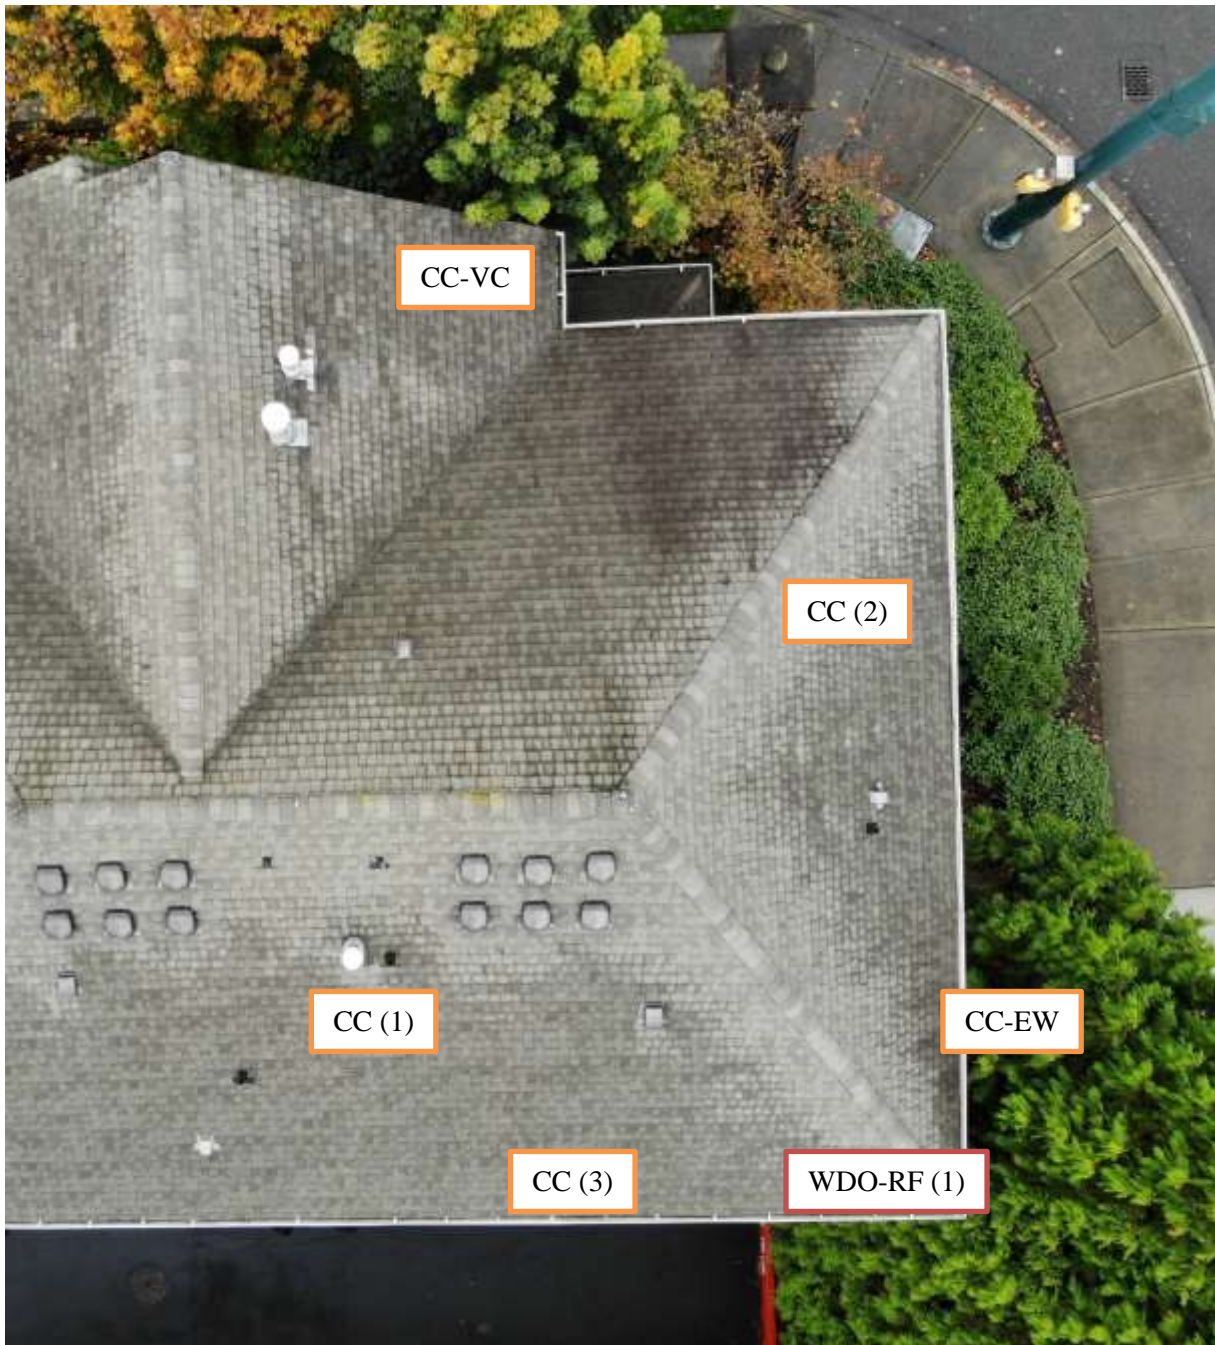
CC-EW Ground in contact with structure
CC-VC Vegetation contact with structure
CC-EM Excessive Moisture

CC (1) Moisture seepage at a plumbing vent (roof)
CC (2) Plumbing leak into living room
CC (3) Broken hose bib pipe (when active)
