Client:
Address: xxxx , Sammamish

Property Description: (2) story single family home
Estimated property age: Built 2021 per King Co.
Occupancy Status: Occupied

Inspection Date: 09/23/2022
Inspection Time: 9:30 A.M. - 11:30 A.M. +-
Weather Conditions: Overcast, 65 deg f +-

Hergert Inspection LLC

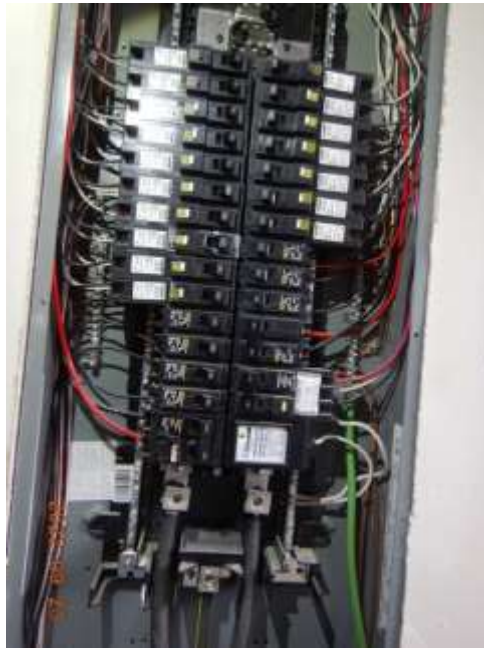
Electrical panel

Location: Garage
Manufacturer: Square D
Type: Dual bus bar
Panel Rating: 200 AMP
Main Disconnect: 200 AMP
Serv. wire Size/ Rating: Estimated 200 AMP
Sub-panel: None located
Grounding: No visibility
Panel Clearance: Appears adequate
Panel Cover: No visible defects identified

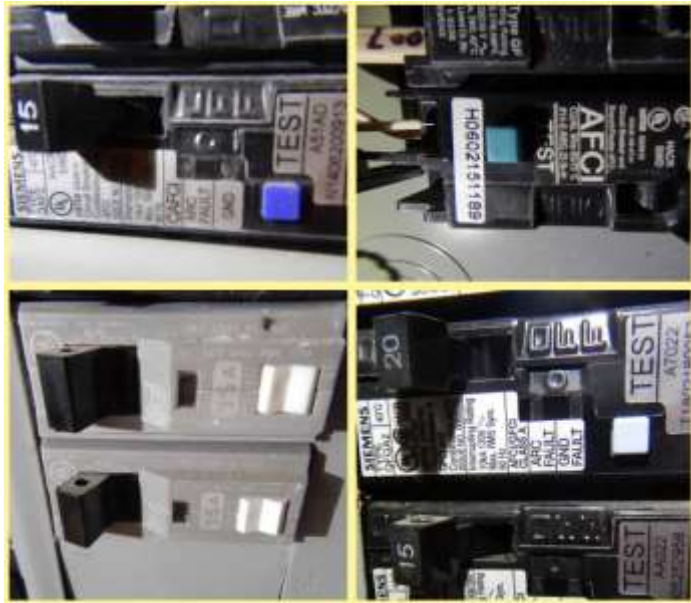
Various arc fault breakers

Type: Copper and multi-strand aluminum where visible
Breakers: No visible defects identified
Arc fault breakers: - The arc fault breakers were not tested as the circuits were in active use by the occupants.

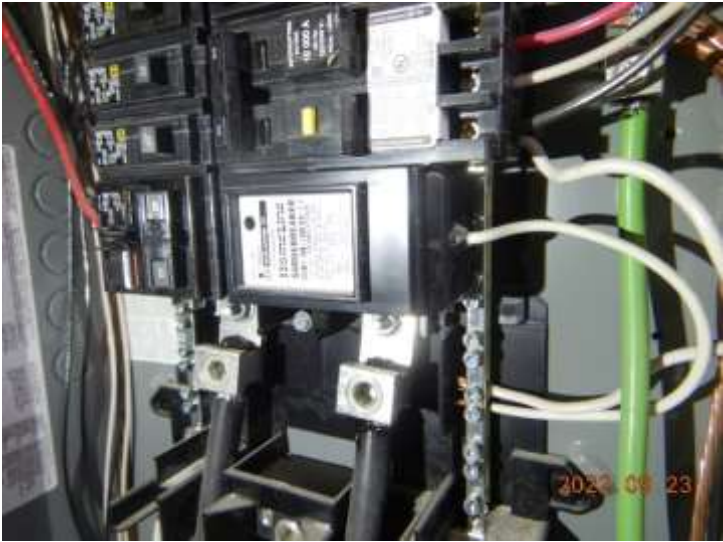
A surge protector is located at the electrical panel

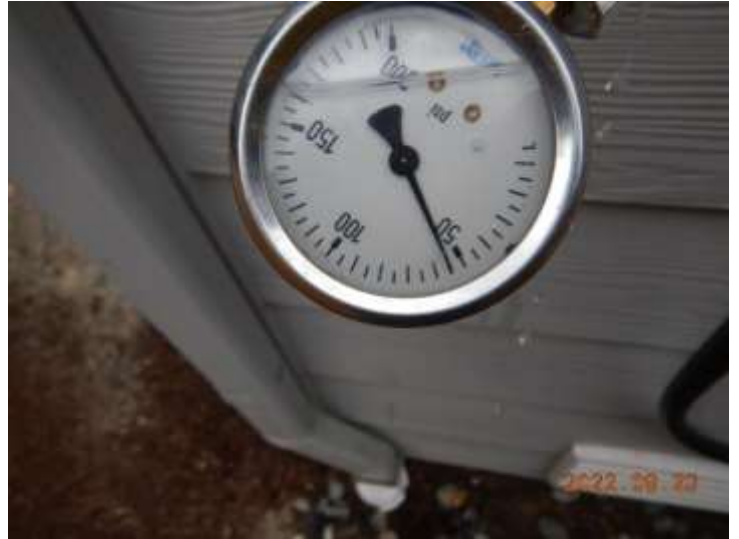
Measured water pressure: 55 P.S.I. Water pressure is adequate and not excessive

Water pressure is adequate and not excessive

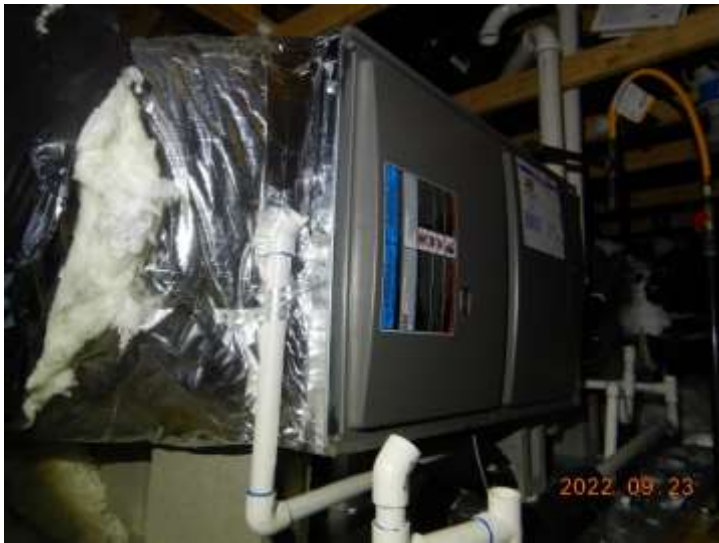
Furnace

Location: Attic
Make/ Model: Lennox
Fuel Type: Natural gas (electricity is needed for this system to operate)
BTUH Input: Not noted
BTUH Output: Not noted
Efficiency Rating: High-efficiency

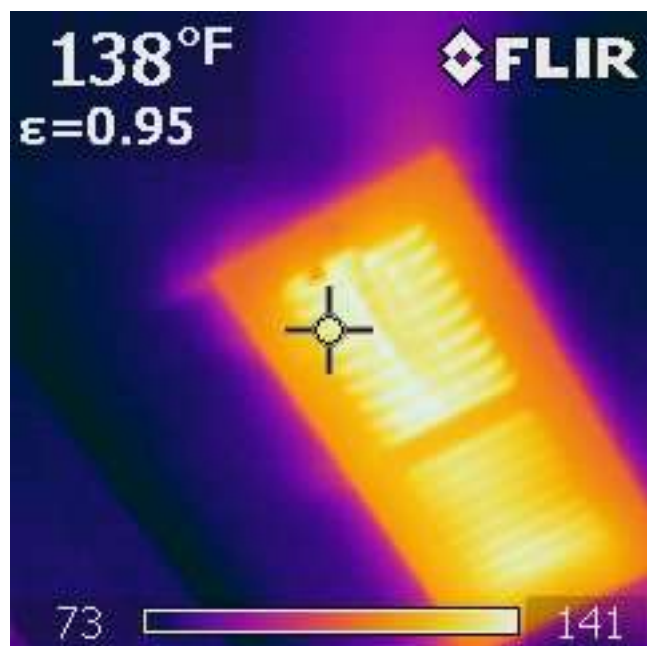
Rating: Not noted
Interior temperature: 70 deg F (approximate)
@ register: 141 deg F
Heat Gain: 71 deg F. Heat gain appears to be sufficient

Temperature measured at a heat register

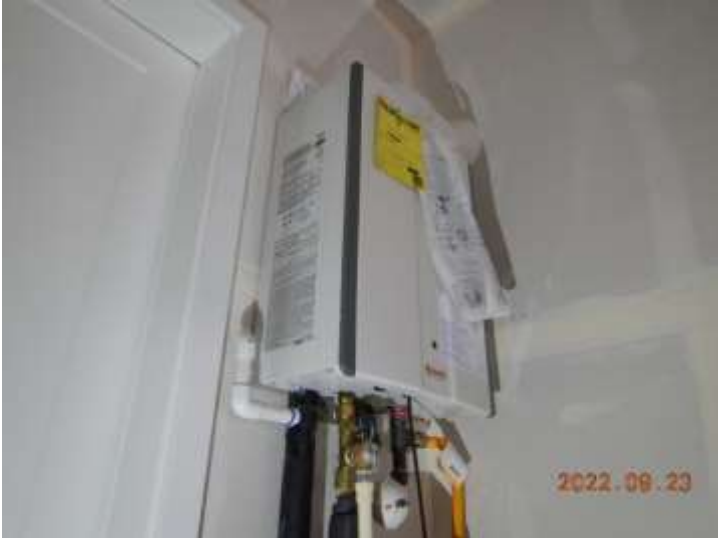
Water Heater

Location: Garage
Manufacturer: Rinnai
Fuel Type: Natural gas (electricity is needed for this system to operate)
Capacity: Tankless

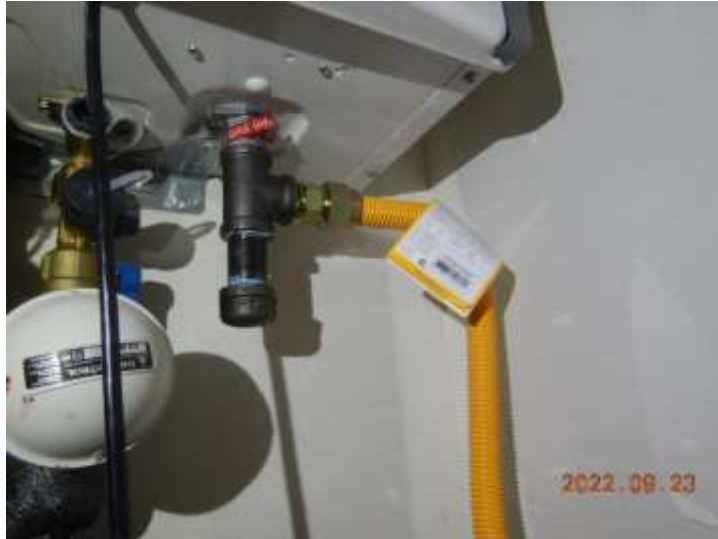
A proper gas shut off valve and sediment trap are installed

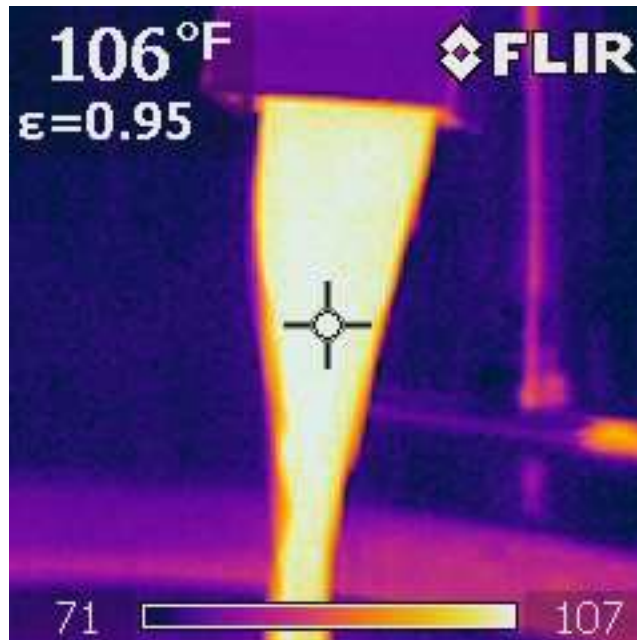
Hot water temperature

Measured temperature: 107 deg F

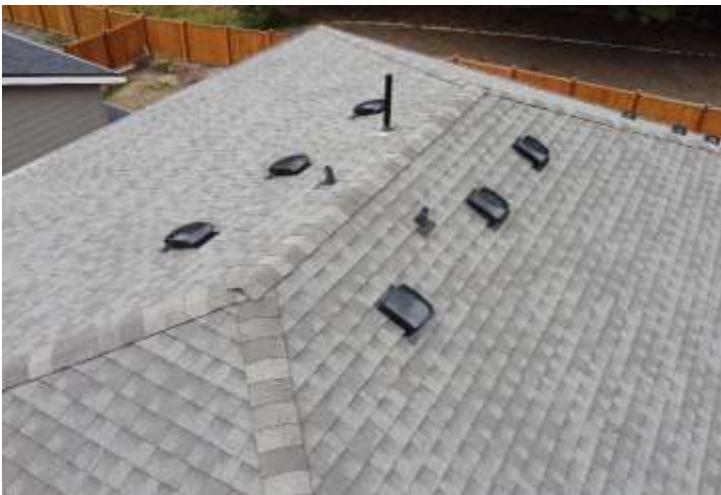
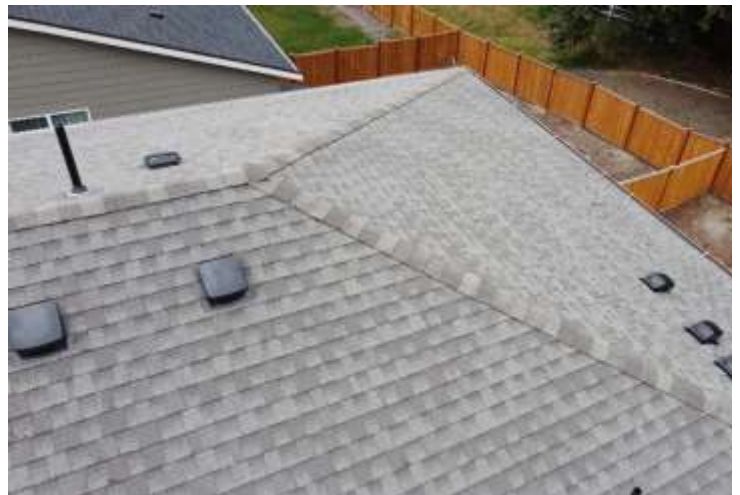
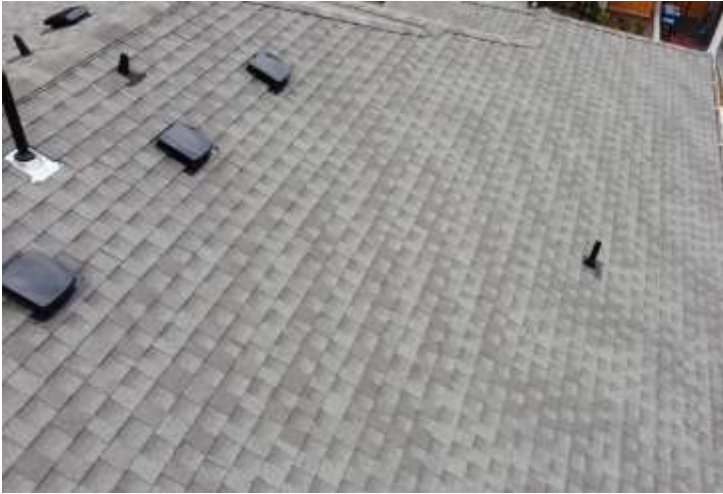
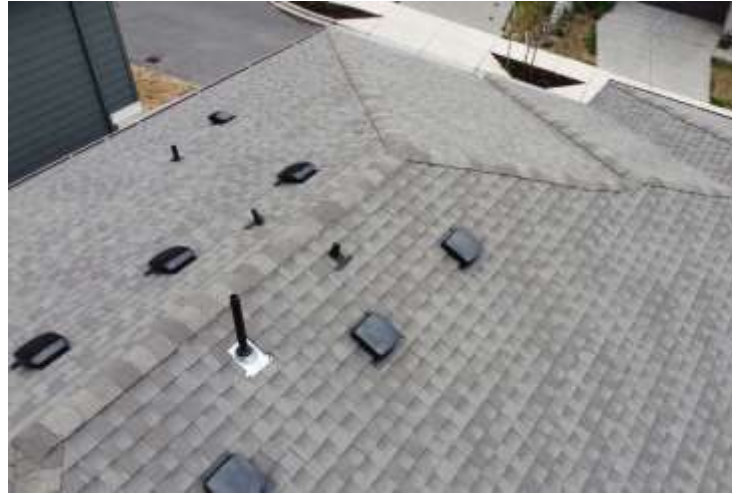
Roof (typical)

Condition: Overall satisfactory

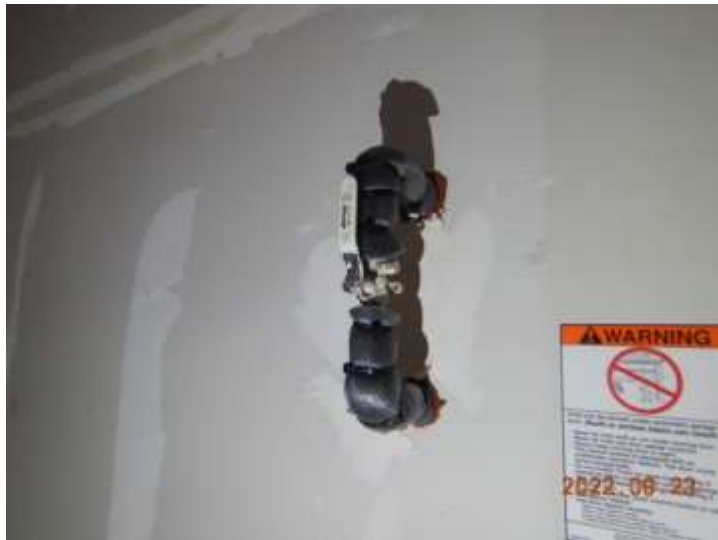
A cold weather shut off valve for the front hose bib is located in the garage

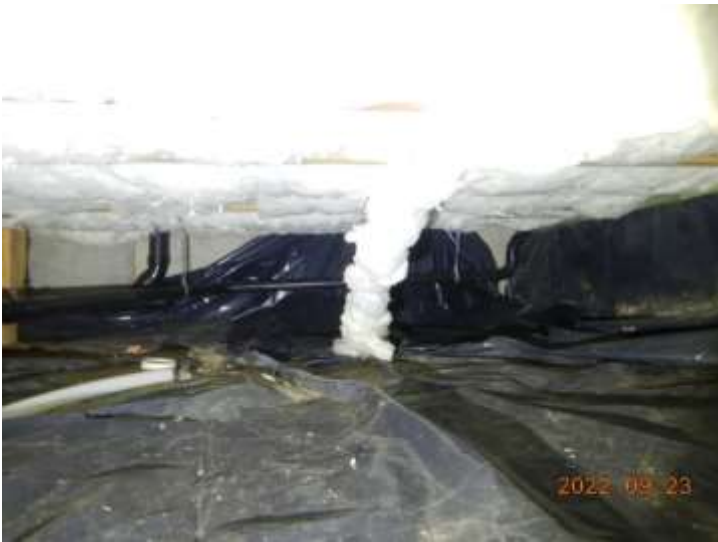
Crawlspace (typical)

Visibility: Space is vacant, except as noted below
- All construction debris should be removed from the crawlspace.

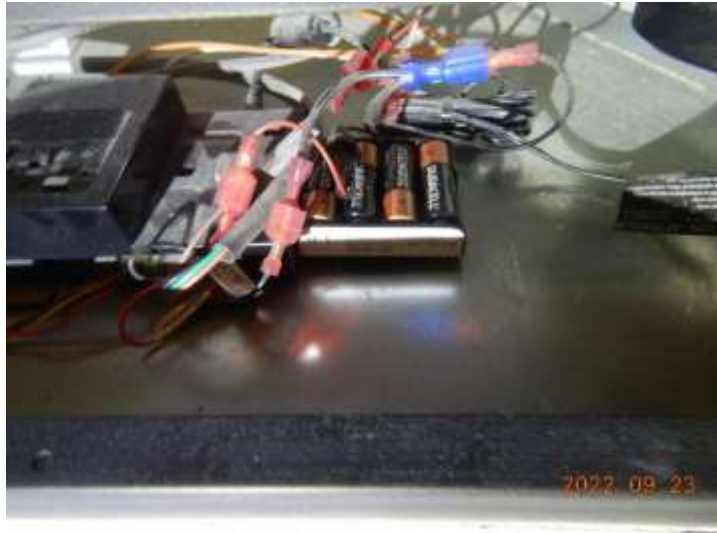
A battery backup compartment is provided to ignite the fireplace during a power outage. The batteries should be installed in the fall and removed in the spring as the batteries will corrode if left in place for an extended period of time
