Client:  
Address: xxxxxx, Black Diamond, WA 98010

Property Description: (2) story single family home  
Estimated property age: Built 2021 per King Co.  
Occupancy Status: Occupied

Inspection Date: 11/19/2022  
Inspection Time: 1:00 P.M. - 3:00 P.M. +-  
Weather Conditions: Overcast, 45 deg f +-

Hergert Inspection LLC

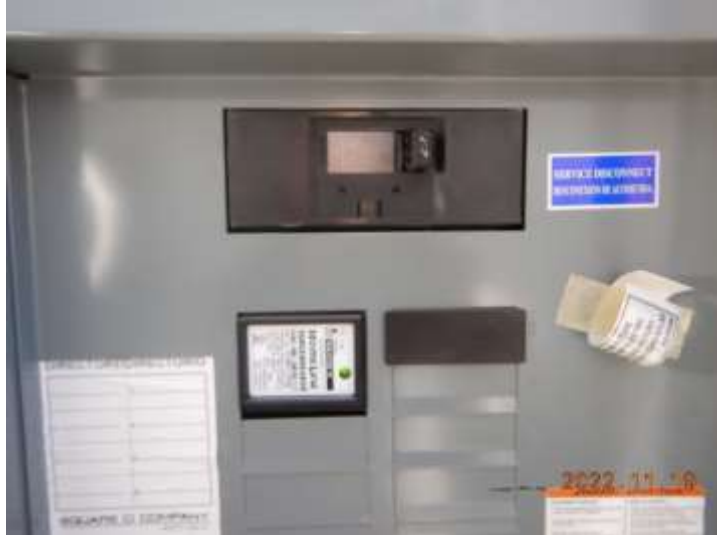
Type: Underground  
Condition: No visible defects identified  
Meter Location: Side of garage

Exterior electrical disconnect

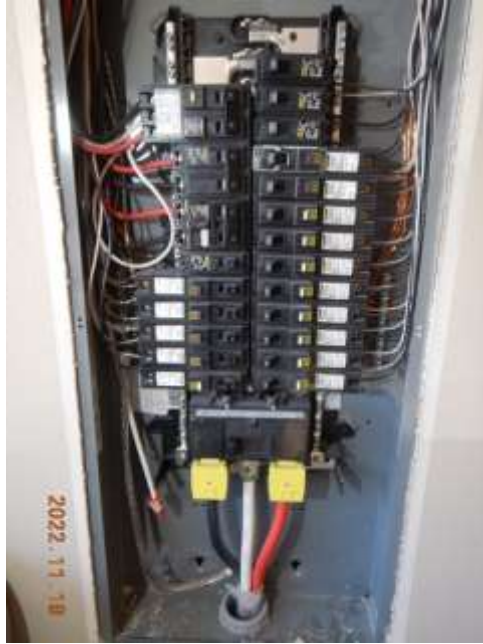
Location: Garage  
Manufacturer: Square D  
Type: Dual bus bar  
Panel Rating: 200 AMP  
Main Disconnect: 200 AMP  
Serv. wire Size/ Rating: Estimated 200 AMP  
Sub-panel: Yes  
Grounding: No visibility  
Panel Clearance: Appears adequate  
Panel Cover: No visible defects identified

Electrical panel

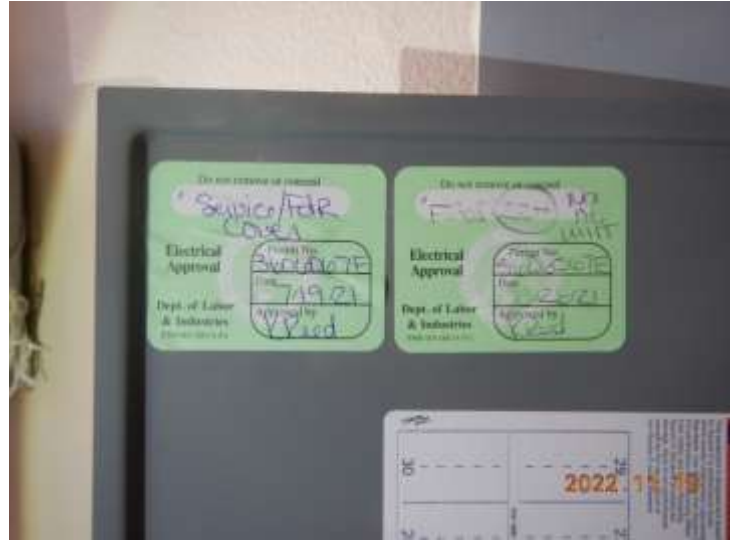
Electric service permit tags

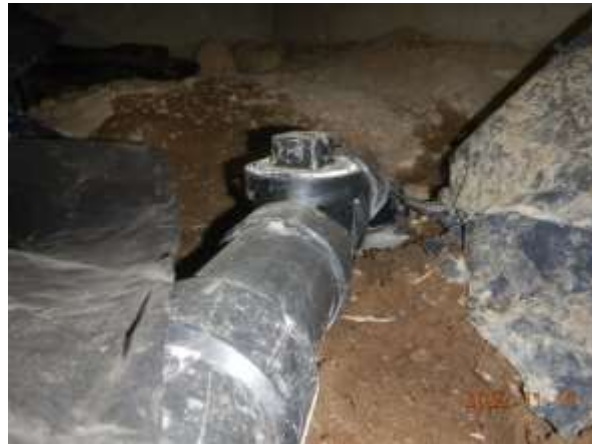
House Piping: ABS where visible

ABS waste lines

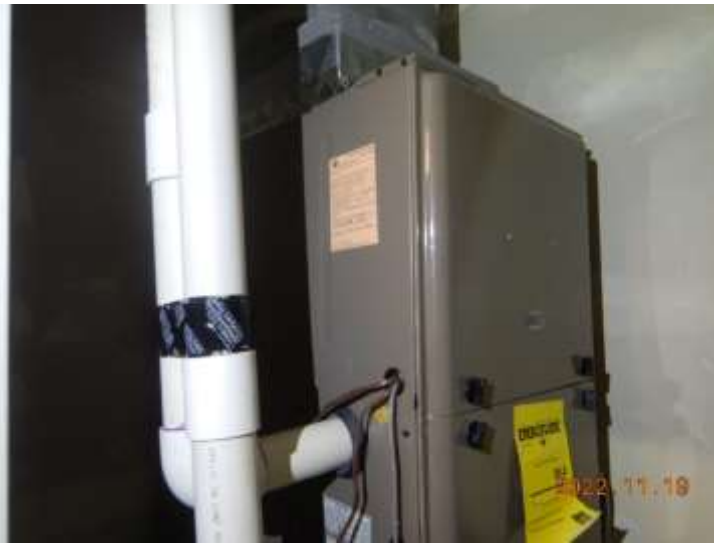
Furnace

Location: Hallway closet  
Make/ Model: Not noted  
Fuel Type: Natural gas (electricity is needed for this system to operate)  
BTUH Input: 60,000  
BTUH Output: 57,000  
Efficiency Rating: High-efficiency

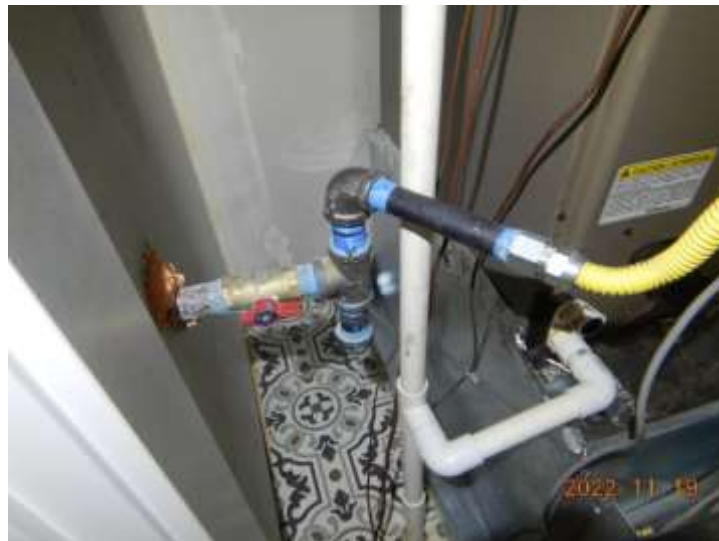
Gas piping: No visible defects identified

A proper gas shut off valve and sediment trap are installed

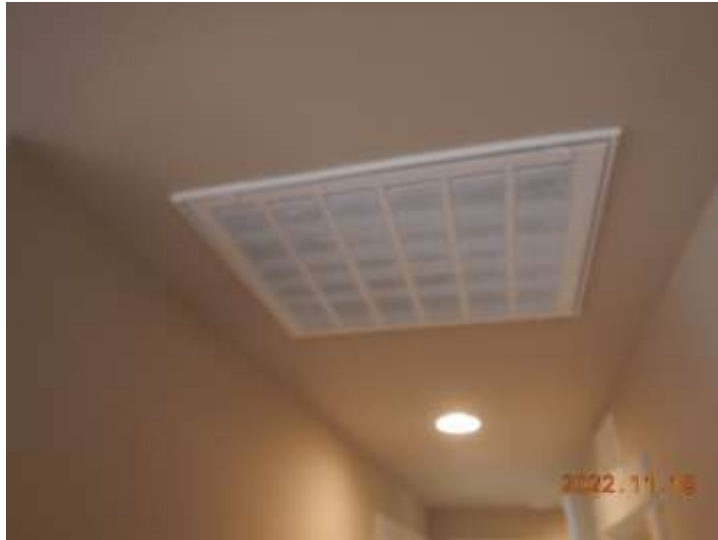
Filter: Located at the return air intake

Furnace filter location

*Note: The condition of the furnace filter is not a part of an inspection. A new filter should be installed when moving into the property.*

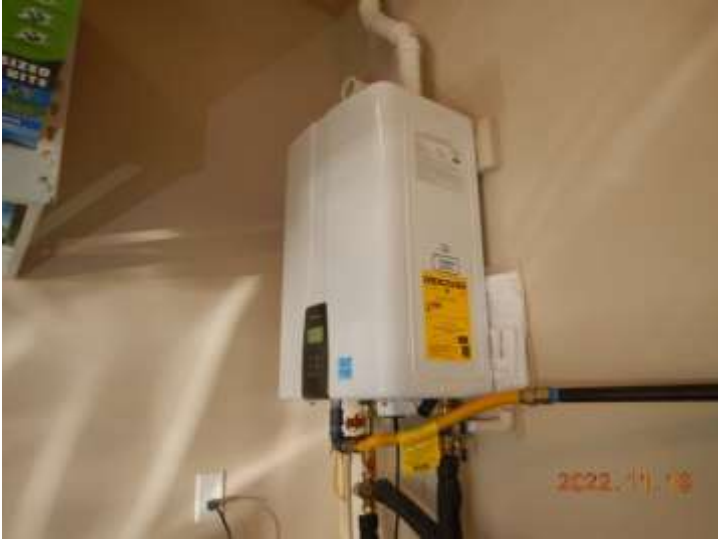
Water Heater

Location: Garage  
Manufacturer: Navien  
Fuel Type: Natural gas (electricity is needed for this system to operate)  
Capacity: Tankless

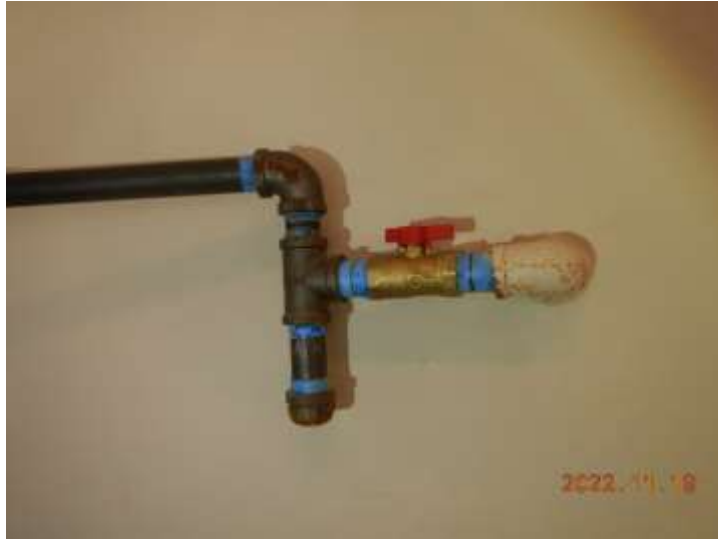
Gas flue: No visible defects identified  
Clearances: Appears adequate  
Draft Hood: not applicable; direct vent  
Gas piping: No visible defects identified  
Water connection: No visible defects identified  
Expansion Tank: No visible defects identified

A proper gas shut off valve and sediment trap are installed

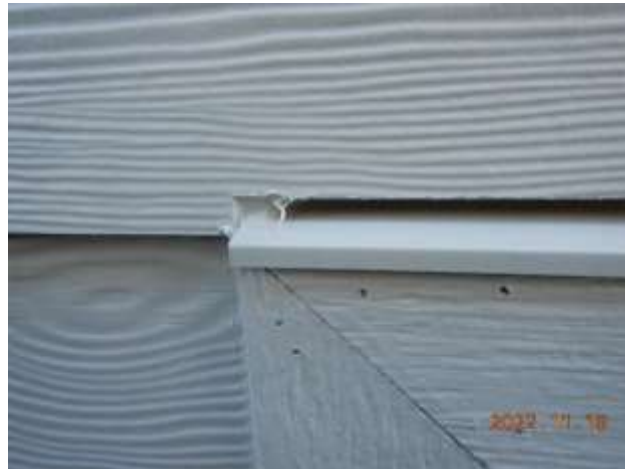
Proper head flashings are installed

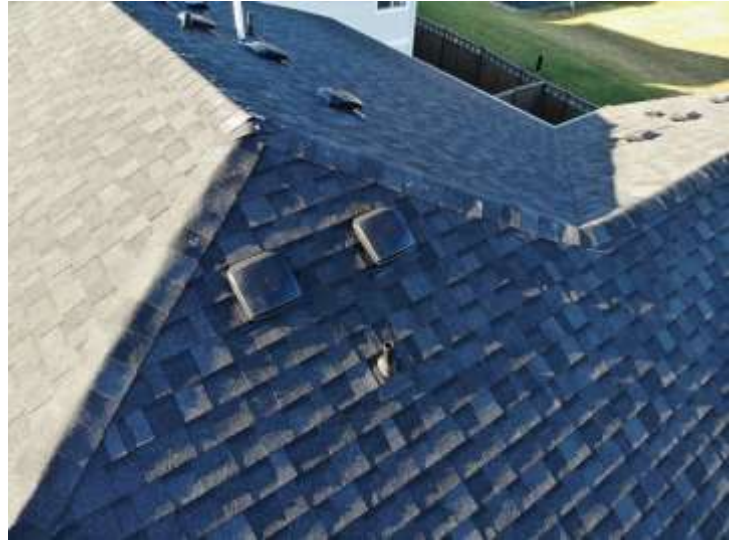
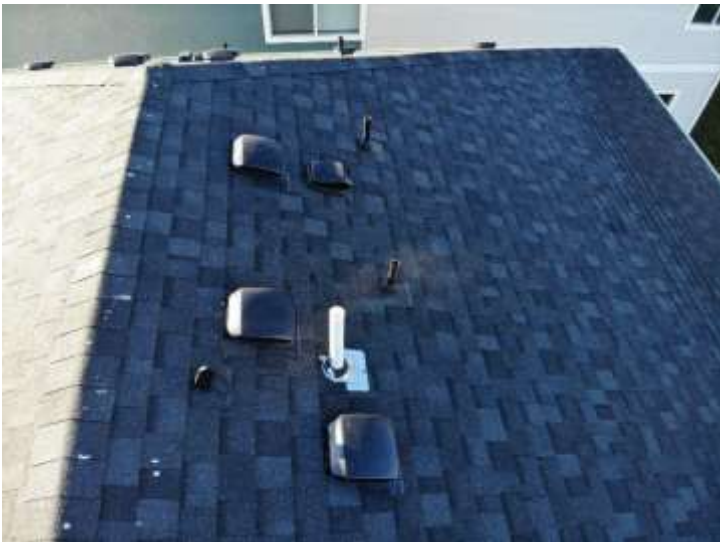
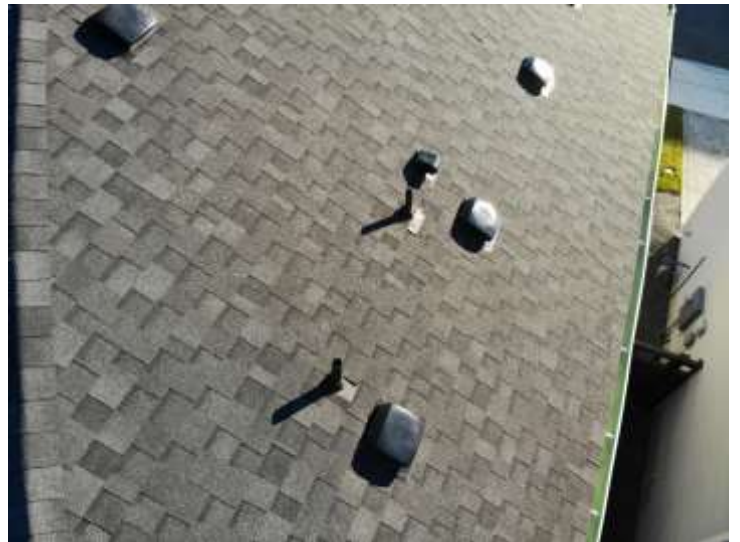
Estimated Pitch: 4:12  
Material: Composition  
Layers: 1+  
How Inspected: From floor 2, the street, rear yard, and a drone  
Roof access condition: Roof was not traversed as traversing the roof is deemed unsafe by the inspector  
Condition: Overall satisfactory  
Ventilation: Eave and roof hat vents  
Flashing: No visible defects identified, except as noted below  
- The top of the false beams should be covered with metal flashing or roofing to prevent wood rot.  
Plumbing Vents: No visible defects identified  
Flues and Chimneys: No visible defects identified

Roof (typical)

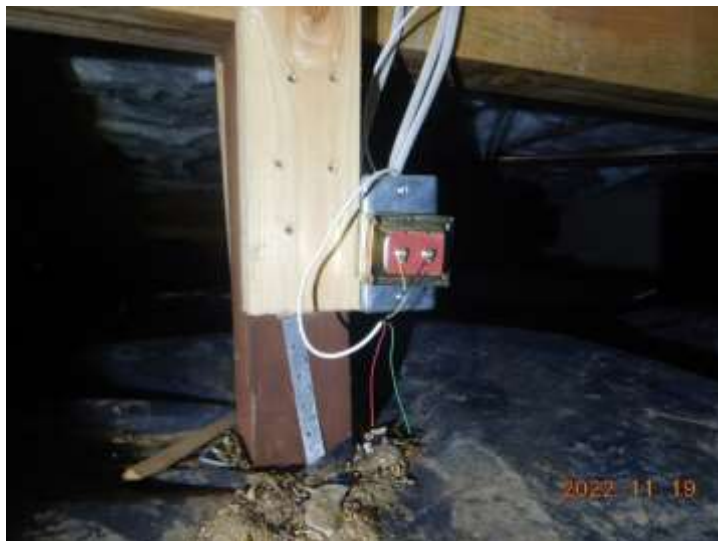
The doorbell transformer is located in the Crawlspace

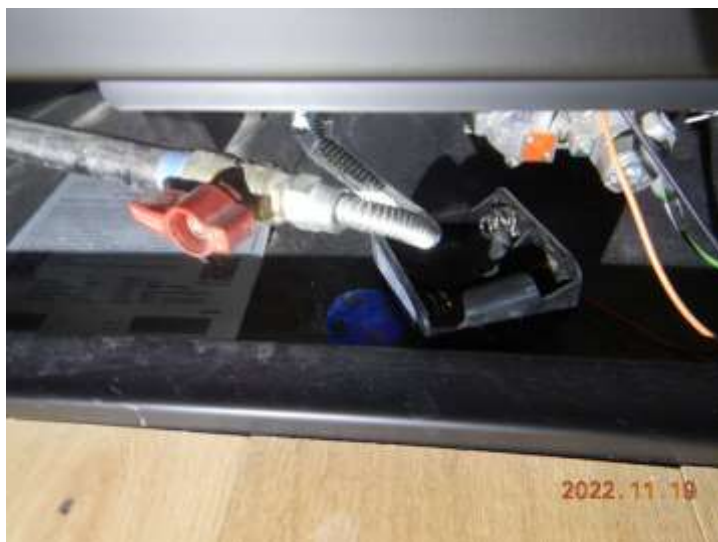
Type: Direct vent gas fireplace  
*Tip: the inside of the glass cover of sealed direct vent gas fireplaces tends to become dirty over time. The glass can be removed for cleaning purposes. All gas valves should be in the Off position during removal of the glass and cleaning*  
Tested: Ignition of the fireplace  
Condition: Satisfactory where visible

A battery backup compartment is provided to ignite the fireplace during a power outage. The batteries should be installed in the fall and removed in the spring as the batteries will corrode if left in place for an extended period of time

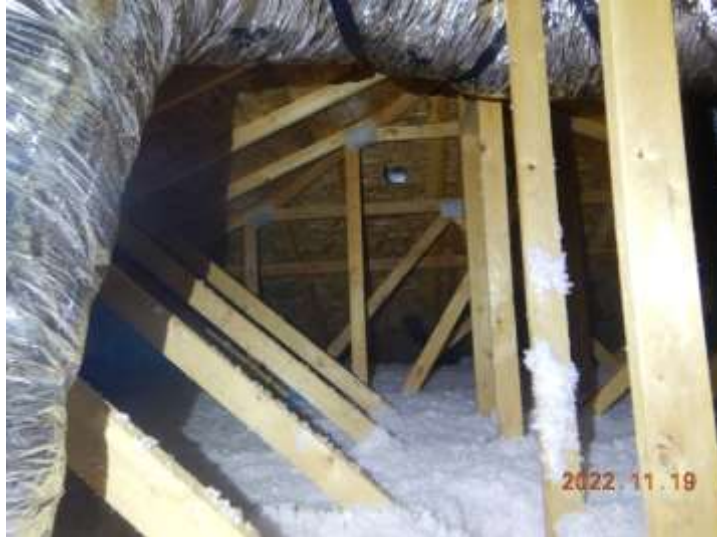
Attic

Visibility: Space is vacant  
Access location: Hallway  
How viewed: From the attic access as traversing the attic will damage the blown in insulation

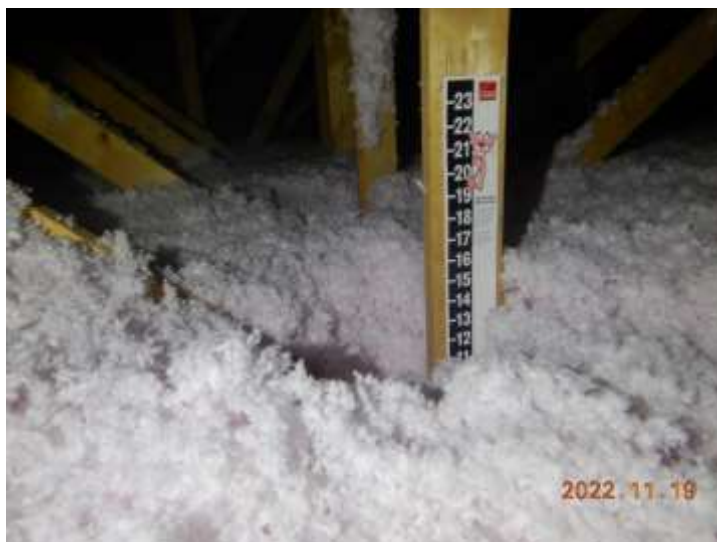
Type: Blown in  
Condition: Insulation is installed in the attic

Insulation depth measurement in the Attic  
(measurement by others)

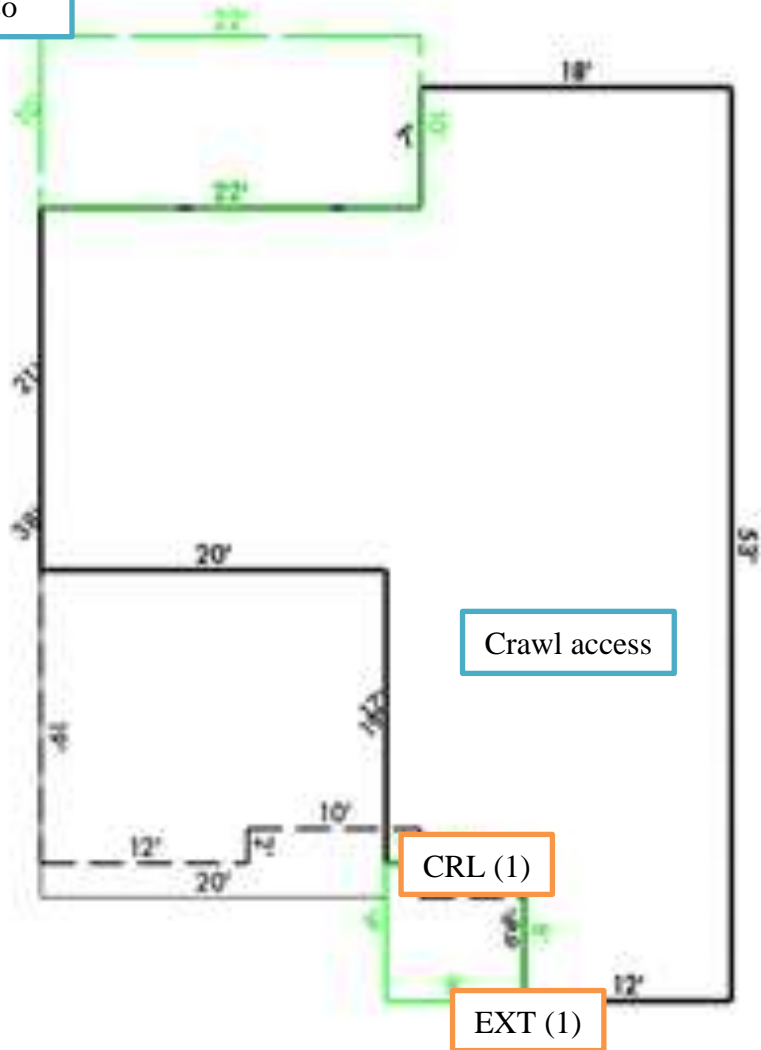
Exterior	EXT (1): Exposed top of false beams (typical)
Attic	There are no structural pests or substantive conducive conditions identified.
Interior/Garage	There are no structural pests or substantive conducive conditions identified.
Crawlspace	CRL (1): Missing vapor barrier
