(425) 652-6515
www.Hergert.com
Kevin @ Hergert.com
Wa. Home Inspector 619
WSDA Inspector 79988
WSDA Control # 10961AQ-02

Property Description: (1) story single family home
Estimated property age: Built 1956 per listing
Occupancy Status: Vacant

Inspection Date: 11/08/2018
Inspection Time: 1:00 P.M. - 3:00 P.M. +-
Weather Conditions: Clear, 50 deg f +-

Hergert Inspection LLC

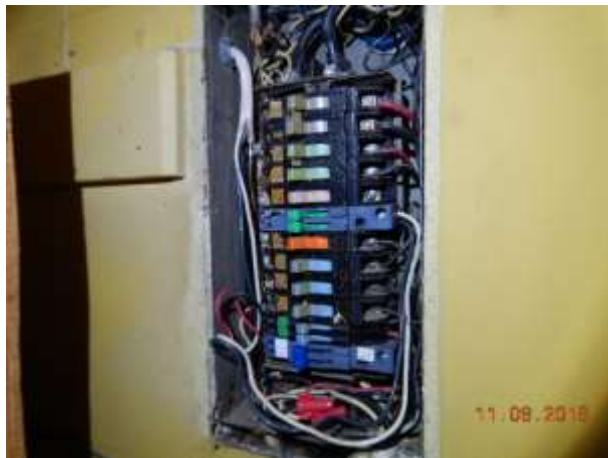
Electrical panel

Location: Dining Room
Manufacturer: Zinsco
- The home is equipped with a Zinsco brand panel. Zinsco components are considered problematic by industry professionals due to their high failure rate. Failure of any component within the electrical system may result in fire and/or electrocution. Evaluation of the panel by a qualified electrician is advised to determine its safety, integrity and performance

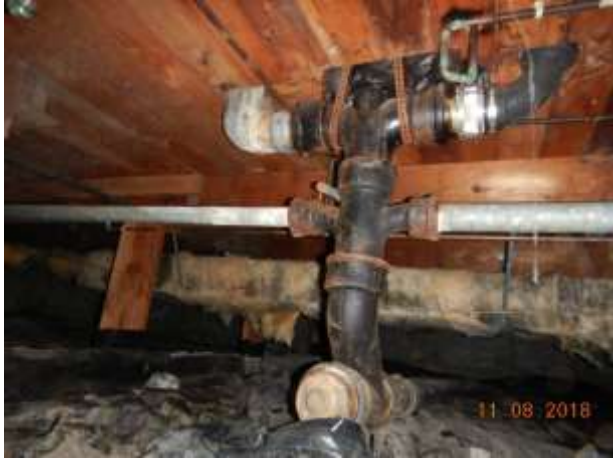
Plumbing waste lines

- Discharge: Public sewer per listing; not included in this inspection
House Piping: ABS, steel, and cast iron where visible
- Recommend a sewer scope due to the age of the property (or verification that the side sewer is "newer")

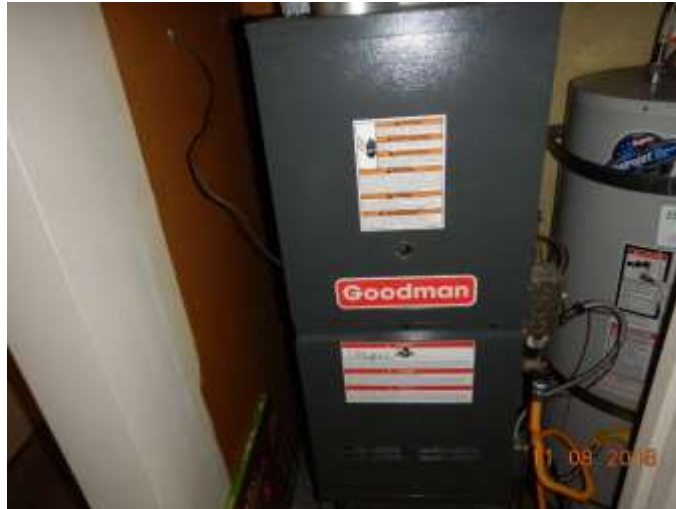
Furnace

- The furnace is 7 years old. The anticipated useful life is 25 years
 - The air conditioning system is 23 years old. The anticipated useful life is 25 years
- Servicing: - Recommend furnace and air conditioning systems to be cleaned, serviced, and shown to be in good working order by a qualified furnace technician. There is no tag on the furnace which indicates any prior servicing of the systems
- *The inspection of the heat exchanger involves dismantling of the components of the furnace and is beyond the scope of a Home Inspection*

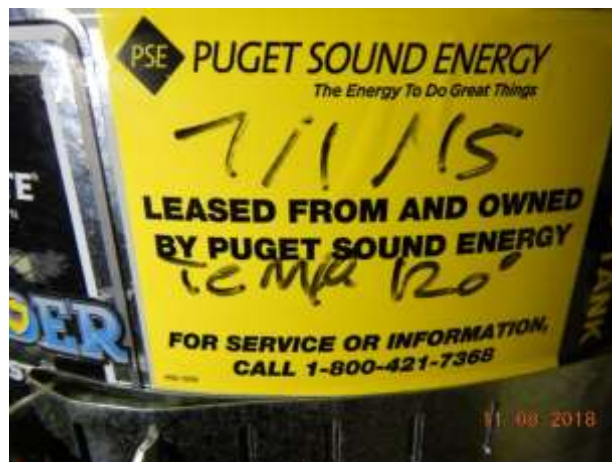
Leasing tag

Est. Useful Life new: 12 years
Serial number MB (2015)
Est. age of heater: 3 years based on the serial number
Est. remaining life: 9 years
- The water heater is leased per the tag on the water heater

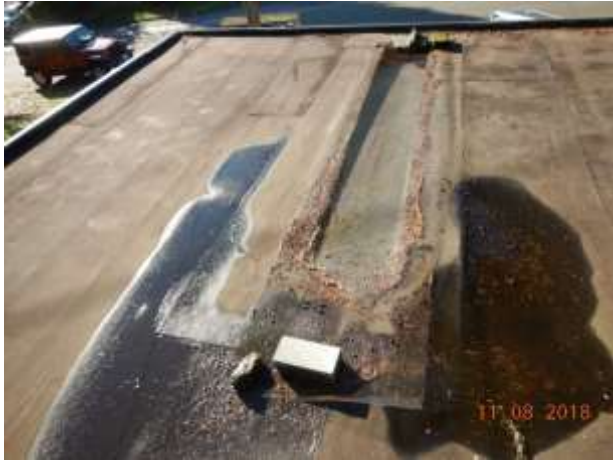
Garage roof

Estimated Pitch: Near flat
Material: Torch down
Layers: 1+
How Inspected: Traversed the roof
Roof access condition: Reasonable and safe access
Condition: - Recommend cleaning the roof of debris and the chimney for the buildup of moss. Do not high pressure wash the roof
Ventilation: Eave and roof hat vents
Plumbing Vents: Satisfactory
Flues: - There is evidence of substantial deterioration (spalling) of the chimney. Recommend repair (AKA tuck pointing) as needed. All cracks at the chimney cap should be properly sealed to prevent moisture intrusion and related damage
Flashing: Satisfactory
