Property Description: Multi-level home
Property age/ size: Built 1958, 2,320 s.f. per King County Assessor
Occupancy Status: Occupied

Inspection Date: 01/21/2012
Inspection Time: 2:00 P.M. – 3:30 P.M. +-
Weather Conditions: Overcast, 40 deg F +-

Hergert Inspection LLC

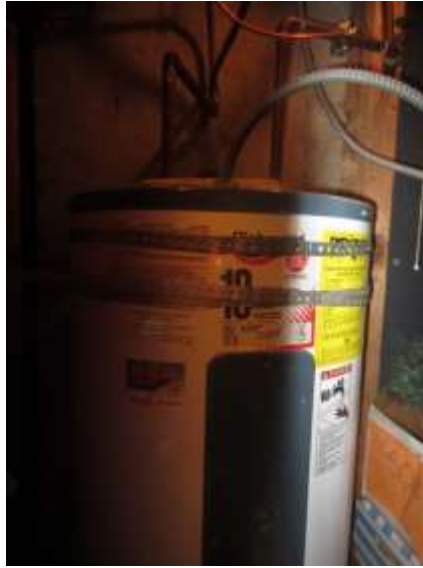
Water Heater

- Water heater is beyond its anticipated useful life expectancy

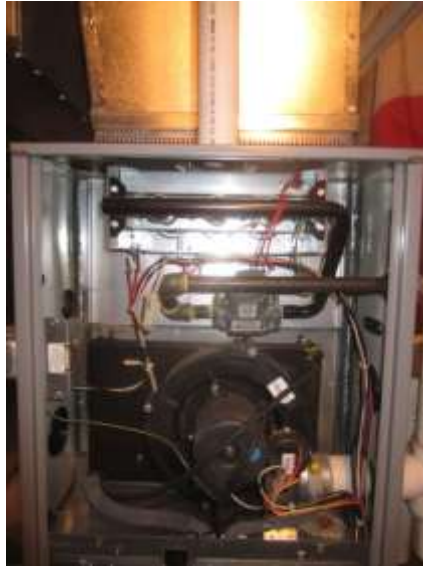
Furnace

- Recommend servicing of furnace by a licensed furnace technician and every (2) years thereafter. There is no visible tag that this furnace has ever been serviced. Evidence of condensate leakage near flue inside furnace

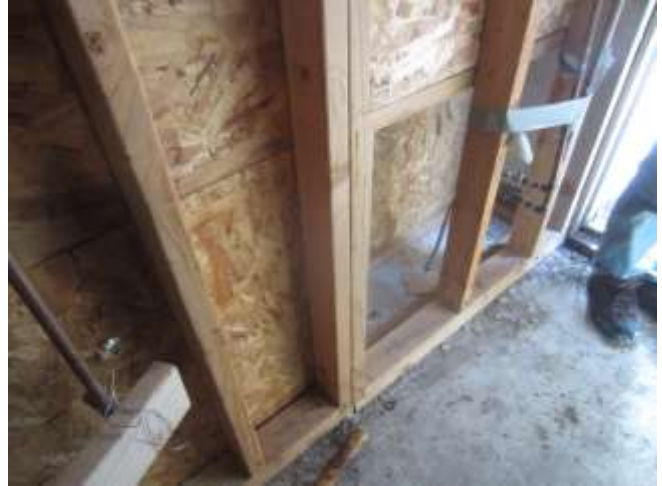
- Rear storage shed has been added as habitable space. Unknown if an appropriate building permit was obtained from the City of Bellevue. Construction is not consistent with current building codes

Partition separating the new bathroom and remaining storage shed area
